CK-2124  
2124B

HARRISON EAST 60.5km

2022 Inspection

Crossing Name Spade Creek

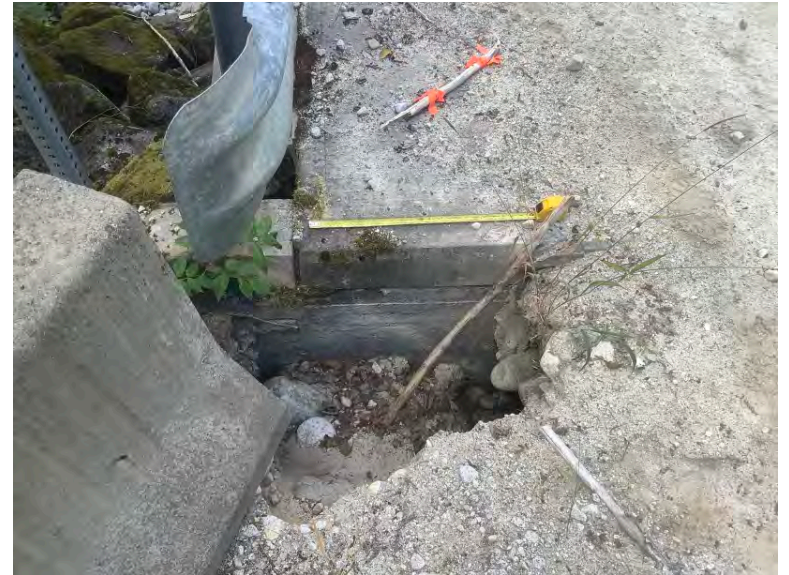
Grading required. Fill eroding fro, behind upstream woods ballast wall.

Fill eroding from behind woods ballast wall

Woods ballast wall eroding.

Eroding fill

Repair/replace the eroded fill from behind right bank ballast wall and monitor the riprap condition. The current load rating of BCL-625 or 64 tonnes to continue.

| Repair Item | Repair Description |
|---|---|
| 1 Approach. Approach fill repair. m³. Priority:Low | Repair fill erosion behind woods ballast wall. |

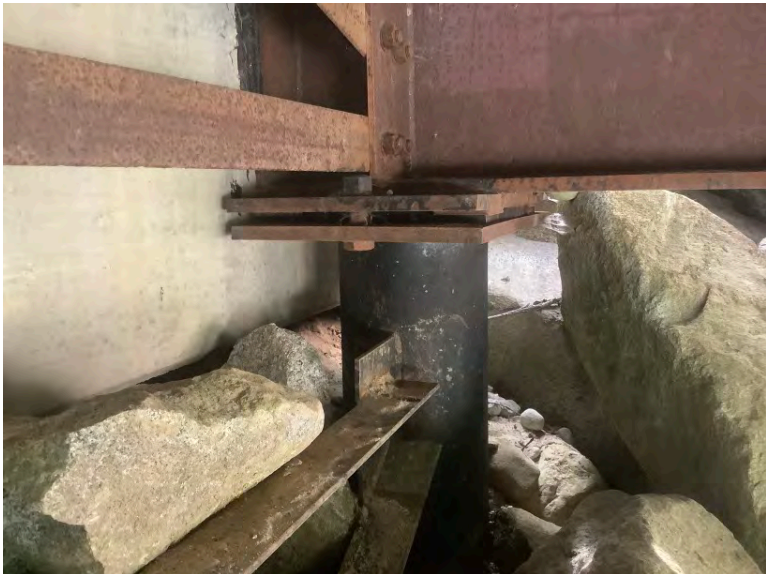
Minor bulging

Bearing

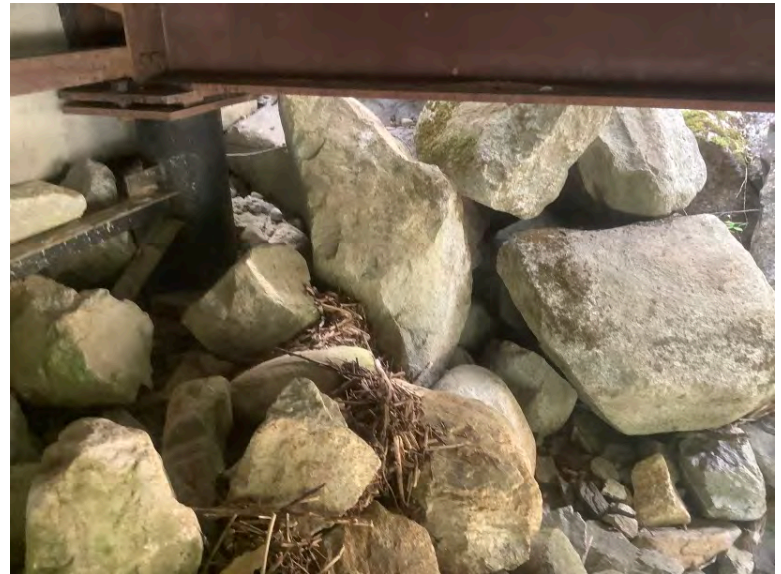
Deposited woody debris

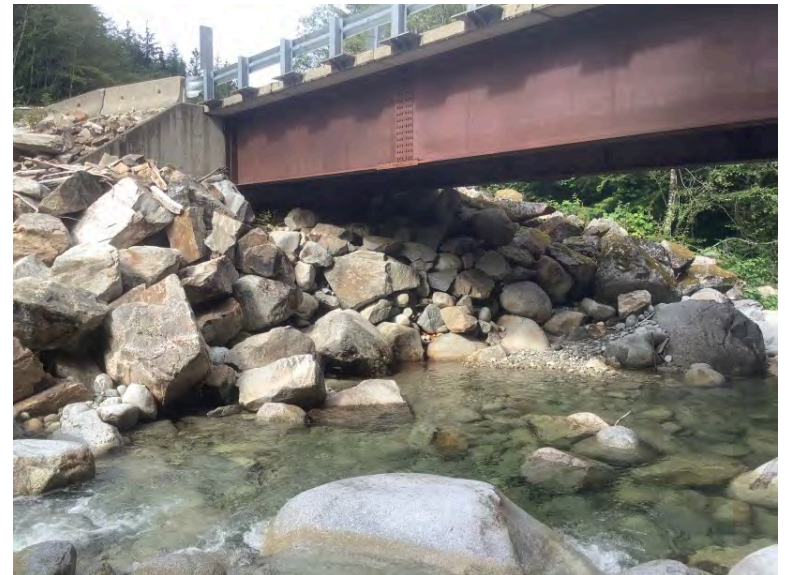
Scour evident beneath structure of both sides. Large rock still present, monitor.

Comments Appears November 2021 storms were within 0.5m of superstructure. Mobilized riprap beneath structure.

Riprap

| Item | Monitor Description | Frequency |
|---|---|---|
| 1 Monitor riprap | | Routine Inspection |
