CK-2125  
CK-2125

HARRISON EAST 71km

2022 Inspection

Structure Class Major Culvert

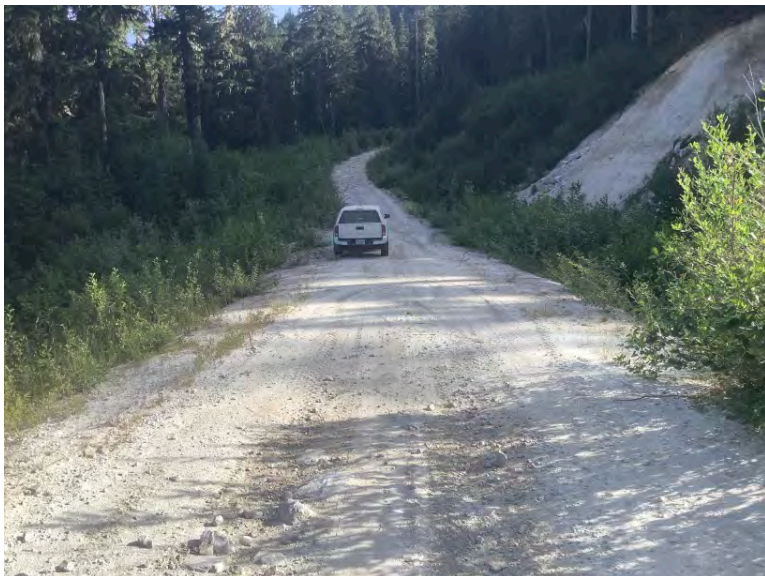
Road over culvert

Road Surface **Fair**

Appears to have puddles on running surface. Crowning road recommended.

| Repair Item | Repair Description |
|---|---|
| 1 Approach. Approach surfacing grading. m. Priority:Low | Grade to control surface water |

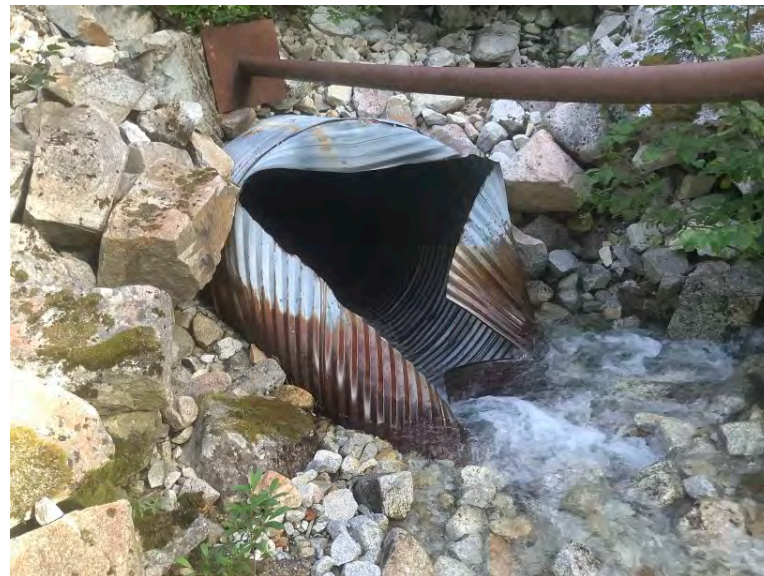
Inlet Fair Bent, increased risk of plugging

Comments Bent inlet increases risk of plugging. Monitor upstream fill slope for continued erosion. Road to crossing is 4x4 access only.

Comments: monitor for debris build up at inlet, high risk of plugging.

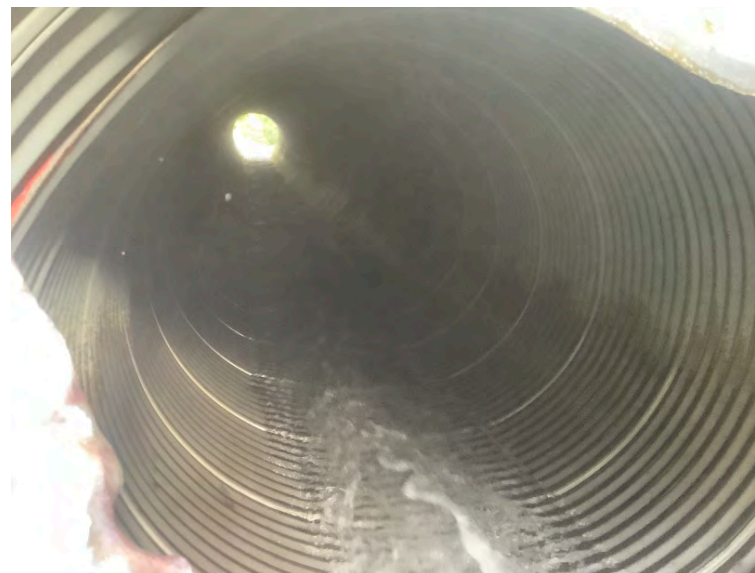
Culvert Floor

Floor Fair

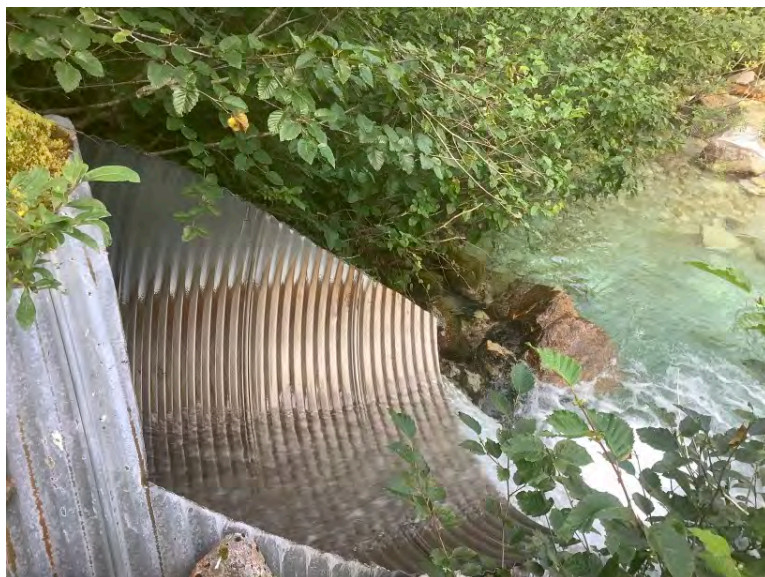
Outlet Good

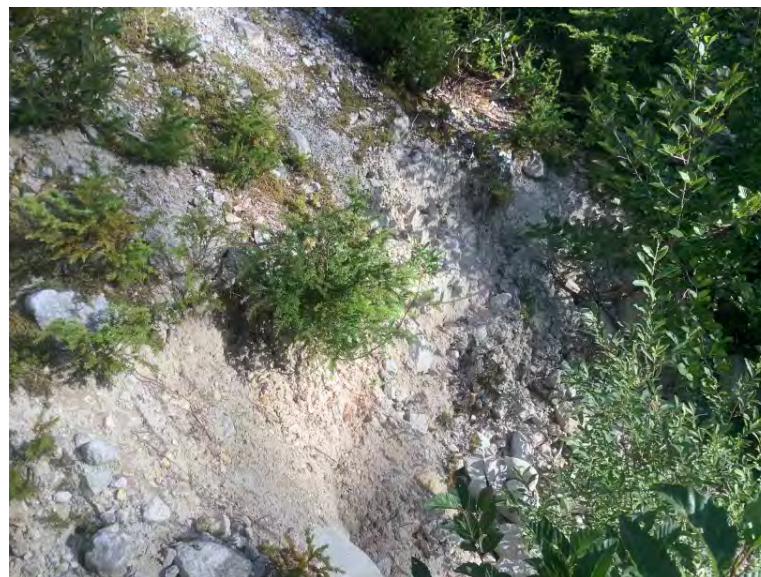
Fill **Fair** grading to control surface water on road, some fill movement on upstream fill slope.

Fill slope instability

| Item | Monitor Description | Frequency |
|---|---|---|
| 1 Upstream fill slop | | Routine Inspection |
