CK-2126  
CK-2126

BEAR 7500 0.1km

2022 Inspection

Crossing Name Bear Creek

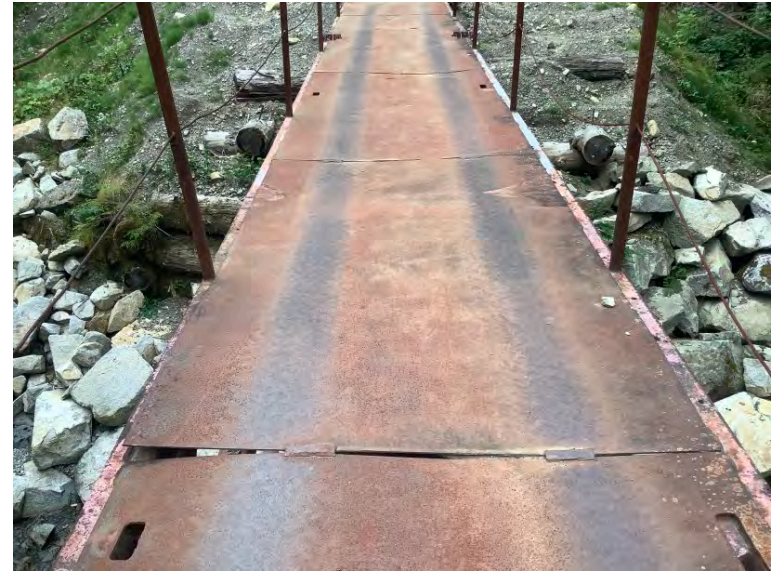
Deck

Warping, left approach is bent up. Drops when you walk over it

Uprights bent and cable no longer fit for guard rail/safety barrier

Cable is loose

Poor

Due to safety cable

Comments: either deactivate structure, or install barriers to prevent ATV access, and install warning signs, pedestrian only, repair guard rails cables

| Repair Item | Repair Description |
|---|---|
| 1 Miscellaneous. Deactivate Crossing. # of items.<br>Priority:High | Install Road closure signs, guard wire should be tightened if structure remains accessible to public. |

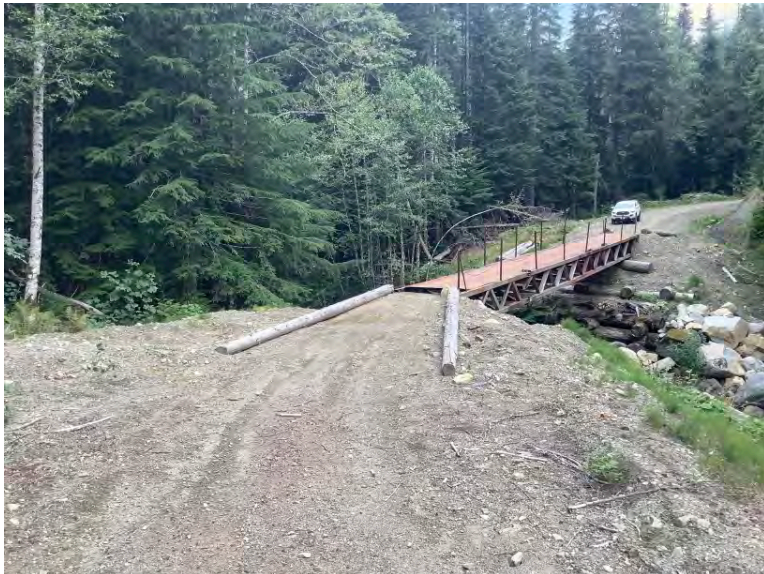
Approach from Left Bank when facing downstream

HC and vc left approach

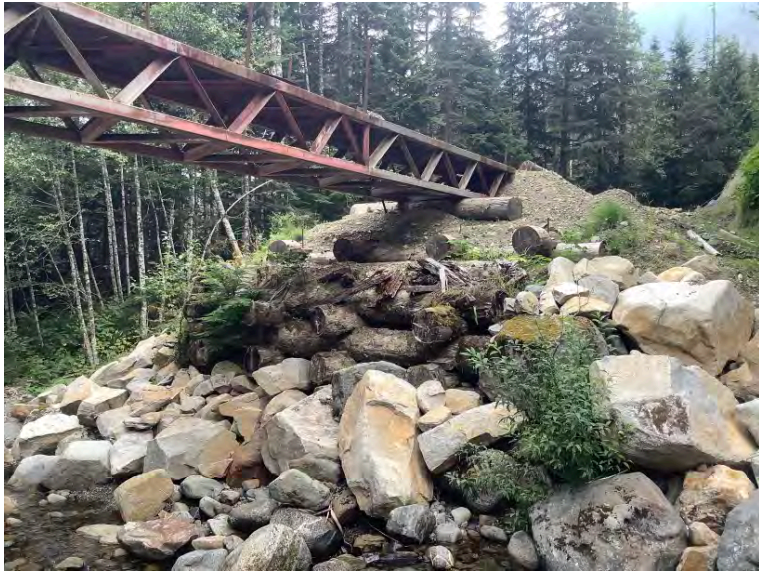
Right Bank Abutment when facing downstream

Log/Timber Cribs Poor

Original cribs 4x. Second crib set back from original 2x with top log removed.

Tie Backs Poor

4x rotting

| Item | Monitor Description | Frequency |
|---|---|---|
| 1 | Crib logs for failure of fill retention. | Routine Inspection |

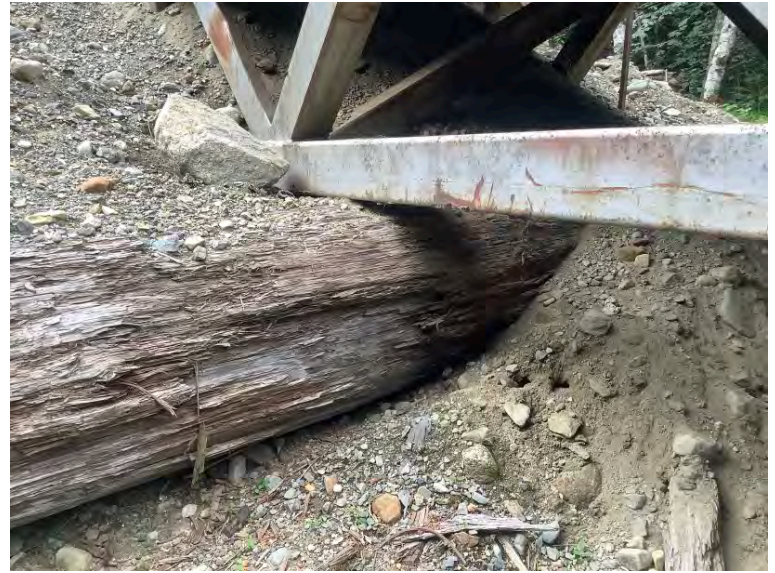
Bearing

Bearings Fair

Sufficient

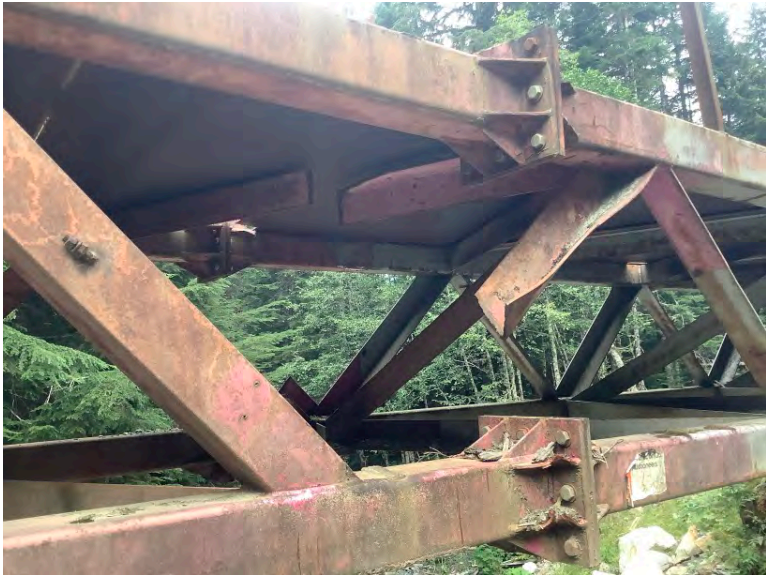
Splice

Appears to be old tower with plate steel welded onto it and safety uprights and cables. One bolted splice, all webbing is cut at this location. Old Richie brothers sticker, likely bought as foot
