CK-2130  
CK-2130-2

## STS'AILES (WEST) 12.8km

2022 Inspection

Crossing Name Wells Creek

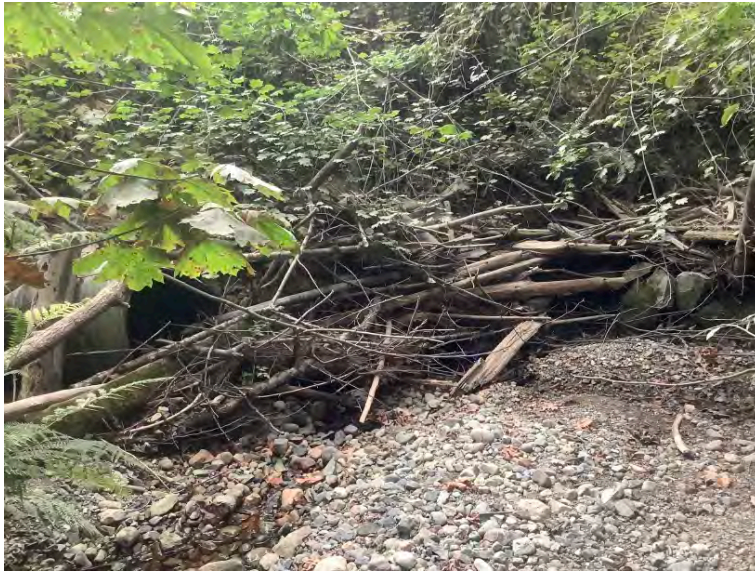
Inlet Unrated Town plugged, woods bent and sits above stream grade

Comments Twin culverts. Town culvert plugged, woods inlet sits .4m above stream. Large amount of fill above.

Inlet

| Repair Item | Repair Description |
|---|---|
| 1 Channel. Debris removal. # of sites/items.<br>Priority:Medium | Town Plugged with woody debris |

| 2 Structure. Lengthen Culvert. # of bearings.<br>Priority:Medium | Fix woods inlet |

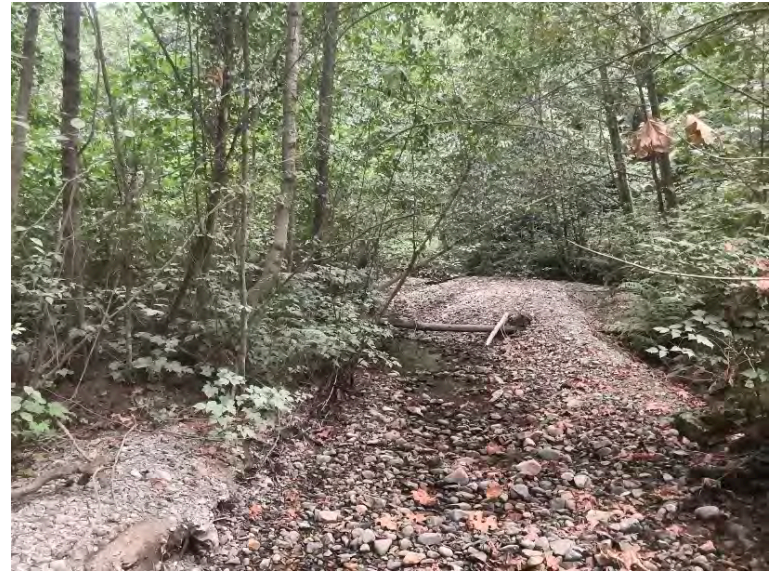
Upstream from Crossing

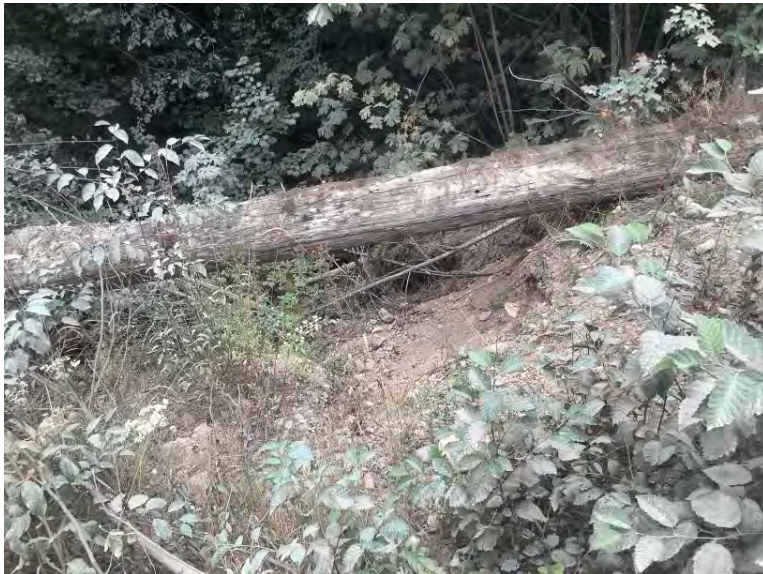
Fill Fair Failure on inside of corner, failed to woods CMP. Road running surface currently not impacted

Slope failure to woods 1800

Remove debris from the inlet and monitor for future debris accumulations. Monitor the condition of the culverts and the fill slope condition. The current load rating of L150 or 136 tonnes to continue. Due to the condition of the culverts plan to replace the entire structure soon.

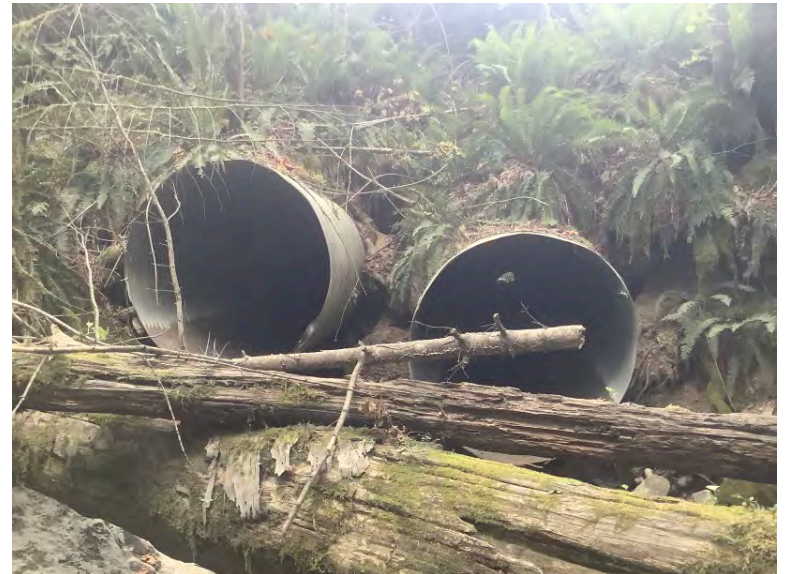
Floor Poor Rusted through, no water currently flowing out of end of pipe. Flows through rusted out floor and beneath pipe. Appears to be last 4m

Outlet Fair Both rusted through and bent

Outlet

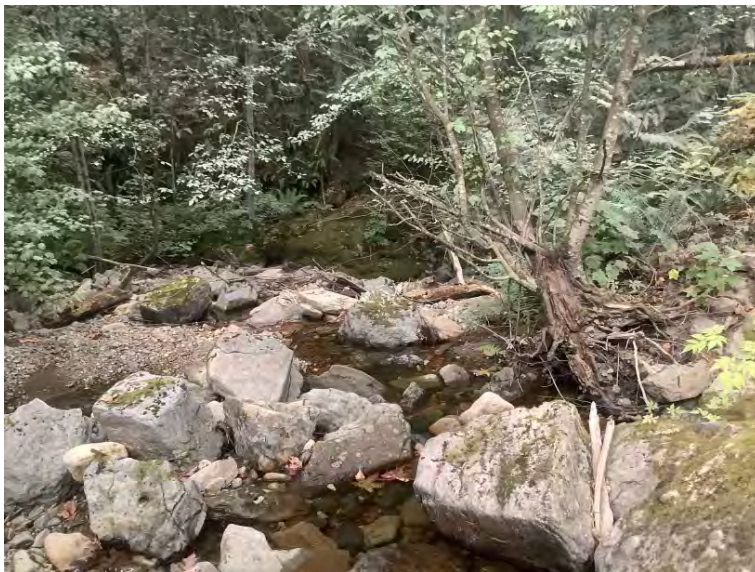
Downstream from Crossing

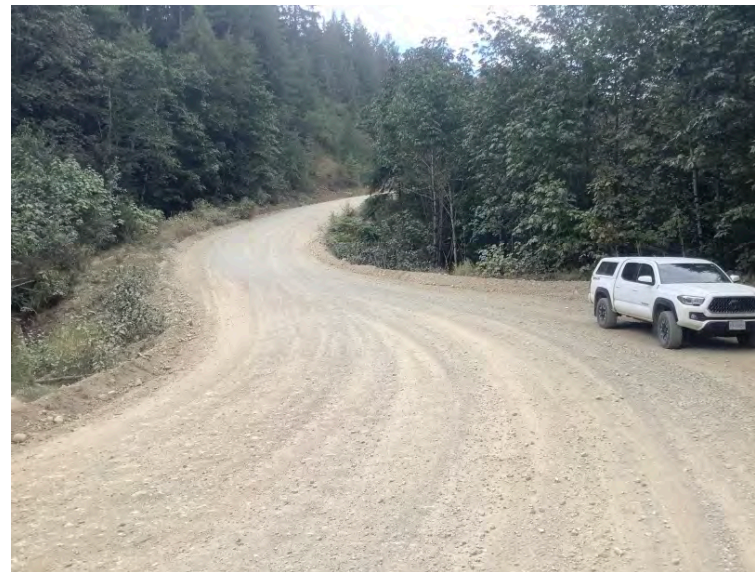
Approach from Right Bank when facing downstream
