CK-2134  
CK-2134

## STS'AILES (WEST) 22.5km

2022 Inspection

Crossing Name Hale Creek

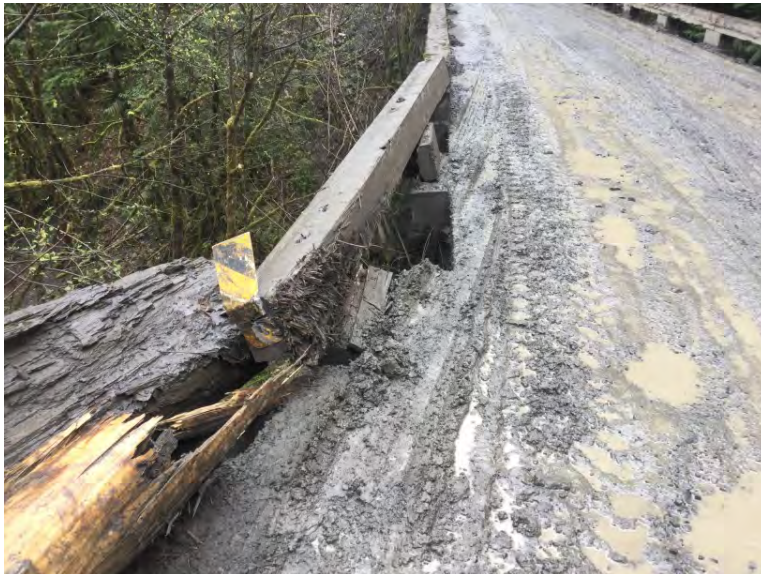
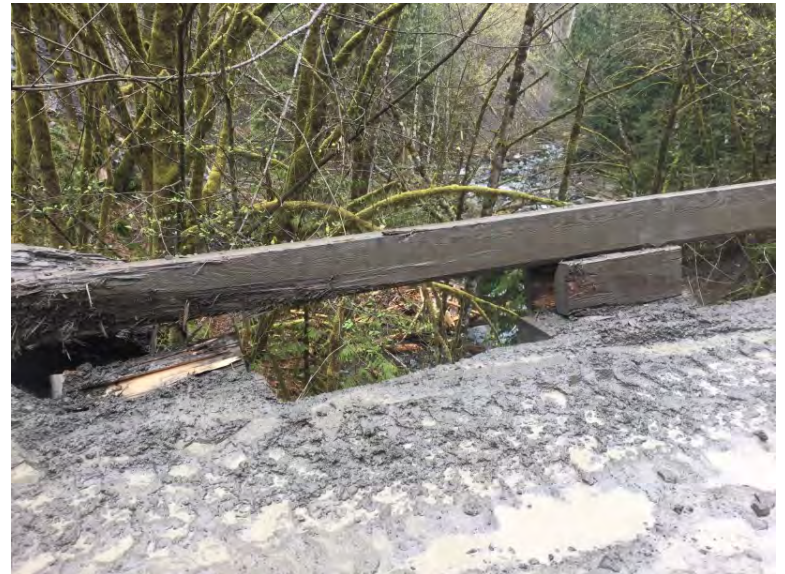
Curb Rail/Blocks/Posts      Poor      Damage noted at both downstream approaches

Downstream left bank guardrail damage

| Repair Item | Repair Description |
|---|---|
| 1 Structure. Curb Maintenance. # sites. Priority:High | Repair damaged section of rail. Requires 3 risers and 3 blocks with hardware |

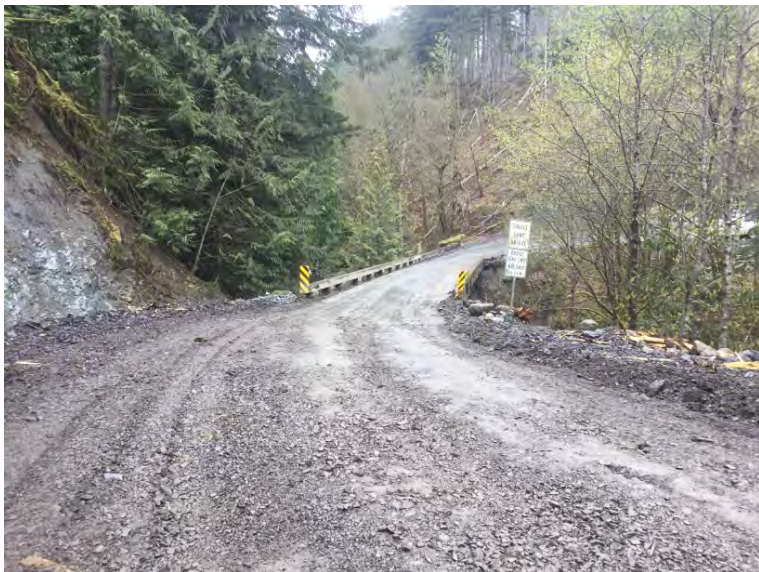
Approach from Right Bank when facing downstream

Non-existent at right approach, inefficient at downstream left approach

| Repair Item | Repair Description |
|---|---|
| 3 Approach High | Install proper approach barriers at right approach and downstream left approach |

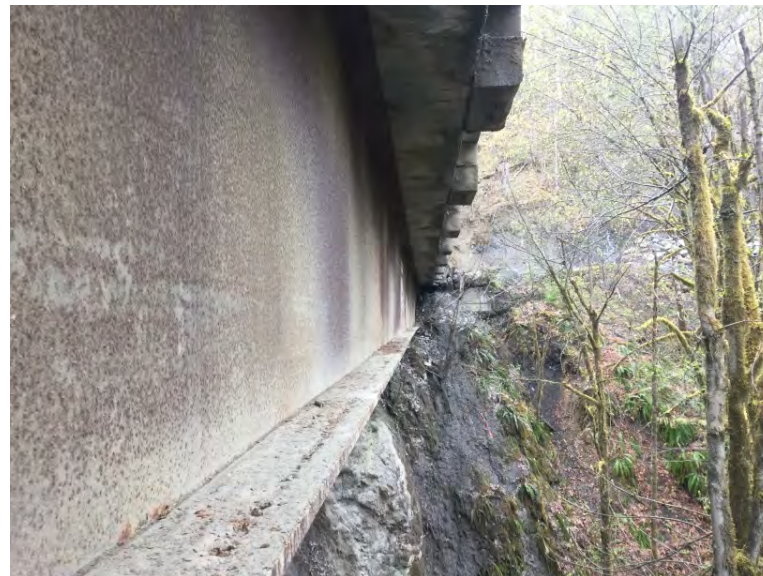
Both girders have noticeable deformation in the webs and bottom flanges throughout entire length

Downstream girder

| Item | Monitor Description | Frequency |
|---|---|---|
| 1 | Deformations in the girders | Annual |

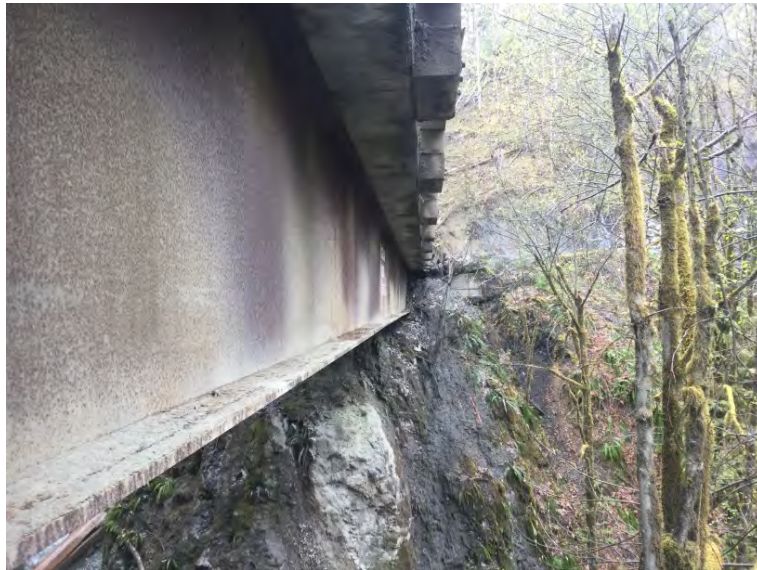
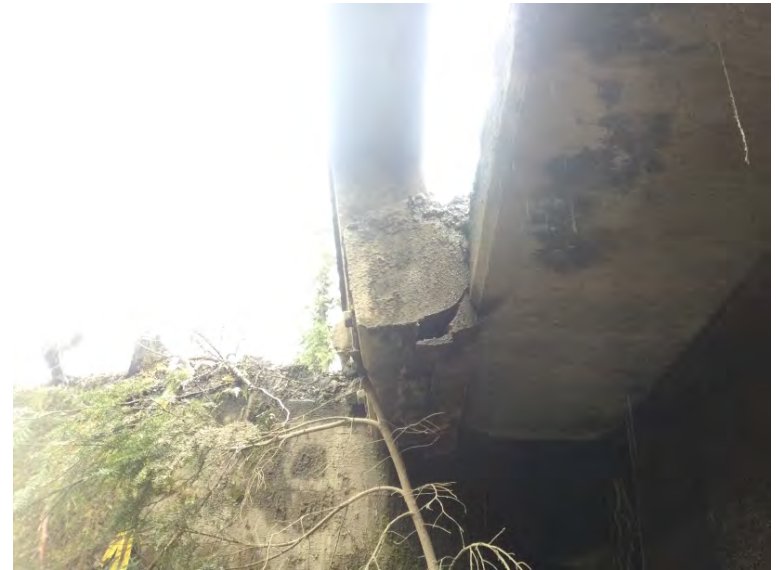
Downstream right bank side block

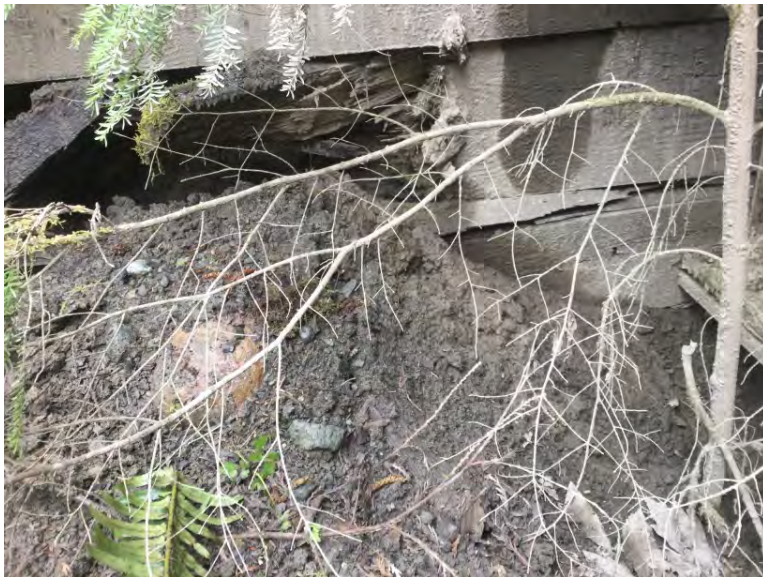
treated timbers, broken and cracked at right bank

Ballast wall condition at downstream right bank

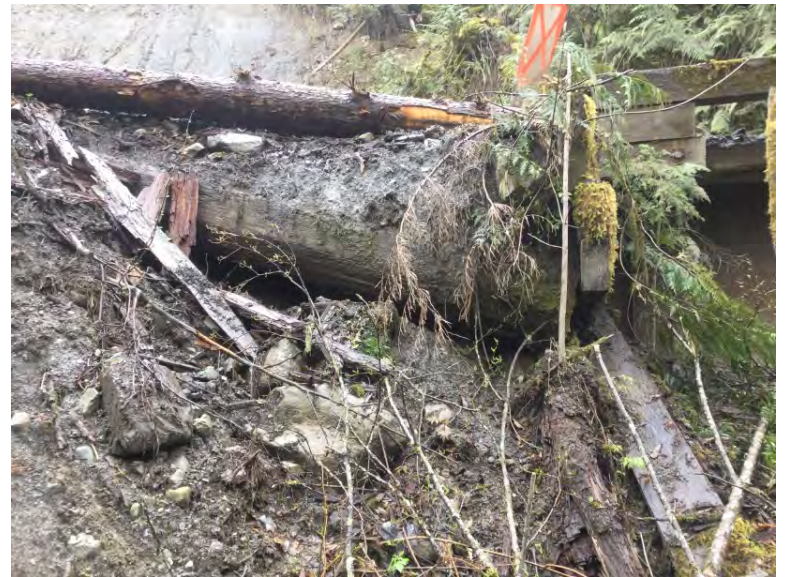
Downstream right bank fill retaining log condition

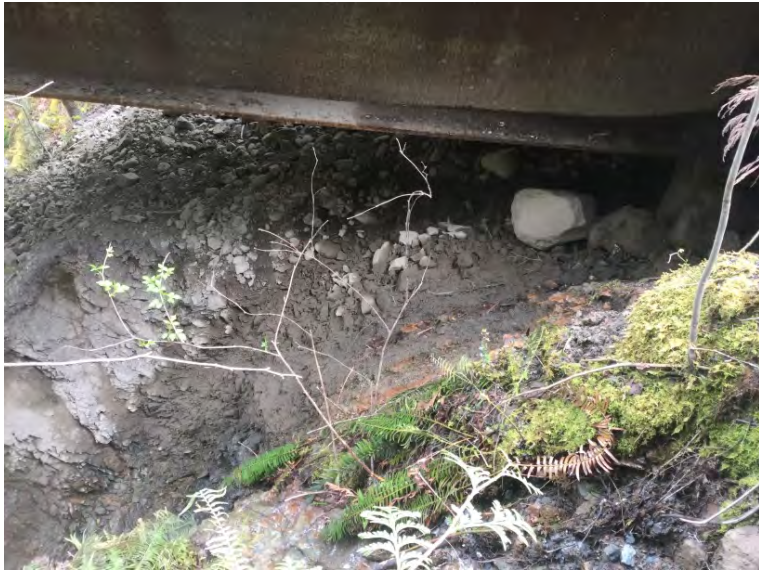
eroding at upstream right bank; however no stability concerns given bedrock foundation

Fill erosion in front of upstream right bank footing

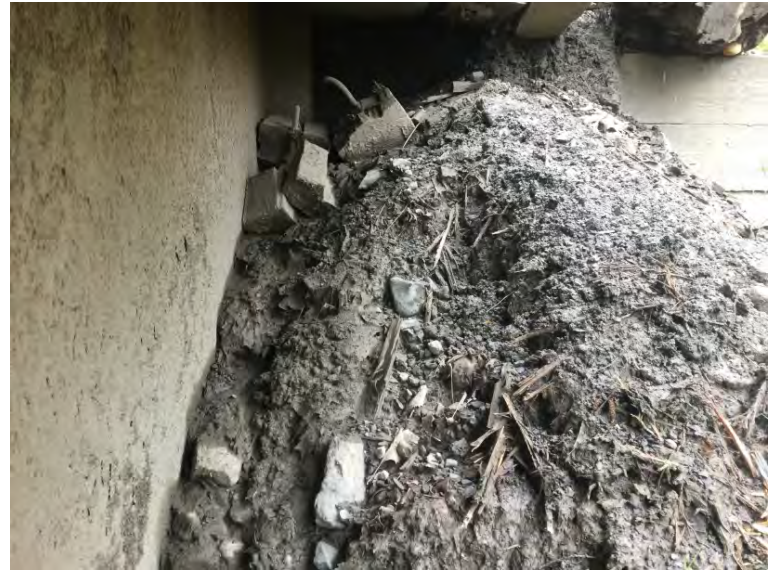
Fill against downstream left bank girder

| Repair Item | Repair Description |
|---|---|
| 2 Structure. . . Priority:High | Remove sediment from the bearings, girder webs and bottom flanges at left bank |

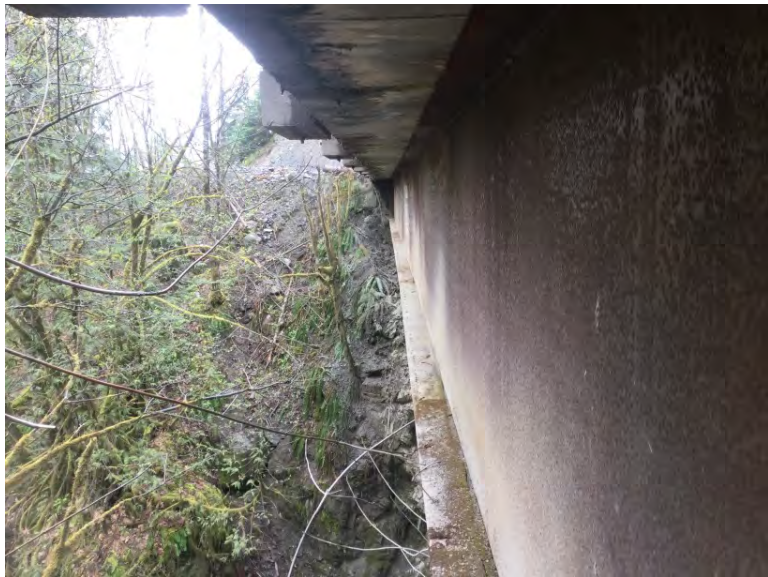
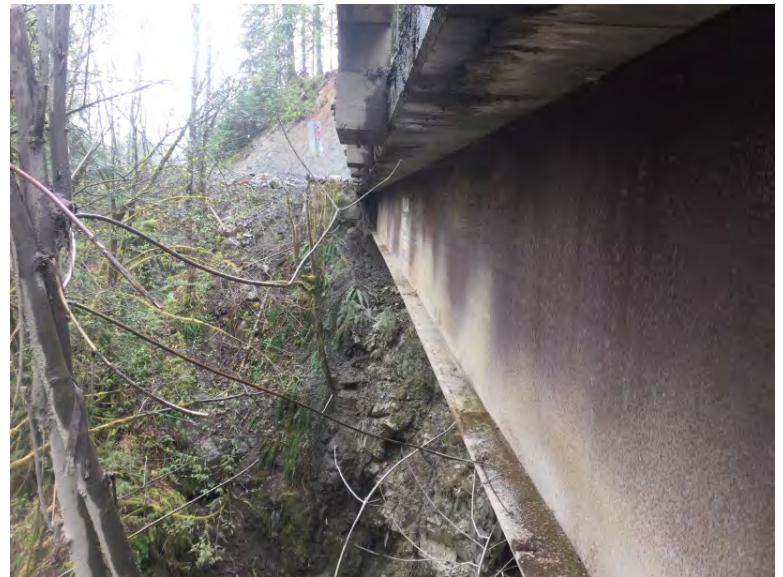
Downstream girder

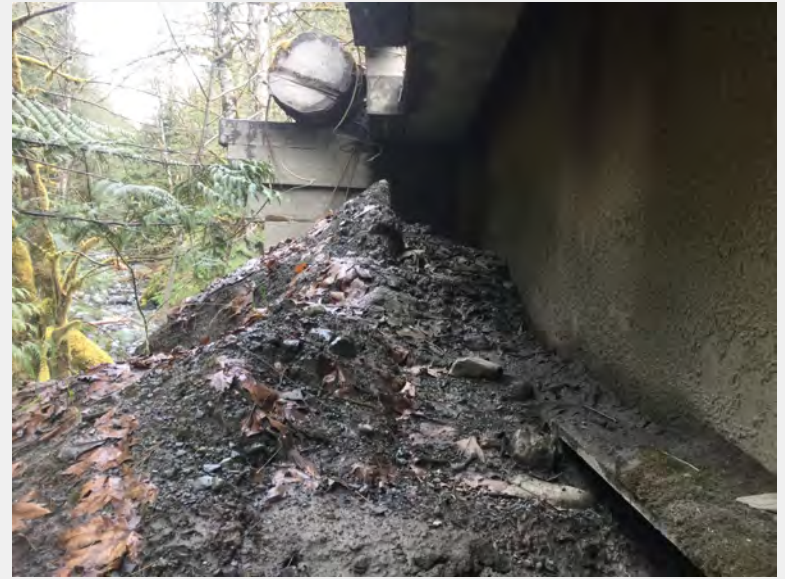
Sediment accumulations on girder bearing at downstream right bank

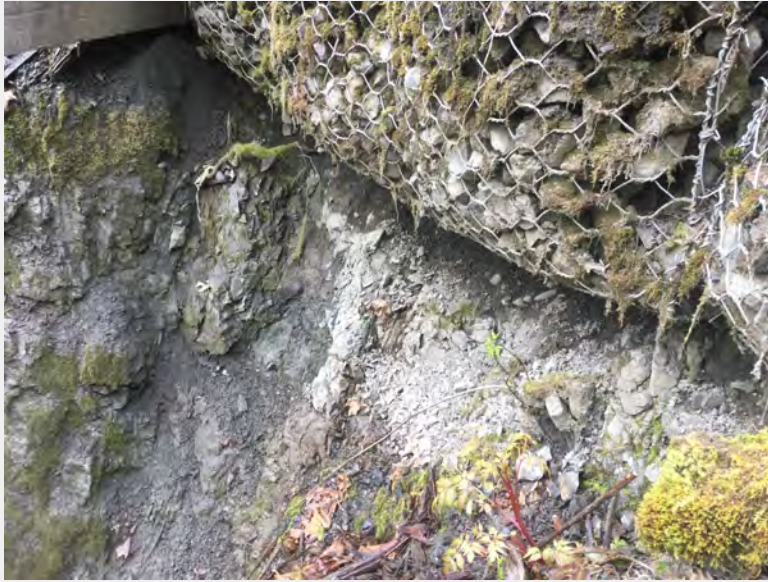
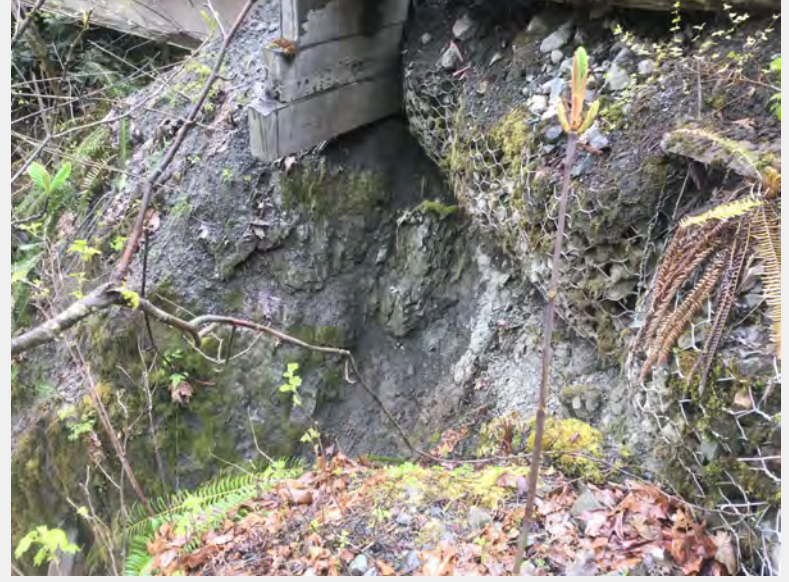
Gabion baskets at right bank, fill eroding under downstream side

Downstream right bank erosion under gabions

| Item | Monitor Description | Frequency |
|---|---|---|
| 2 | Erosion under the downstream left bank gabions | Annual |
