CK-2135  
CK-2135A

## STS'AILES (WEST) 25km

2022 Inspection

Crossing Name Sunrise Creek

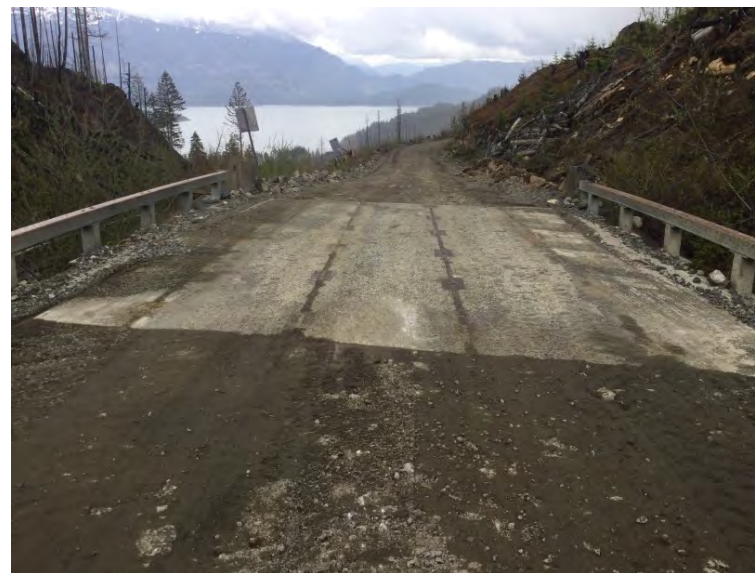
Concrete Deck      **Good**

Overall Deck Condition      **Good**

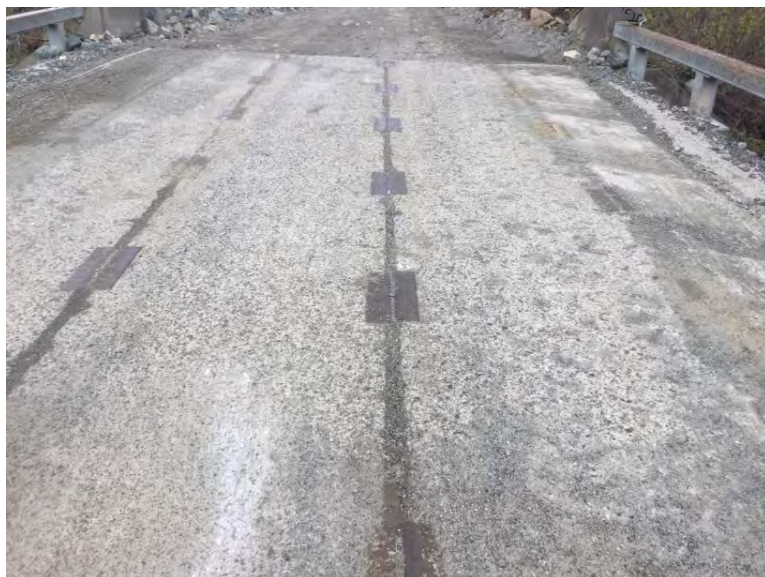
Welded/grouted  
shear connectors Good

Welded shear connectors

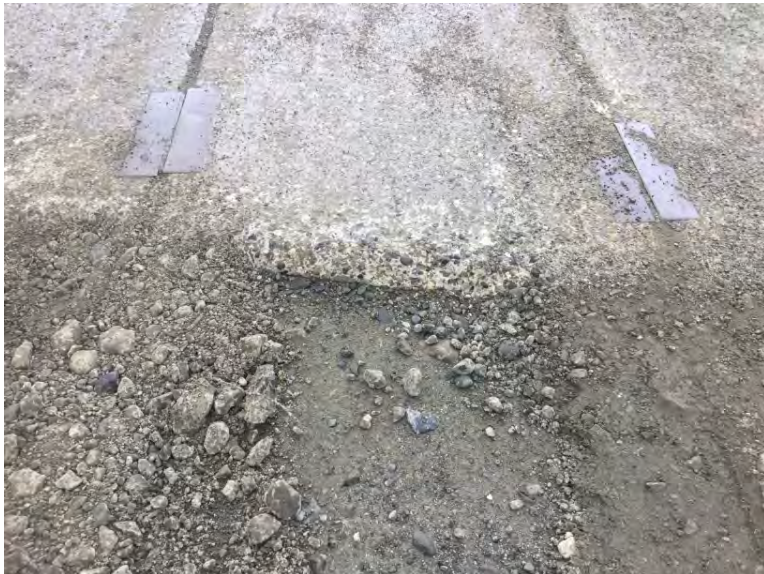
Damage to slab ends
