CK-2139  
CK-2139A

## STS'AILES (WEST) 42km

2022 Inspection

Crossing Name Kirkland Creek

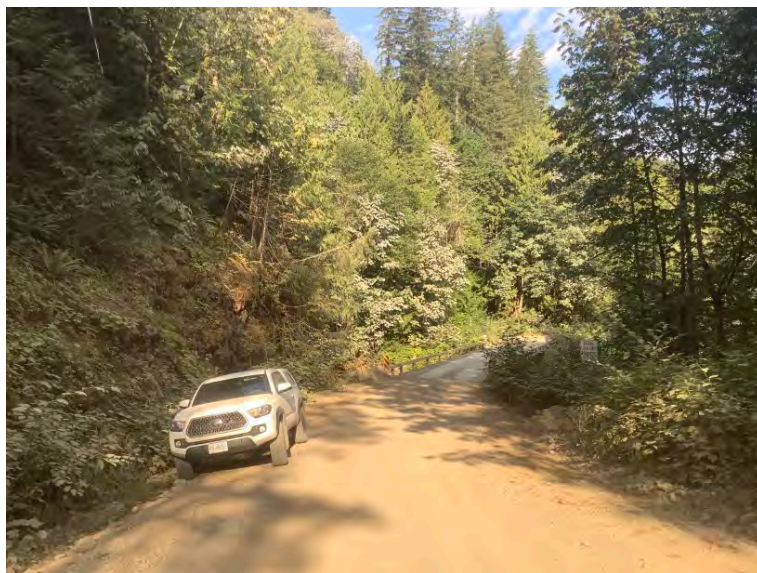
Approach from Right Bank when facing downstream

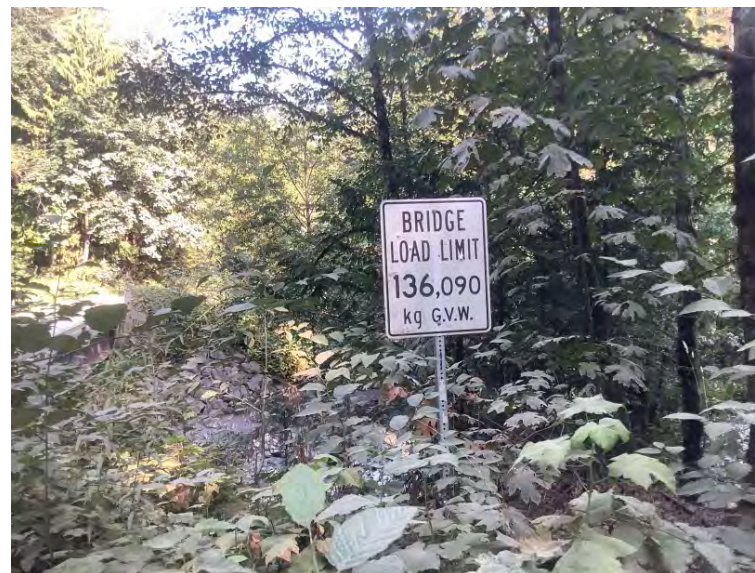
Load Rating Sign

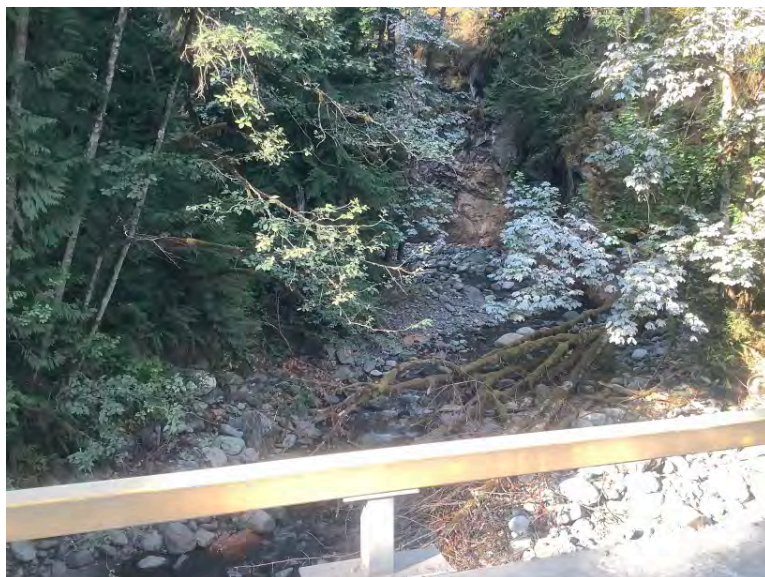
Upstream from Crossing

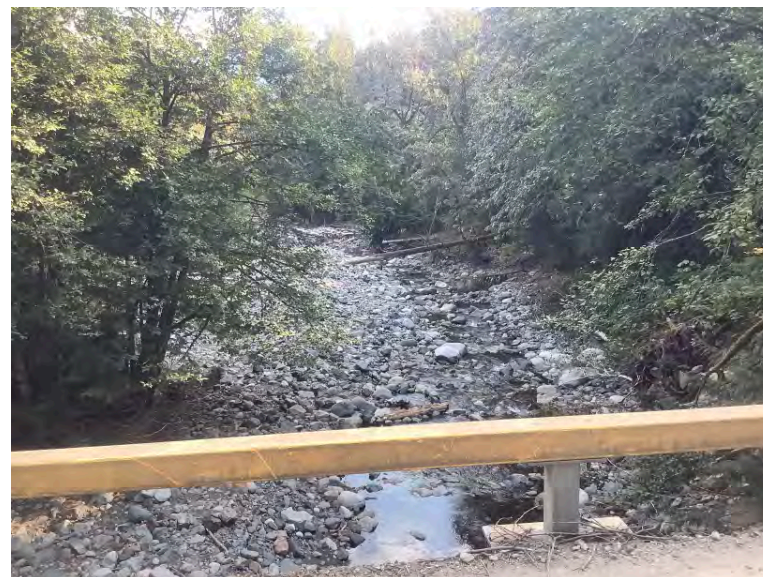
Downstream from Crossing

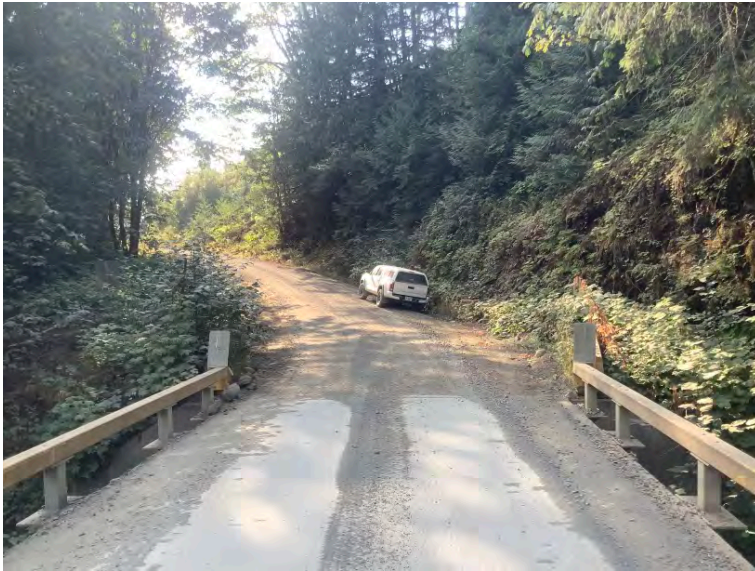
Approach from bridge deck of Right bank approach when facing downstream

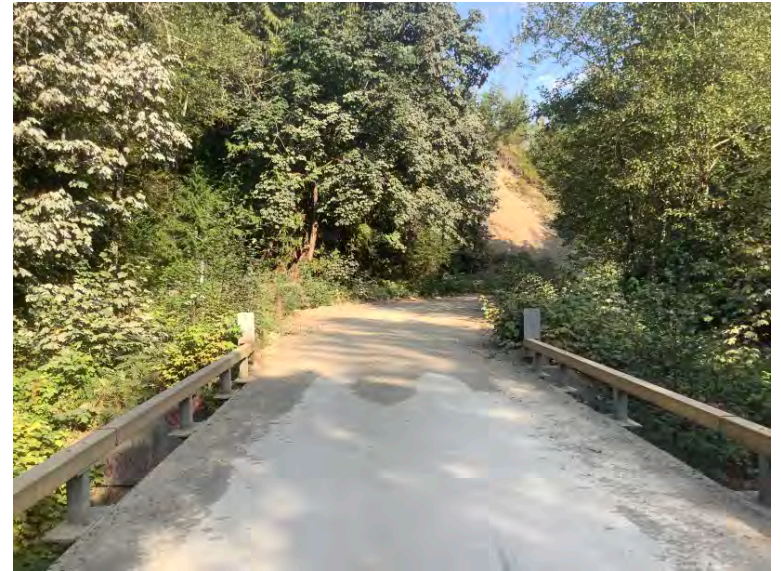
Approach from bridge deck of Left bank approach when facing downstream

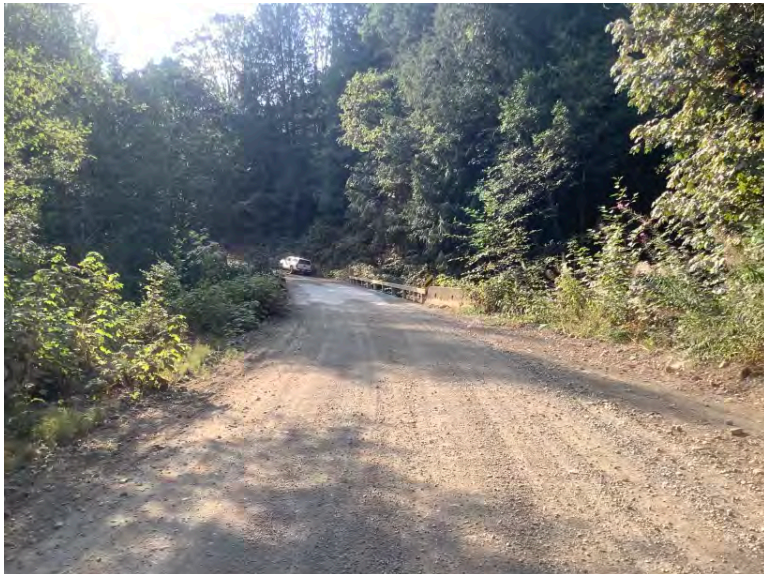
Approach from Left Bank when facing downstream

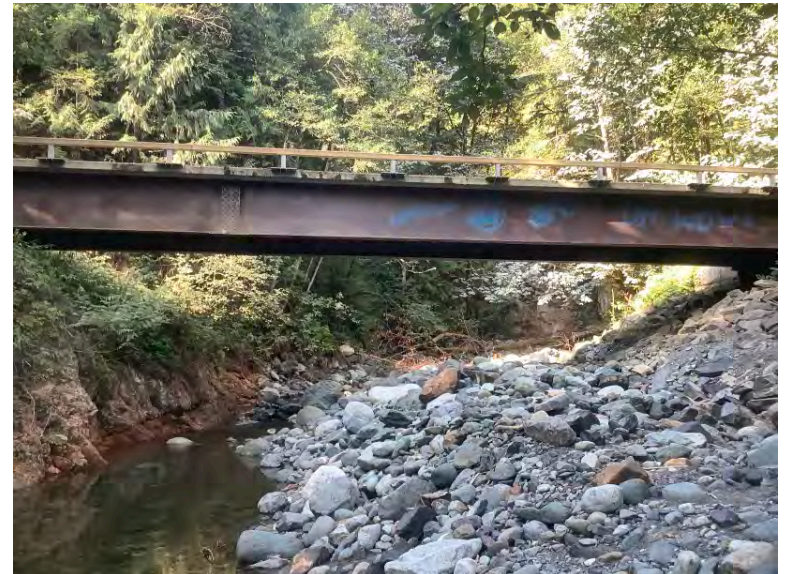
Downstream Profile

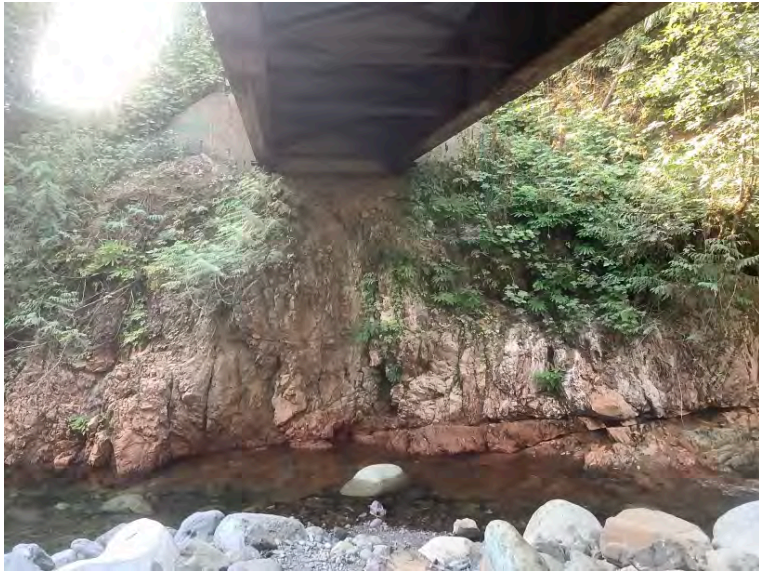
Right Bank Abutment when facing downstream

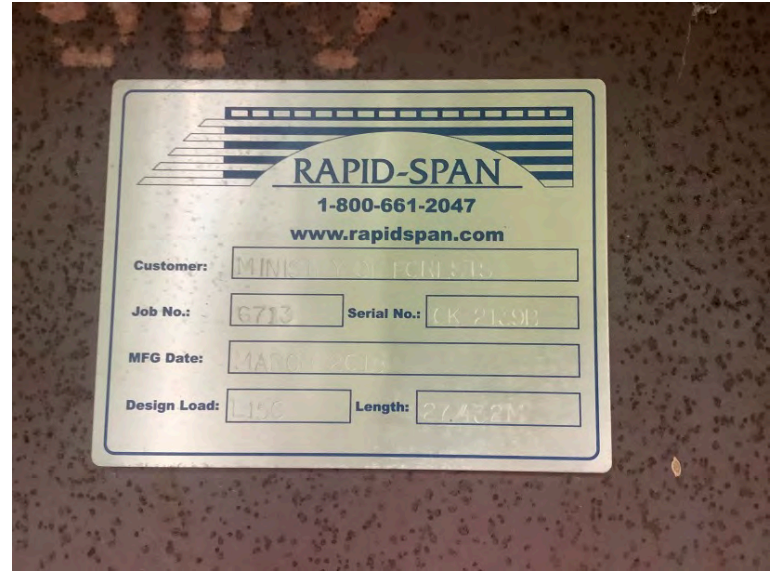
Structure ID

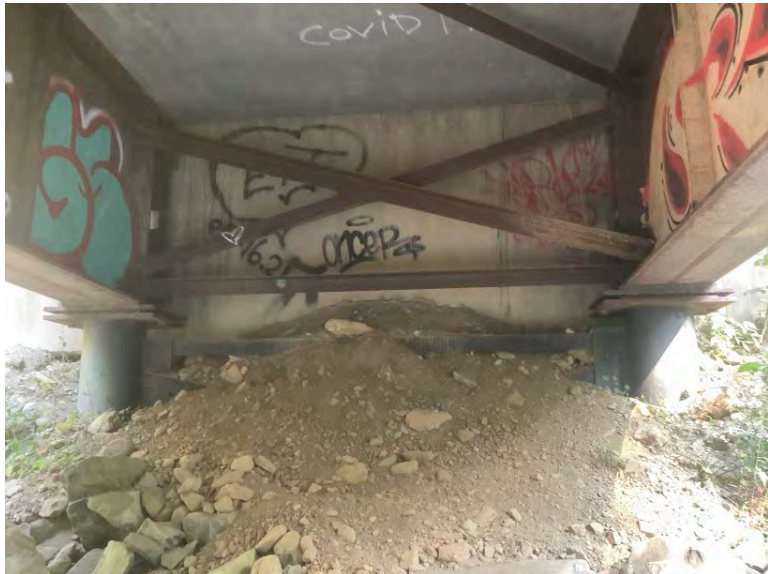
Bearings Good

Bearing

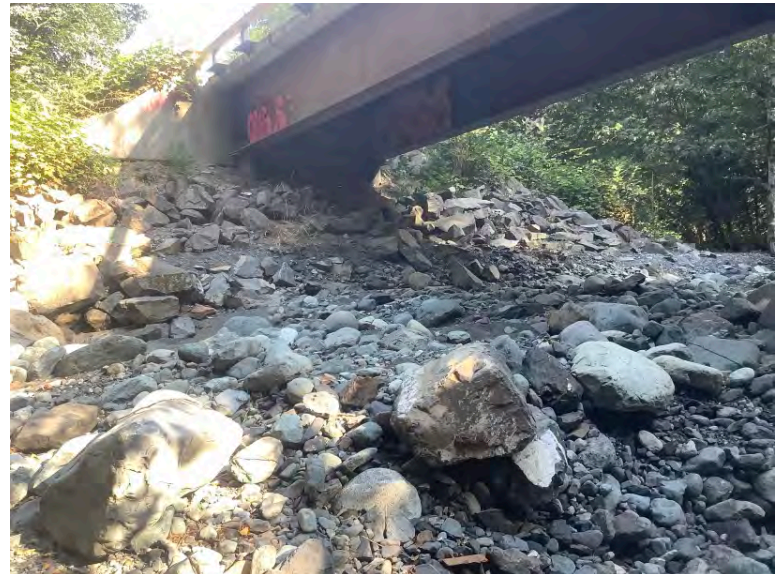
Left Bank Abutment when facing downstream

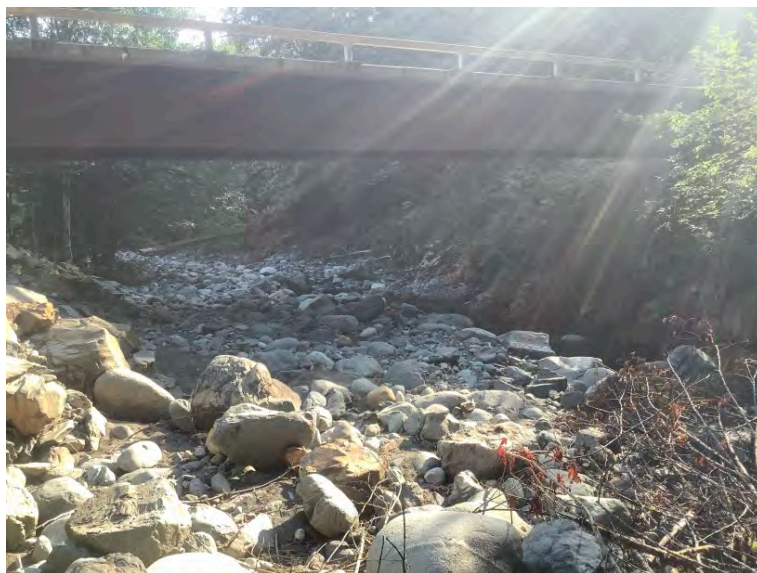
Upstream Profile

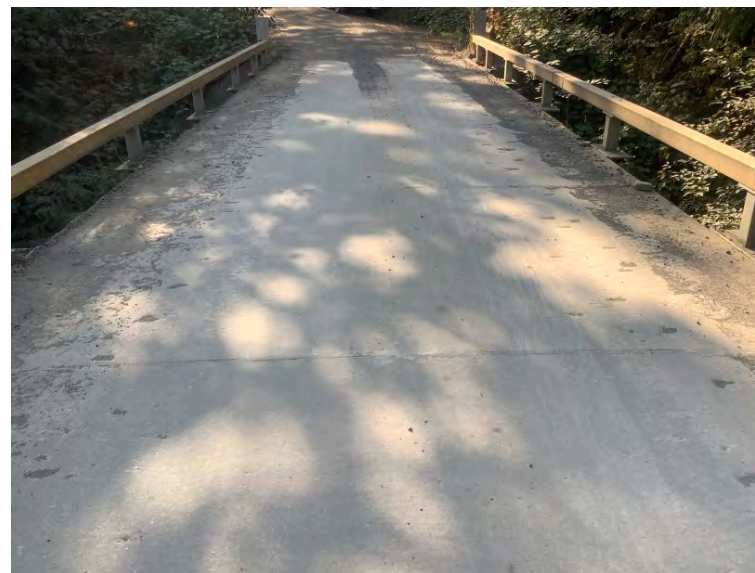
Concrete Deck      Fair      Ice pick damage from tracked machines

Deck
