CK-2140  
CK-2140A

STS'AILES (WEST) 46.5km

2022 Inspection

Crossing Name Davidson Creek

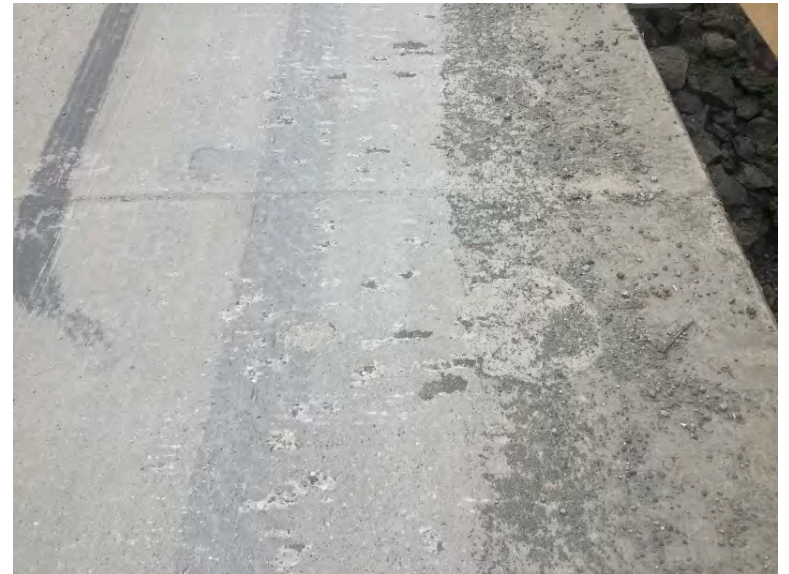
| Concrete Deck | Fair | Signs of tracked machines with picks walking across |

Deck

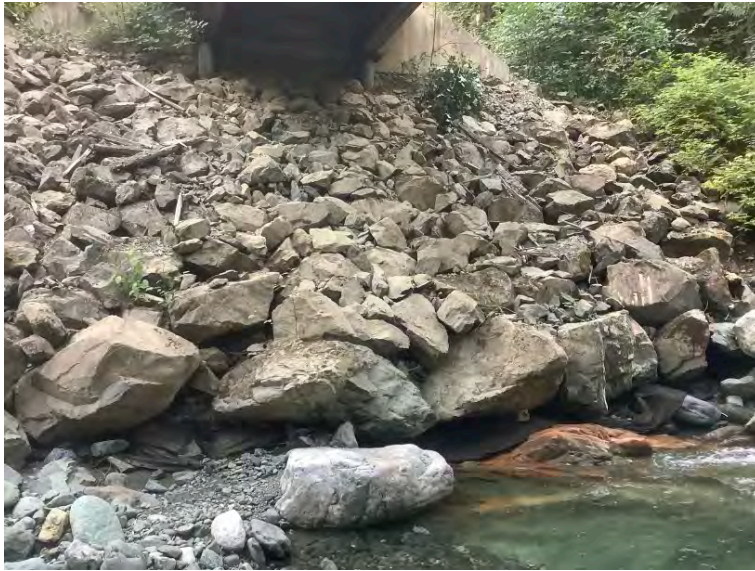
Right bank is large rock sitting atop bedrock. Unsure if benched into rock.

| Item | Monitor Description | Frequency |
|---|---|---|
| 1 | Right bank riprap toe. Appear stable but unable to determine if it is benched onto bedrock | Routine Inspection |

Right Bank Abutment when facing downstream

Repair the right bank riprap, until then monitor its condition. The current load rating of L150 or 136 tonnes to continue.

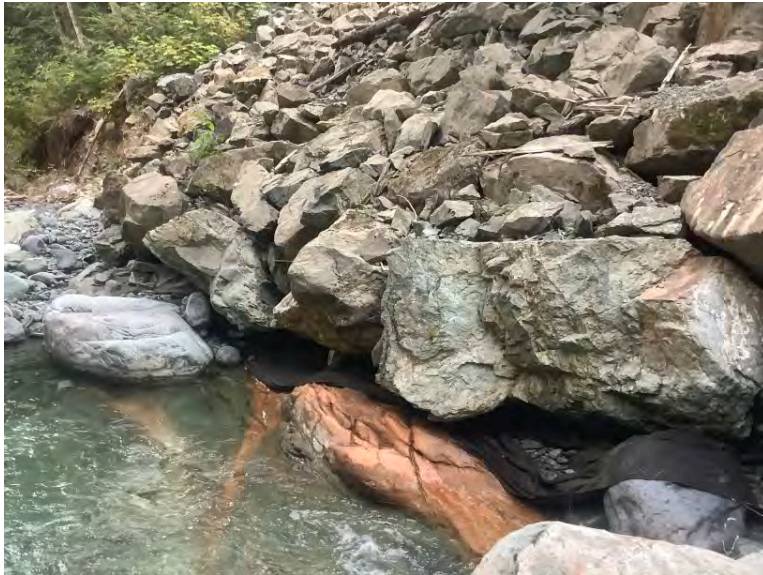
Right Bank Abutment when facing downstream
