CK-2147  
CK-2147

## STS'AILES (WEST) 66km

2022 Inspection

Crossing Name Tretheway Creek

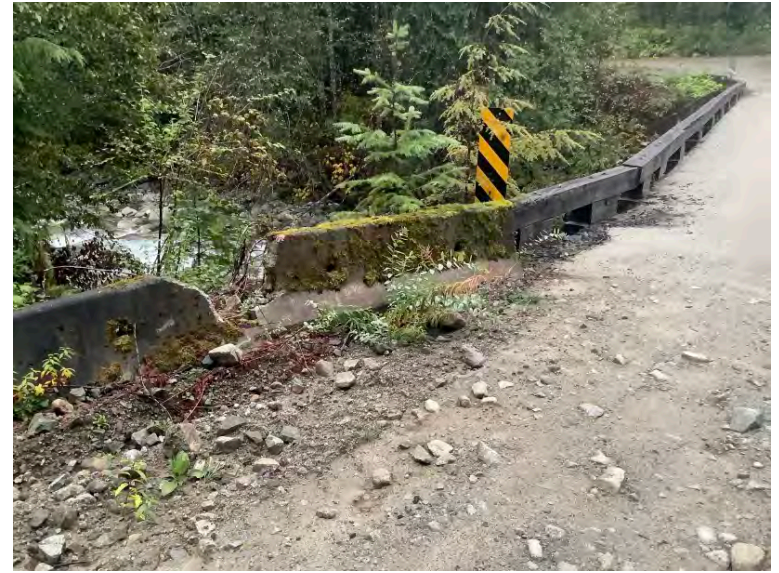
Left downstream damaged and separated

Approach Barrier

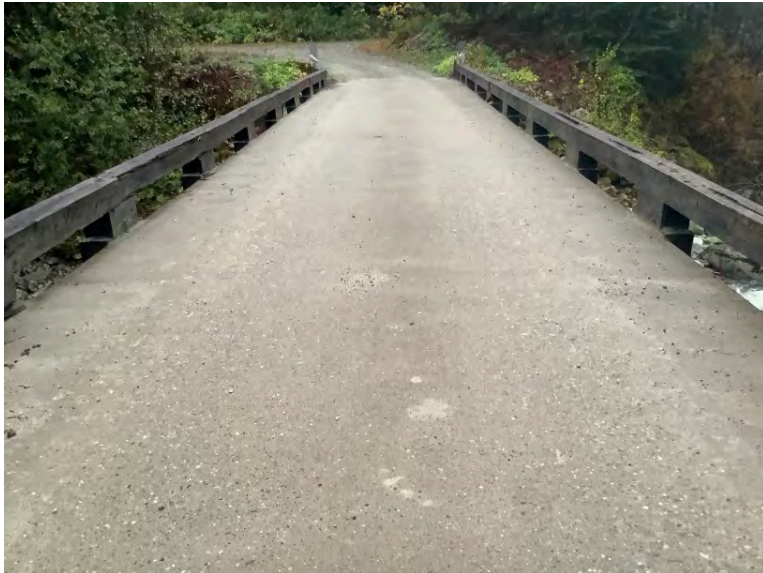
| Concrete Deck | Fair | Minor track damage |

Deck

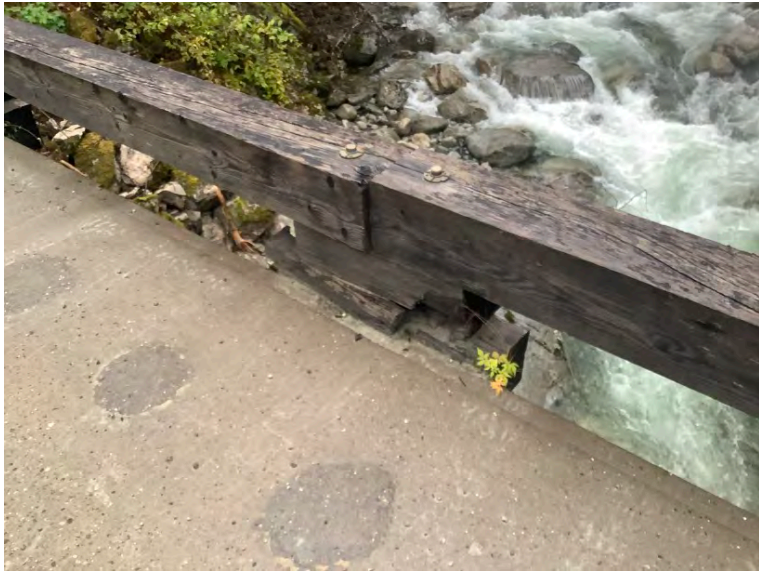
| Curb Rail/Blocks/Posts | Poor | Rotten and require replacing |

| Hardware | Fair | Hardware present, loose due to timber components condition |

| Overall Deck Condition | Poor | Due to rail condition |

Guard Rail

Replace guardrail, risers and blocks. Replace missing delineator. Monitor the upstream right bank riprap and the downstream left bank fill condition. The current load rating of L100 or 91 tonnes to continue.

| Repair Item | Repair Description |
|---|---|
| 1 Structure. Full Curb Replacement. .<br>Priority:Medium | Replace entire guard rail system. Rotten and loose |

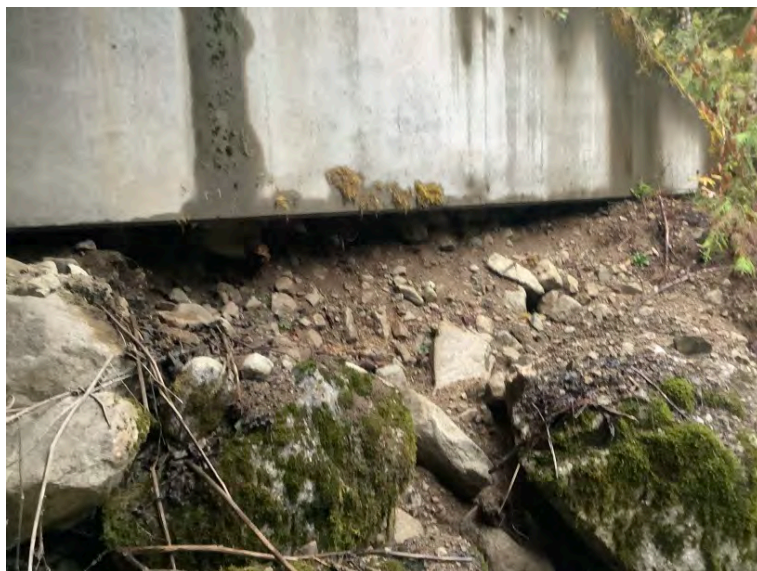
Downstream left starting to erode beneath ballast wall

Downstream left fill loss beneath ballast wall

| Item | Monitor Description | Frequency |
|---|---|---|
| 2 | Left downstream fill loss beneath ballast wall | Routine Inspection |

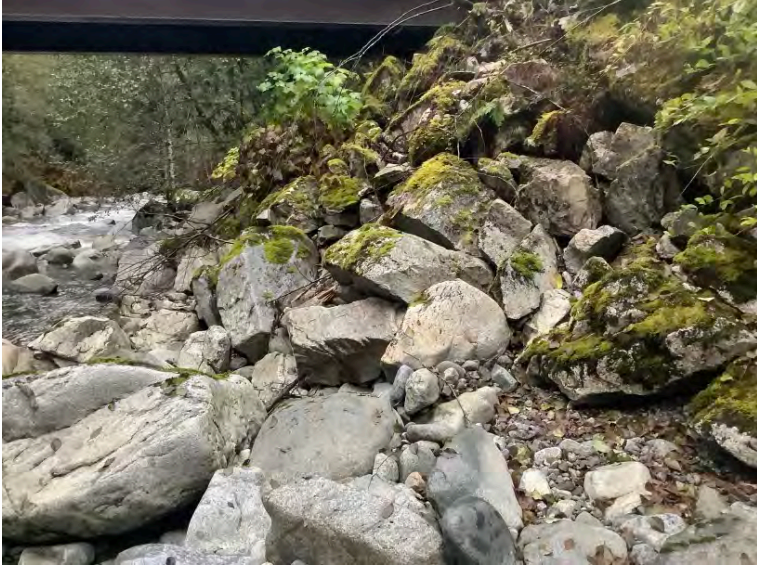
Upstream right has shifted

Upstream right riprap scour

| Item | Monitor Description | Frequency |
|---|---|---|
| 1 | Right upstream riprap | Routine Inspection |
