CK-2158  
CK-2158

HUNTER 4.9km

2022 Inspection

Crossing Name East Fork Hunter Creek

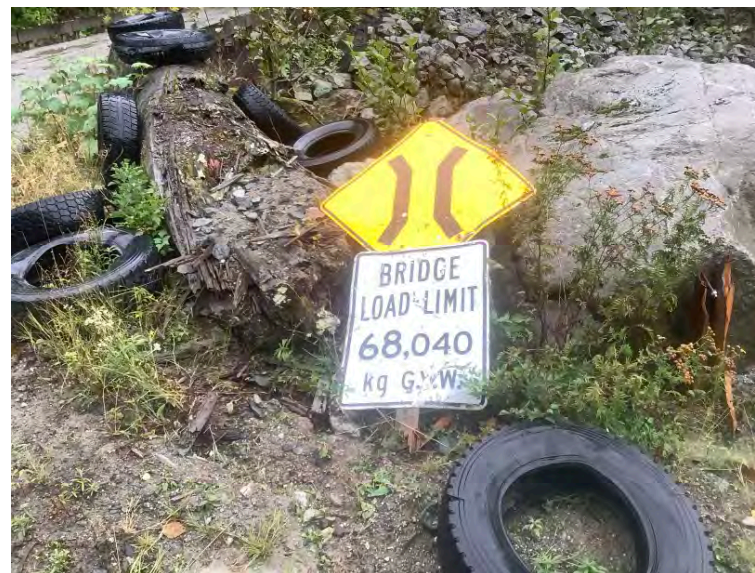
Load Rating Sign

Right bank has been knocked over

30t on woods approach, 68t on town approach

| Repair Item | Repair Description |
|---|---|
| 1 Structure. Add Load Rating Signs. # sites.<br>Priority:Medium | Install proper signage and match loading on both sides of structure. |

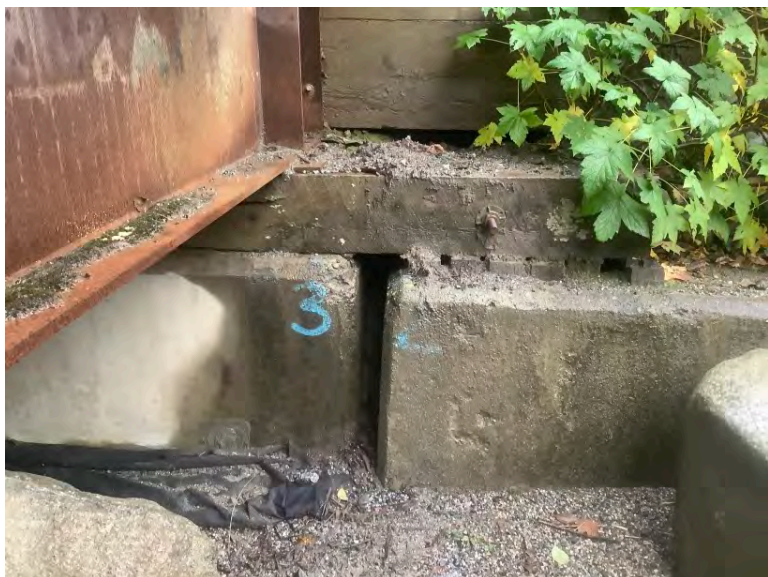
Left bank settling, remedial works have placed material beneath blocks. Timber shims between block and timber sill. Does not appear to have settled additionally since last inspection. Right

Downstream left bearing

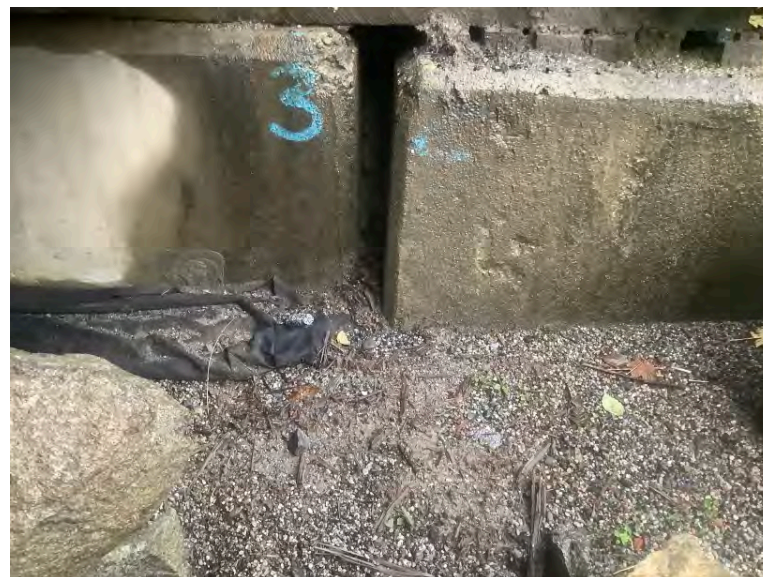
Cip right good condition. Left blocks settings. Have added material beneath blocks some last inspection. ~~Bringing to fair condition~~

Remedial fill heath blocks

| Item | Monitor Description | Frequency |
|---|---|---|
| 1 | Lock block settlement with additional fill added | Anually |

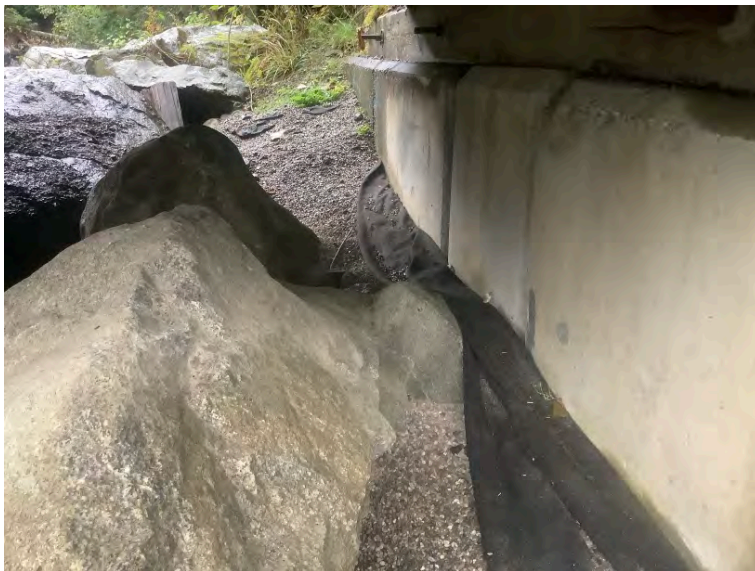
Re,edible fill beneath blocks

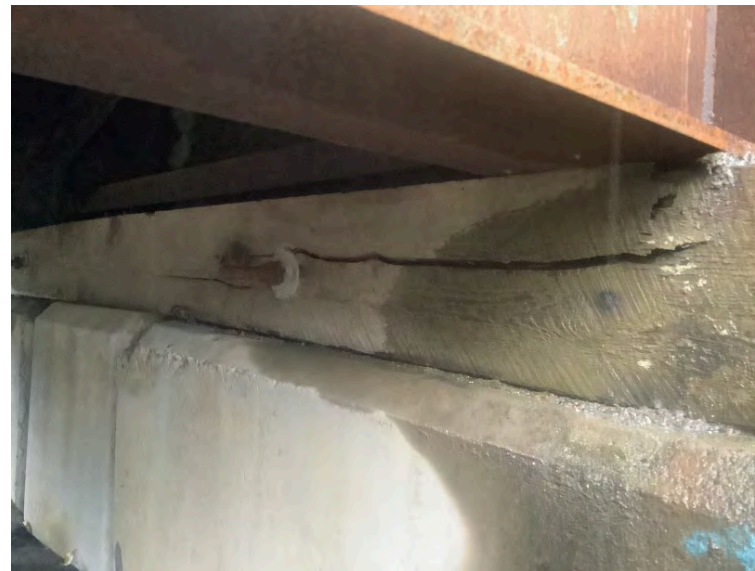
Minor crushing and a crack on left timber sill. Treated timber right bank fair condition.

Left downstream, bearing timber crack

Comments: inspect annually to monitor left abutment lock blocks for settling, and timber sill for further cracks, damage, clean sediment off deck.

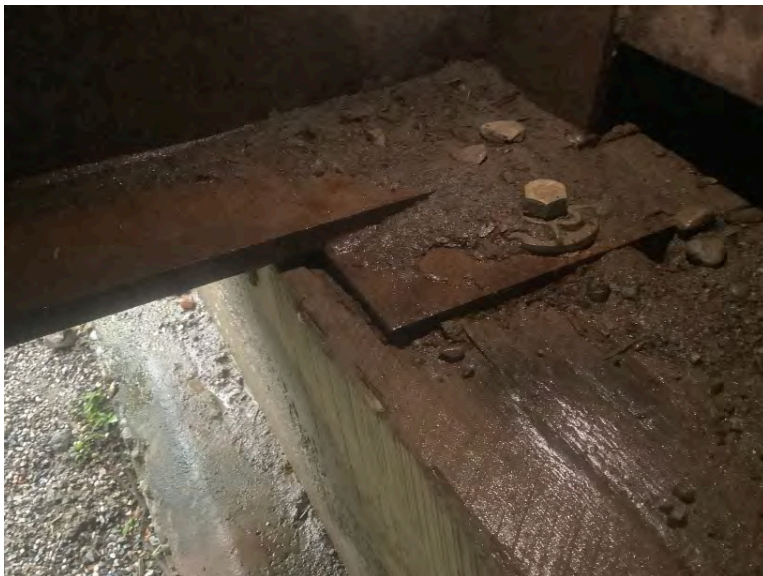
Slight crushing of bearing timber
