CK-2163  
CK-2163A

## LOST CREEK 1.1km

2022 Inspection

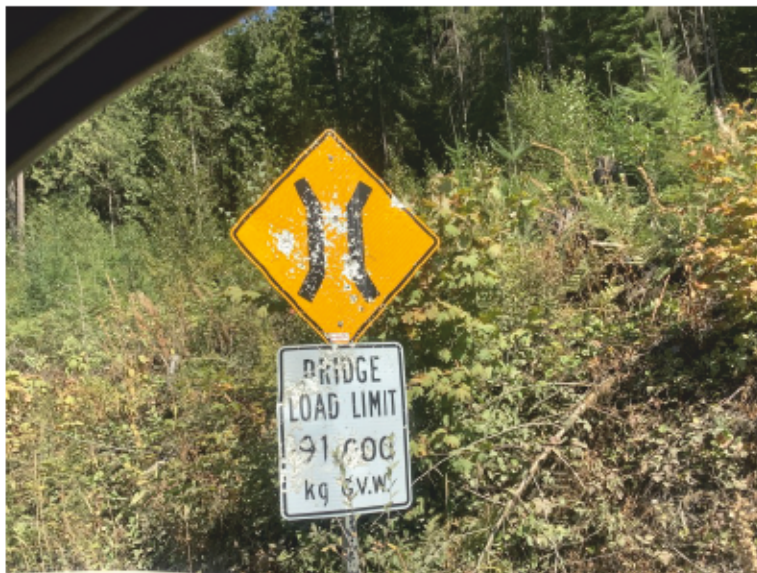
Load Rating Sign

Posted Load Rating 91000

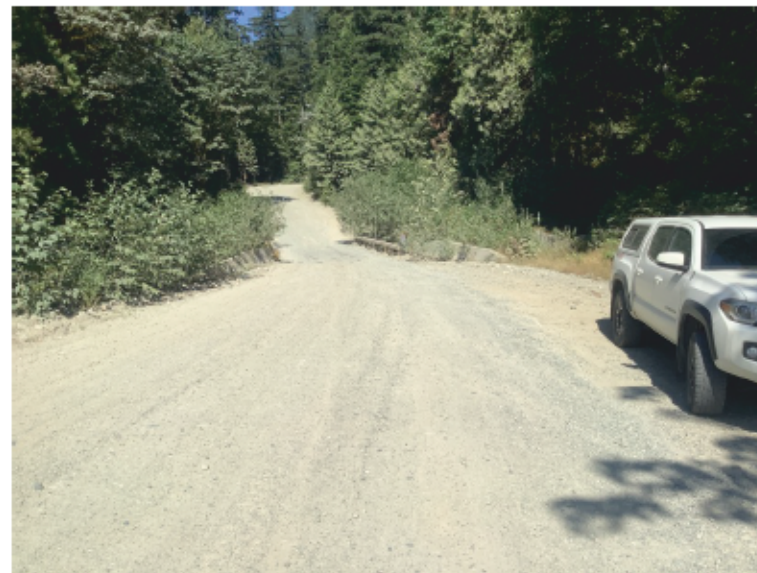
Approach from Left Bank when facing downstream

Upstream town to be realigned so guard rail end not able to be impacted

| Repair Item | Repair Description |
|---|---|
| 1 Approach. Approach fenders (re-Install). # of units.<br>Priority:Low | Realign upstream town barrier |

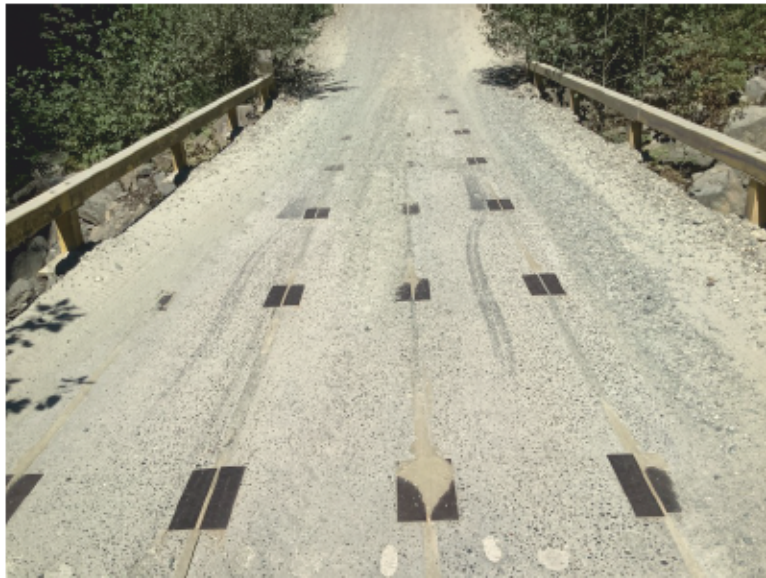
Pothole town end

Overall Deck Condition Fair Shows signs of age. Sediment accumulating on deck.

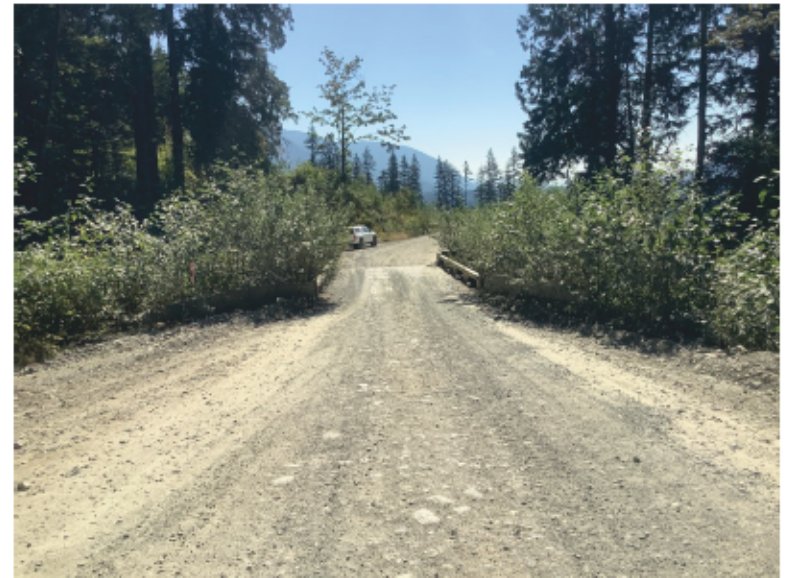
Approach from Right Bank when facing downstream

Pothole town end

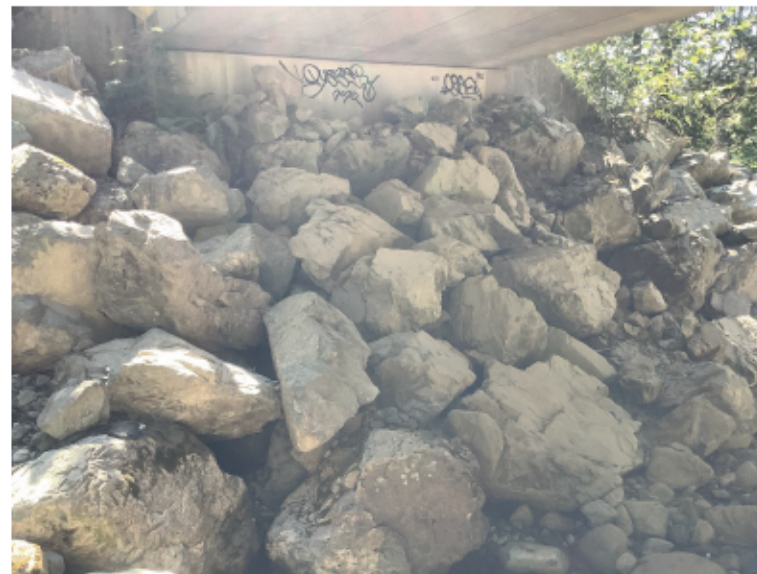
Left Bank Abutment when facing downstream

Oversteepened throughout

Comments All riprap oversteepened and susceptible to scour
