CK-2165  
CK-2165

## LOST CREEK 2.2km

2022 Inspection

Crossing Name Murdo Creek

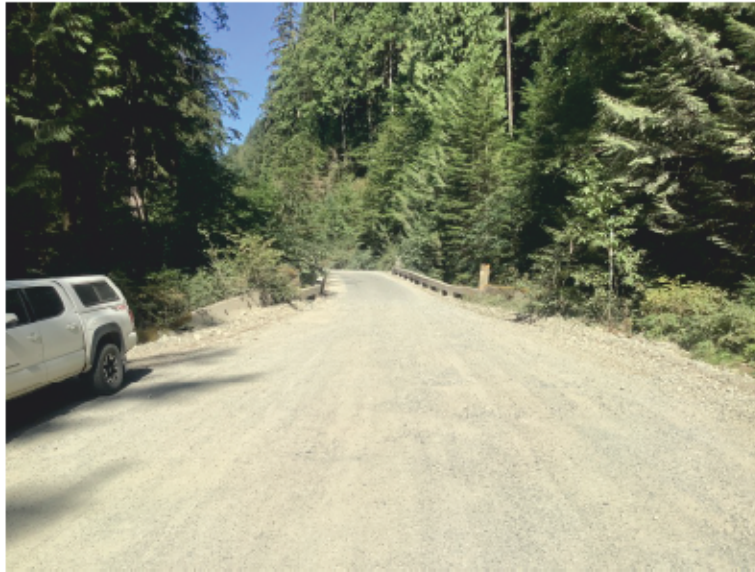
Approach from Left Bank when facing downstream

Small hand made signs present. Replace both

| Repair Item | Repair Description |
|---|---|
| 1 Approach. Bridge Ahead Signs. # of signs. Priority:Low | Install with load rating signs |

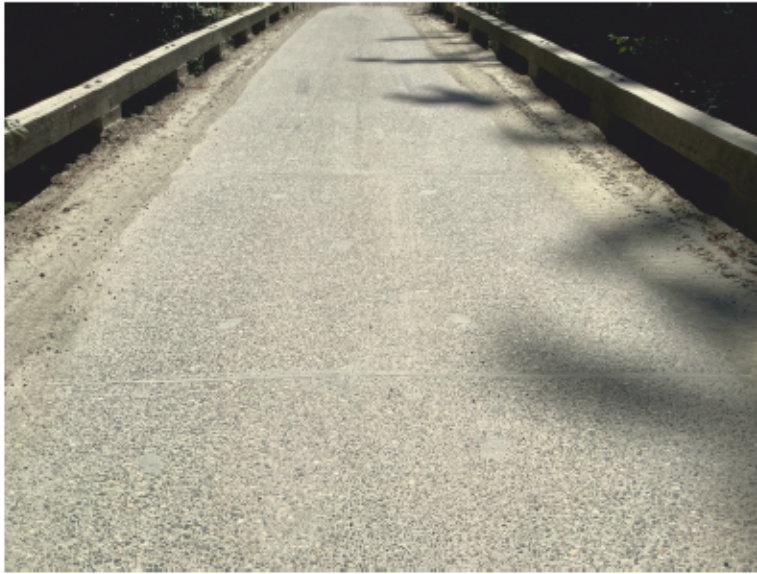
Running Surface      Minor potholes

Concrete Deck      Fair      Showing age

| 2 Approach. Approach surfacing grading. m. Priority:Low | Minor potholes |

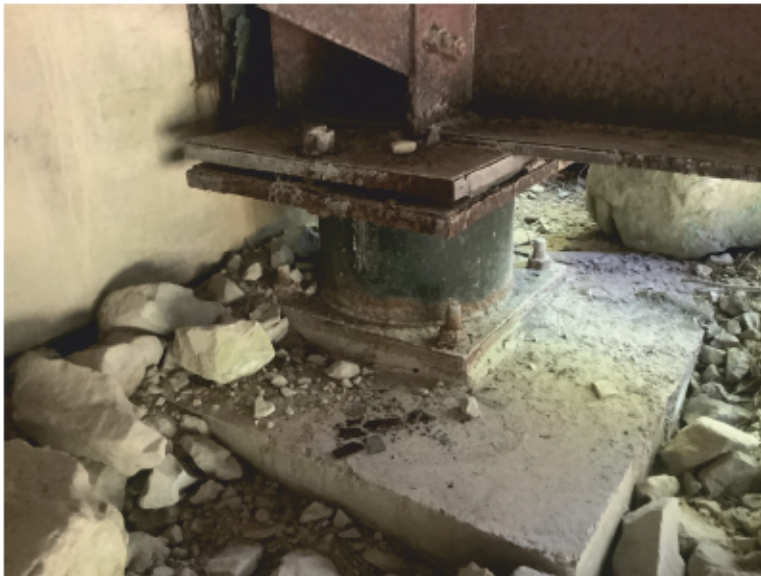
Bearing

Bearings Fair

Steel scaling

| Item | Monitor Description | Frequency |
|---|---|---|
| 1 | Monitor steel scaling. | Routine Inspection |
