CK-2166  
CK-2166

## LOST CREEK 5km

2022 Inspection

Crossing Name Weatherhead Creek

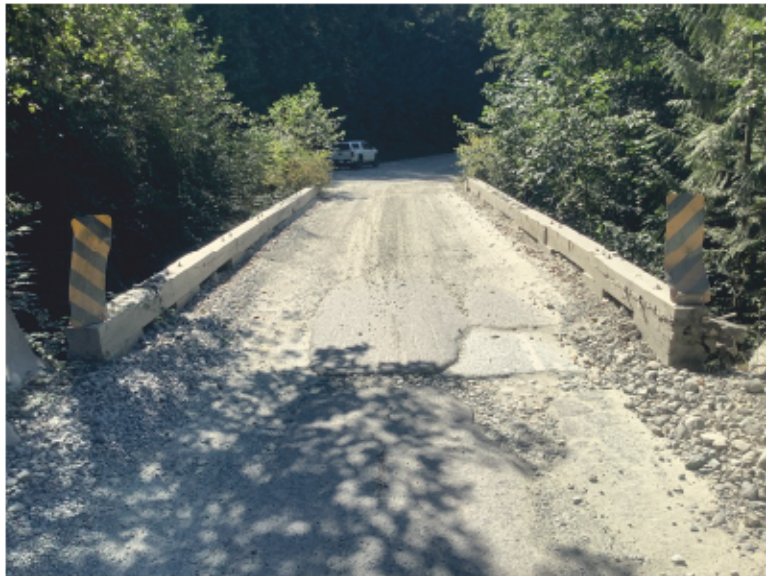
Overall Deck Condition      Fair      Concrete overlain with asphalt. Woods end has asphalt damage. Recommend installing sediment guards

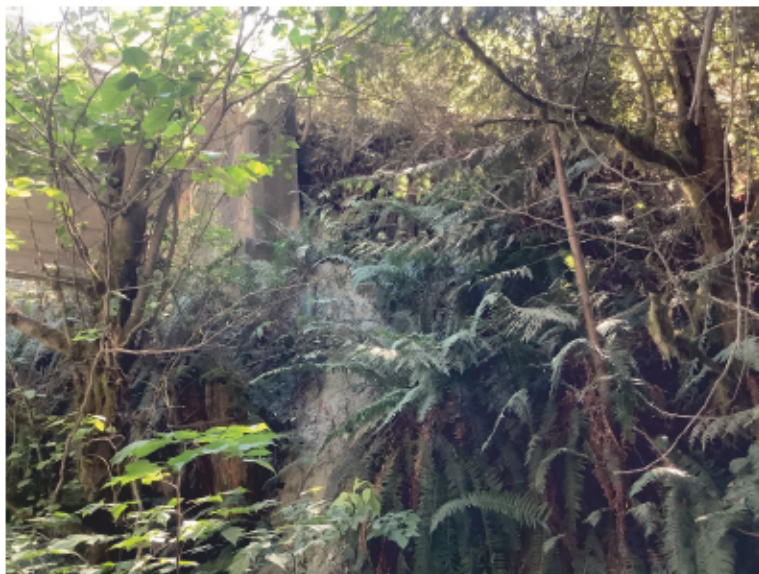
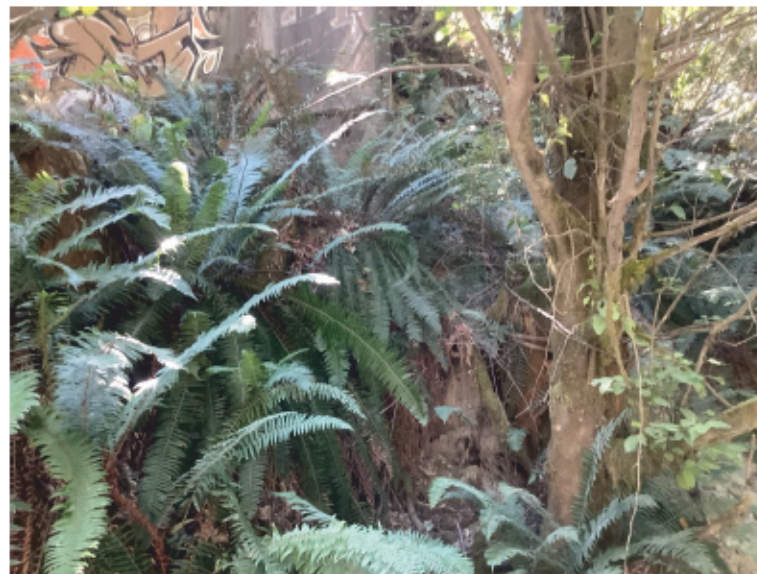
Fill slope

Monitor downstream town fill slope

| Item | Monitor Description | Frequency |
|---|---|---|
| 1 | Downstream town fill slope stability | Routine Inspection |
