## LOST CREEK 8.6km

2022 Inspection

Crossing Name Twin Lakes Creek

Structure Class Permanent Bridge

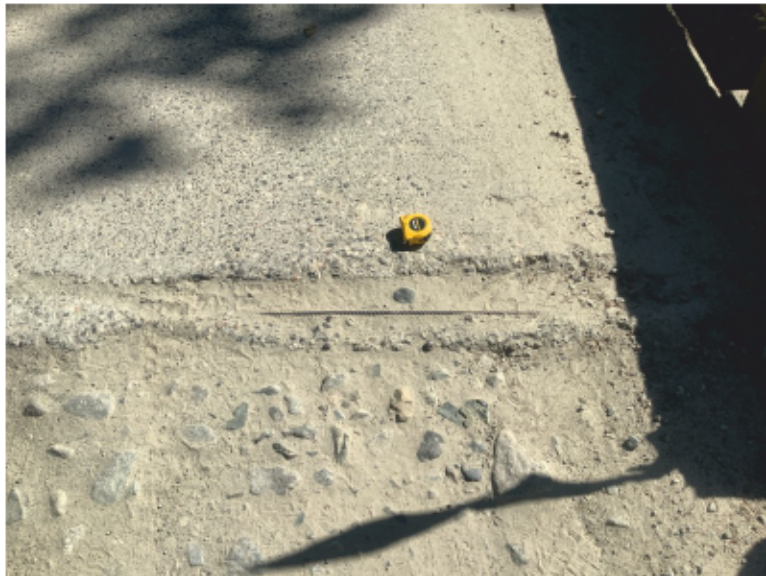
Ballast Wall Fair

Town needs repair. Not load restricting

| Repair Item | Repair Description |
|---|---|
| 1 Structure. Concrete structural maintenance. m².<br>Priority:Low | Town ballast wall top has exposed rebar |

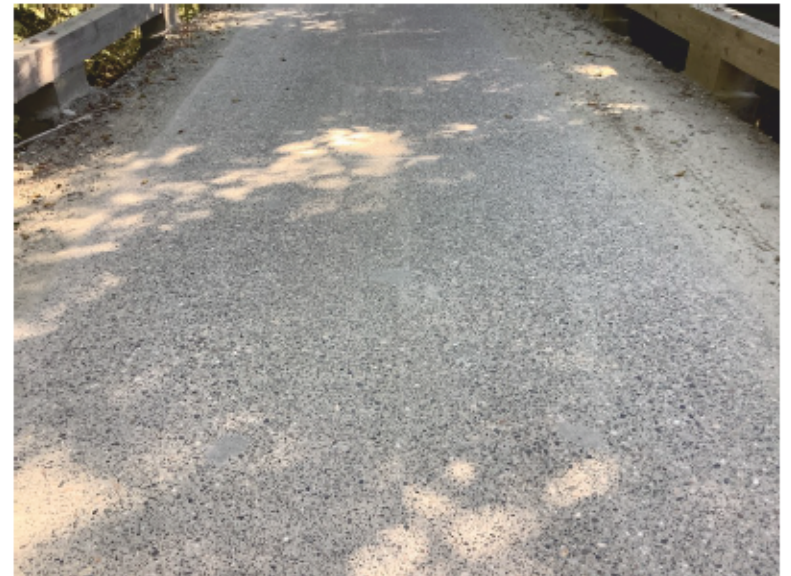
Concrete Deck      Fair      Some wear and sediment on deck

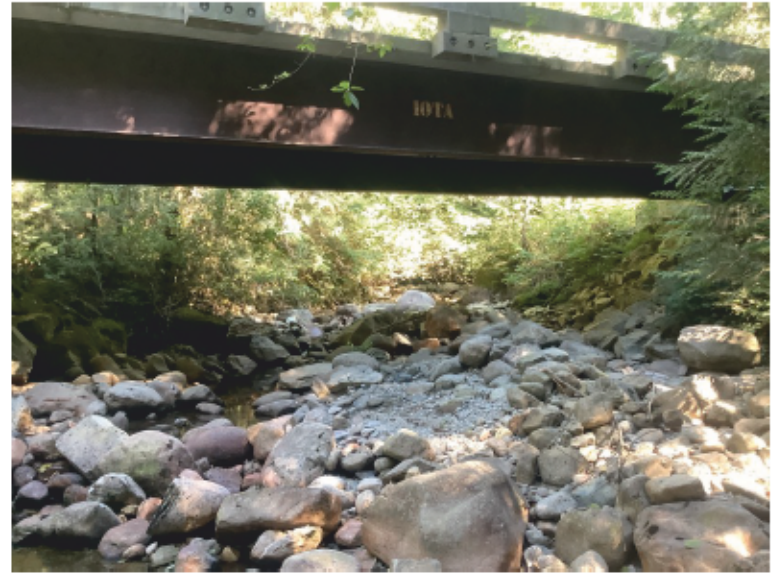
Downstream Profile

Town downstream over steepened appears stable

| Item | Monitor Description | Frequency |
|---|---|---|
| 1 | Town downstream riprap | Routine Inspection |
