CK-2170  
CK-2170

## LOST CREEK 17.1km

2022 Inspection

Crossing Name Teripocki Creek

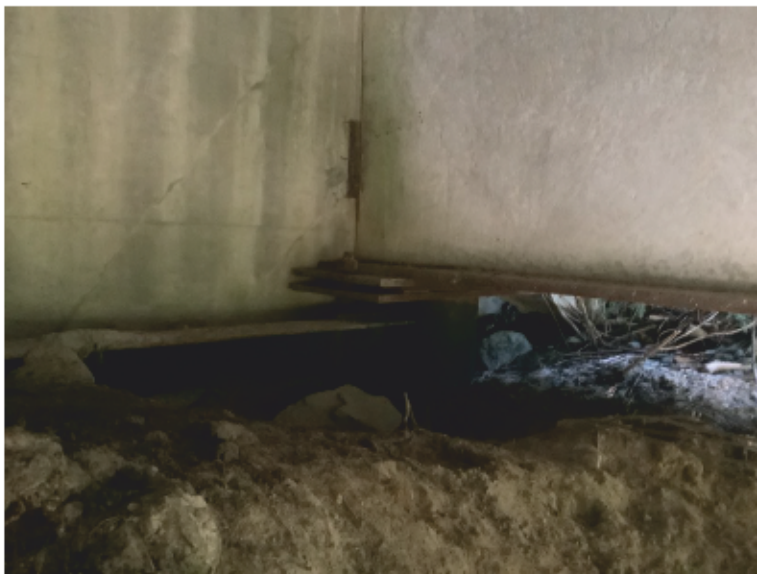
Bearing

Bearings **Good**

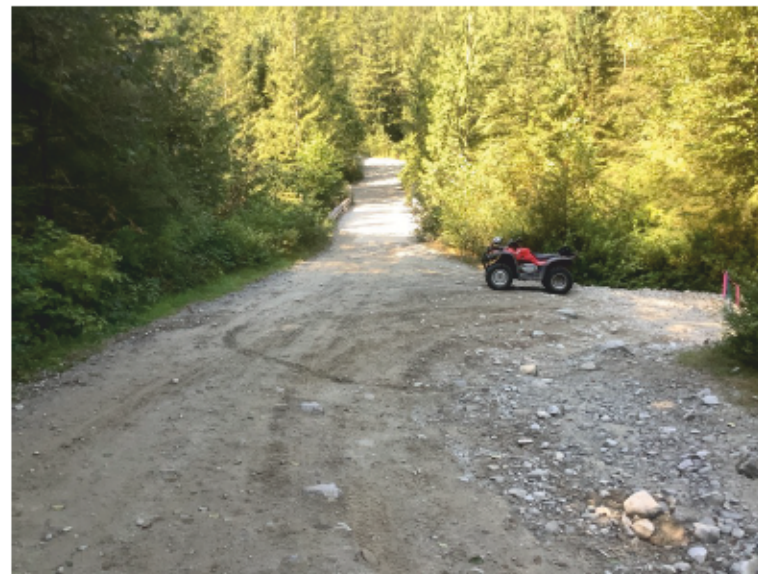
Approach from Left Bank when facing downstream

Road Surface **Poor** Potholes, ramp on woods side from off-roaders cuts into and narrows road running surface

| Repair Item | Repair Description |
|---|---|
| 1 Approach. Approach surfacing grading. m. Priority:Medium | Grade and ballast |
| 2 Approach. Reconstruct fill. m³. Priority:Medium | Woods side upstream. (4x4 ramp to stream) |

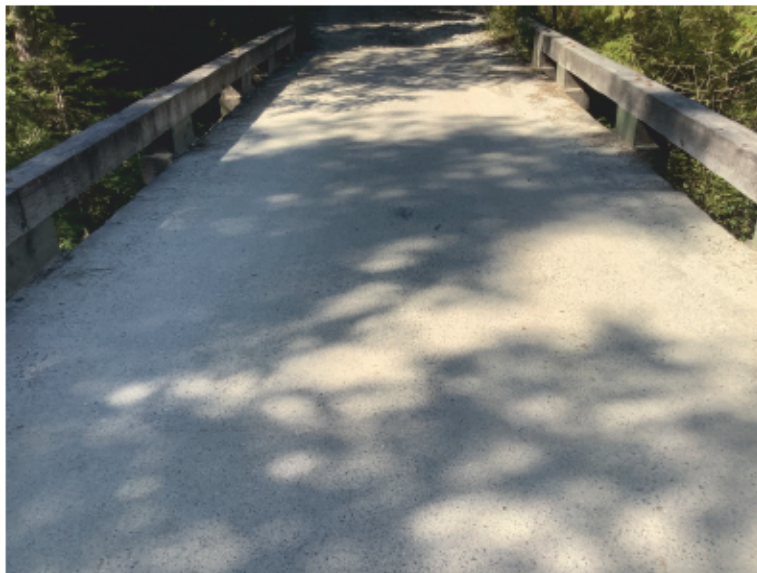
Deck

Running Surface      Good      Potholes, ramp on woods side from off-roaders cuts into and narrows road running surface

Potholes
