## LOST CREEK 18.8km

2022 Inspection

Structure Class Temporary Bridge

Inspection Company Chartwell Resource Group Ltd

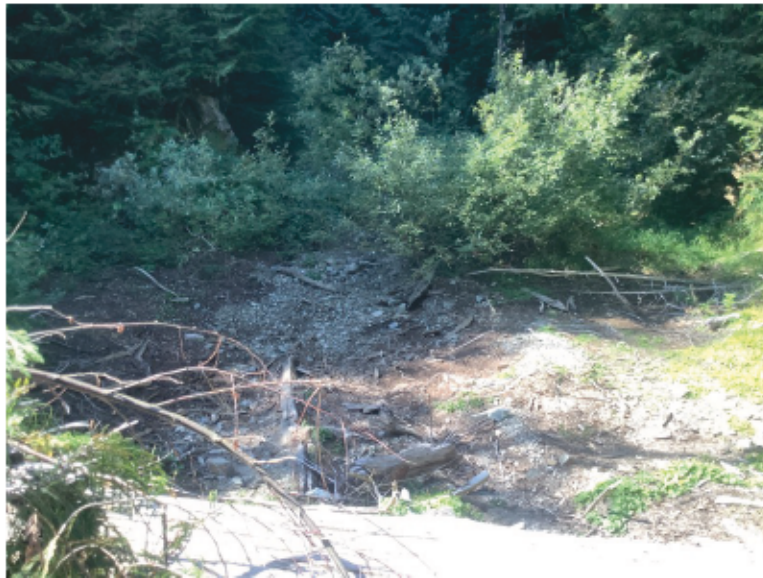
Upstream from Crossing

Comments Flows around structure. Remove structure if not getting replaced.

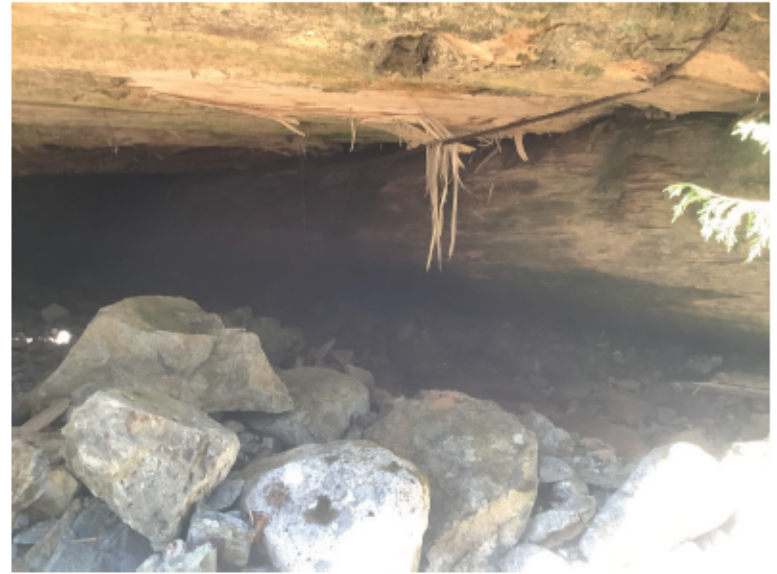
Left Bank Abutment when facing downstream

Old single sill logs

Eroded due to water flowing over structure and around the town end

Replace entire structure

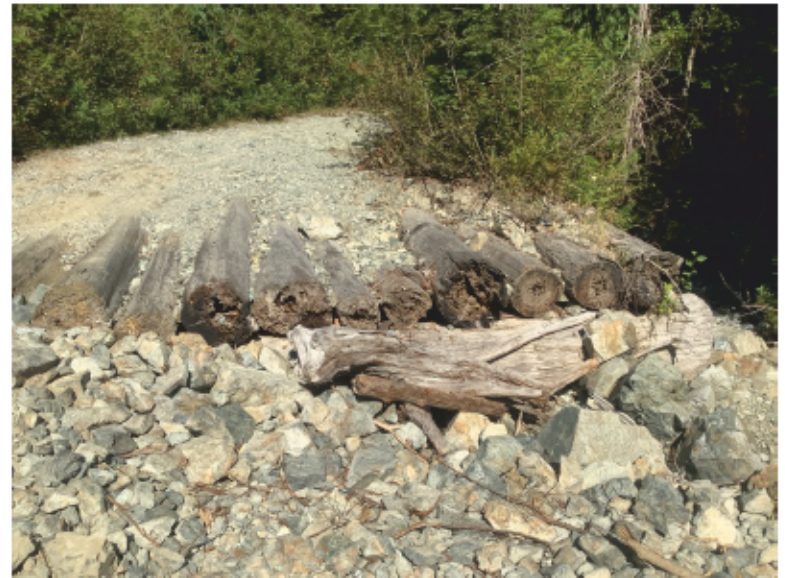
Stringers exposed, damaged and rotten.

Load Rated by: MoF, M.Lowe, RPF, PEng, February 15, 2023  
Load Rating: 68 Tonnes GVW, L-75  
Next Inspection: September 1, 2024  
Comments: Replace crossing
