CK-2173  
CK-2173

LOST CREEK 18.9km

2022 Inspection

Structure Class Temporary Bridge

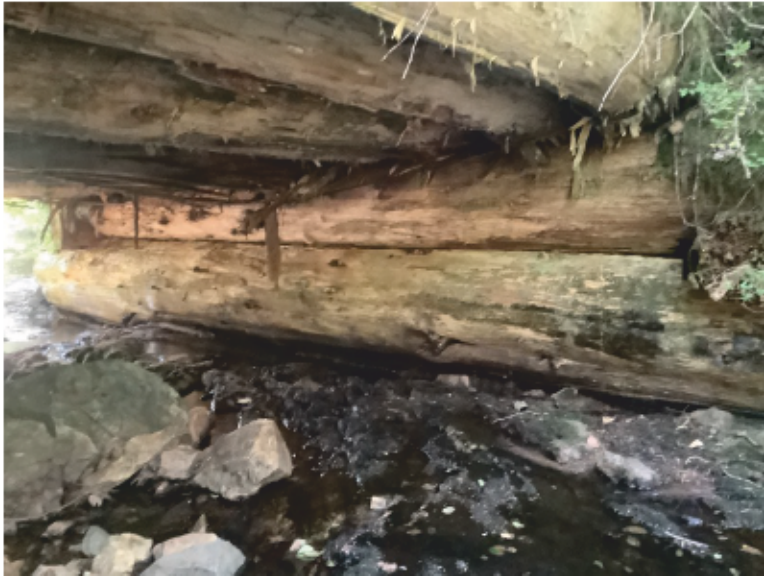
Right Bank Abutment when facing downstream

2 high both sides. Both appear vertical with no crushing.

due to rot

No riprap installed in front of cribs

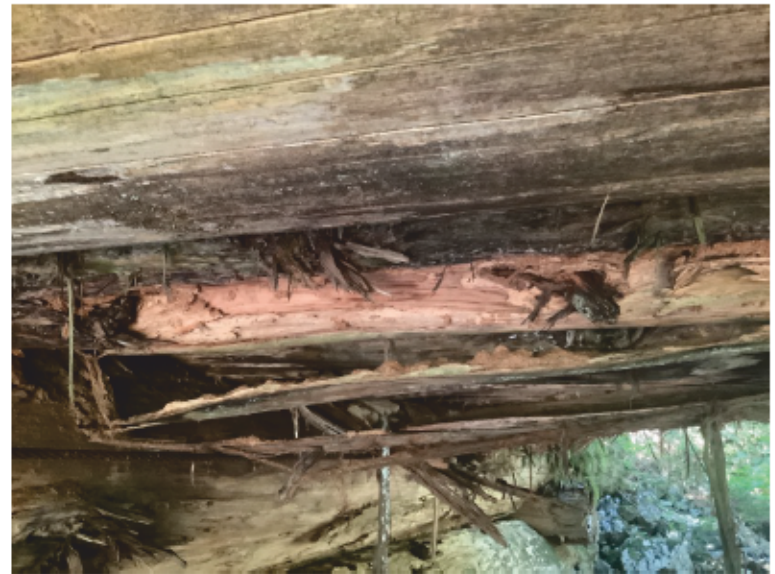
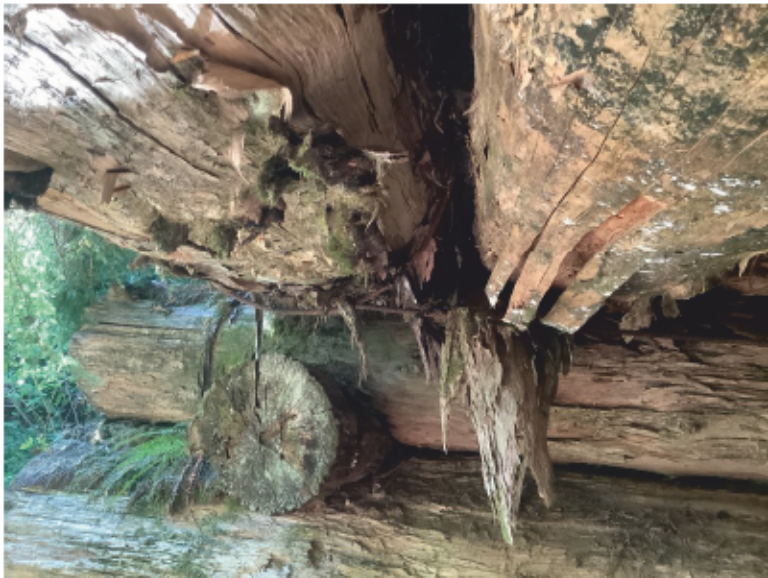
Stringers

Structure In poor condition. Replacement

Load Rated by: MoF, M.Lowe, RPF, PEng, February 15, 2023  
Load Rating: 0 Tonnes GVW  
Next Inspection: September 1, 2023  
Comments: Replace crossing
