CK-2194  
CK-2194

MASELPANIK 0.1km

2022 Inspection

Crossing Name Klesilkwa Creek

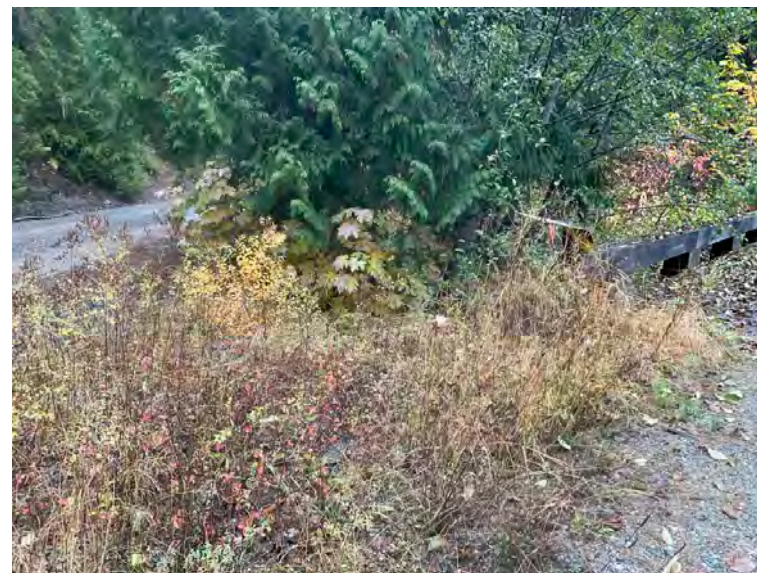
Fender Condition **Poor** Missing 2 and other 2 rotten

Missing downstream left bank fender

| Repair Item | Repair Description |
|---|---|
| 1 Approach. Approach fenders (install). # of units.<br>Priority:Medium | Replace all 4 log fenders with new ones (6m length x 600mm diameter or with concrete no post barriers |

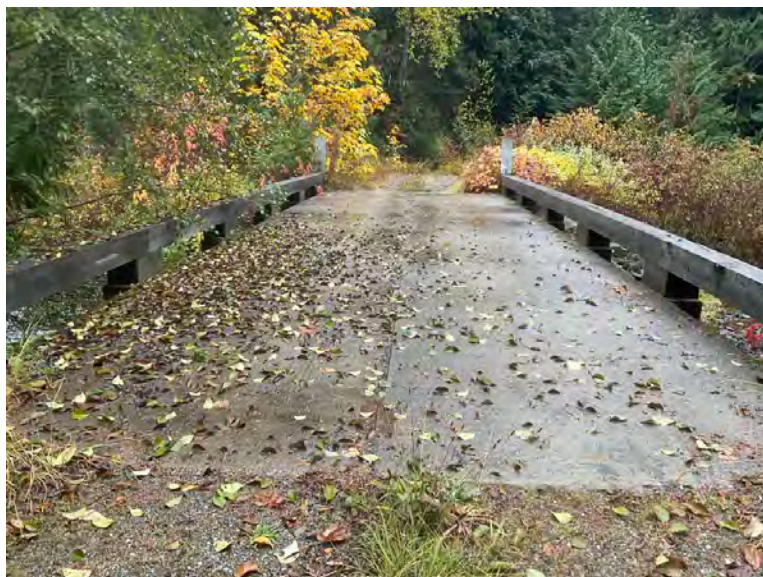
Overall Deck Condition      **Fair**

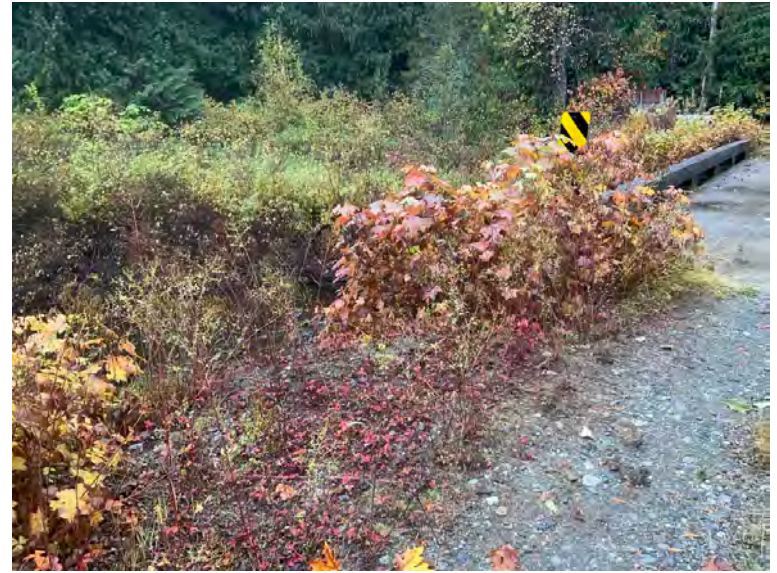
Missing upstream right bank fender

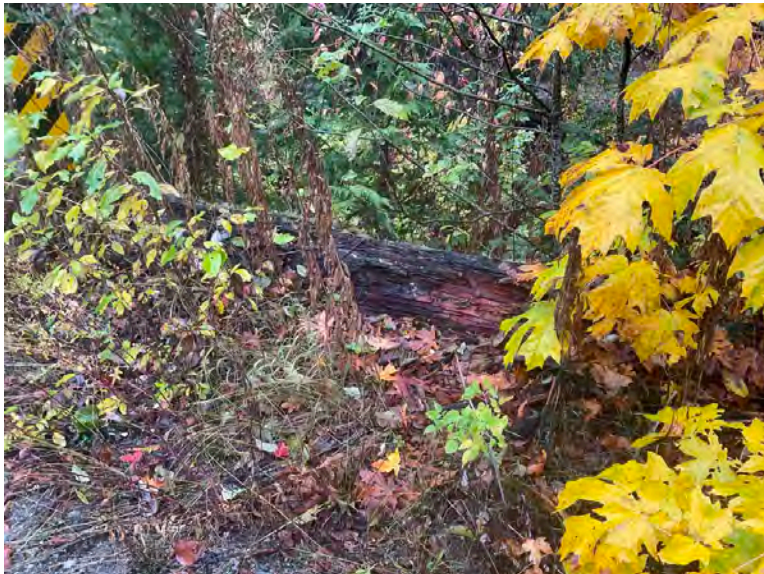
Downstream right bank fender extremely rotten

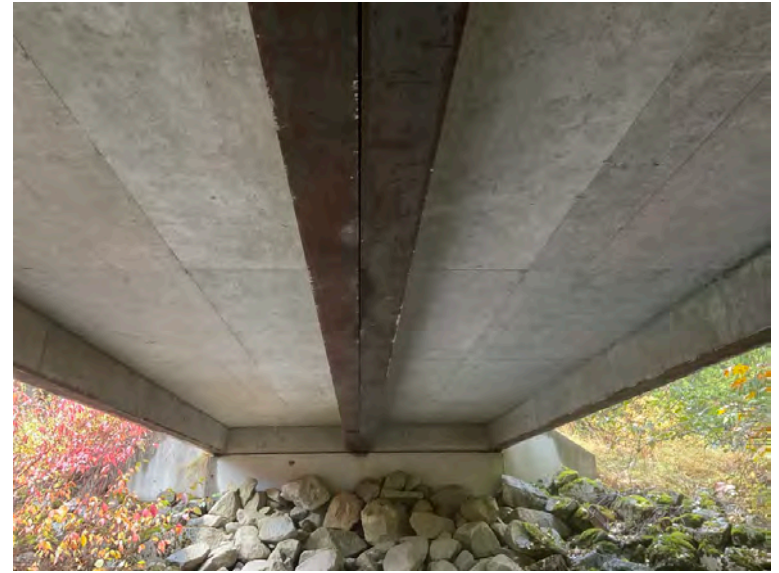
Superstructure

Girders **Good**
