CK-2211  
CK-2211

EMORY 2.8km

2022 Inspection

Crossing Name Side Creek

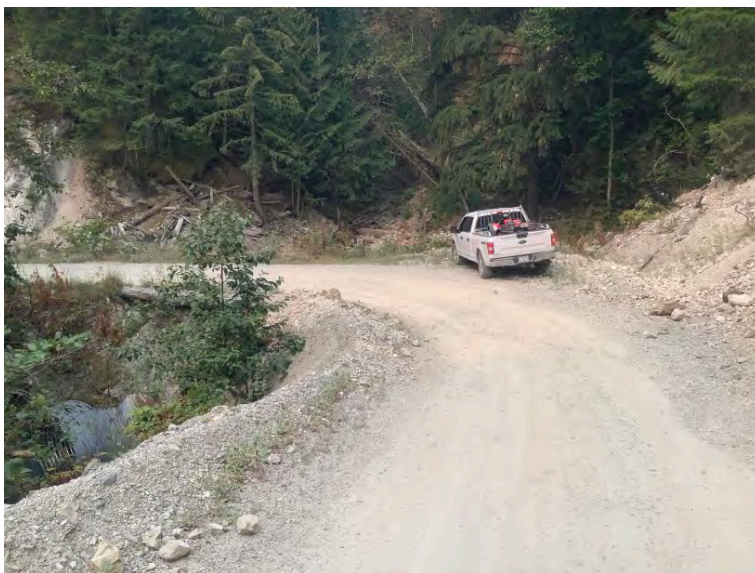
Approach from Left Bank when facing downstream

HC both approaches. In trough of vc

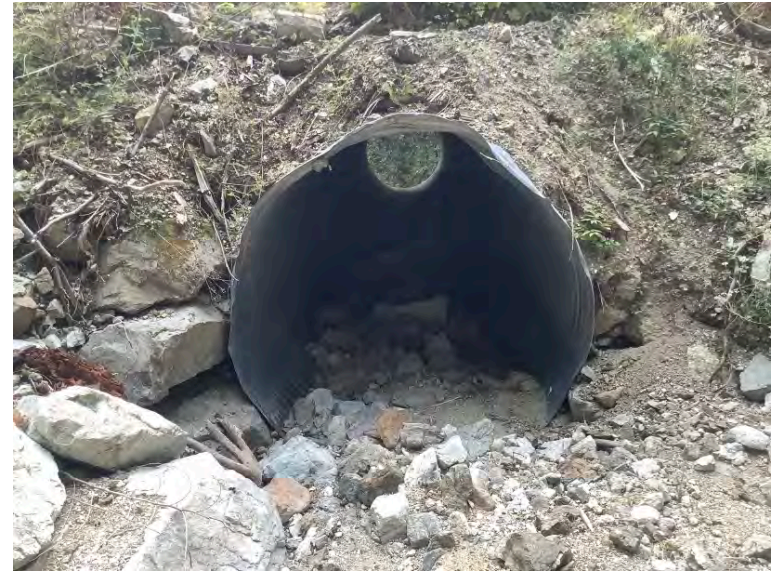
Inlet      Fair      Some damage and material built up in pipe

Comments Upstream third of pipe has rocky debris. Downstream fill slopes require monitoring. Consider installing fenders . CMP is at the junction of 2 drainages, both dry during inspection.

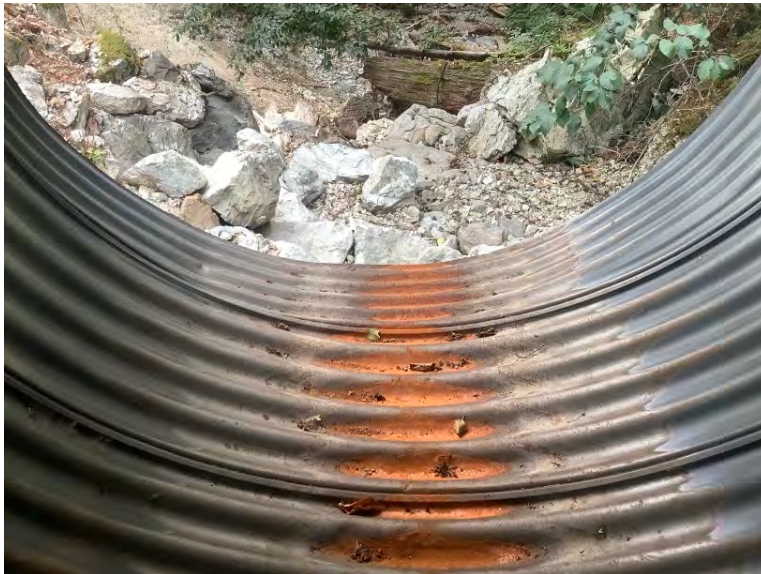
Culvert Floor

Floor      Fair      Minor corrosion

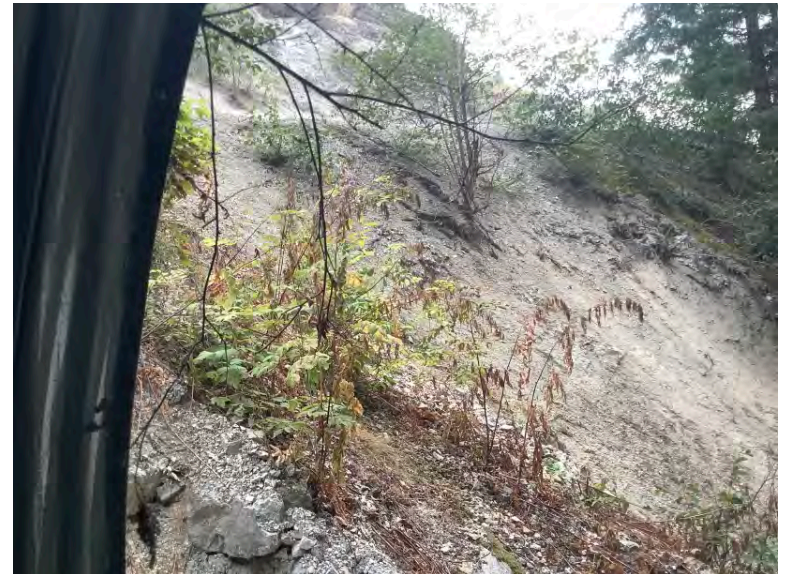
Left bank downstream fill slope

Fill      Fair      Monitor downstream fill

| Item | Monitor Description | Frequency |
|---|---|---|
| 2 | Downstream fill slopes | Routine Inspection |

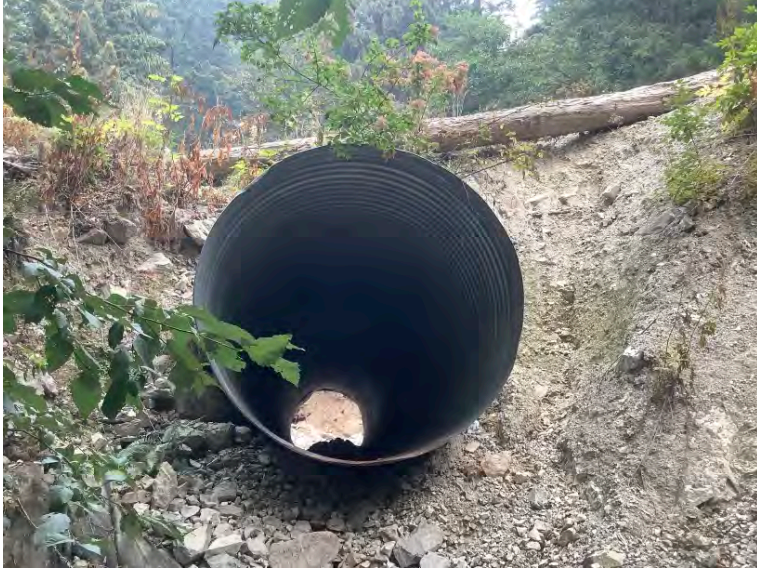
Outlet      Good
