## Permanent Bridge Inspection Report

| Site #: | CK-2213 | Structure Name: | CK-2213 | Road Name: | PEERS | Inspection Date: | 2022/08/21 |

**BRIDGE INFORMATION:**

**Bridge No./Name** CK-2213: Peers Creek FSR  
(0.2 km)

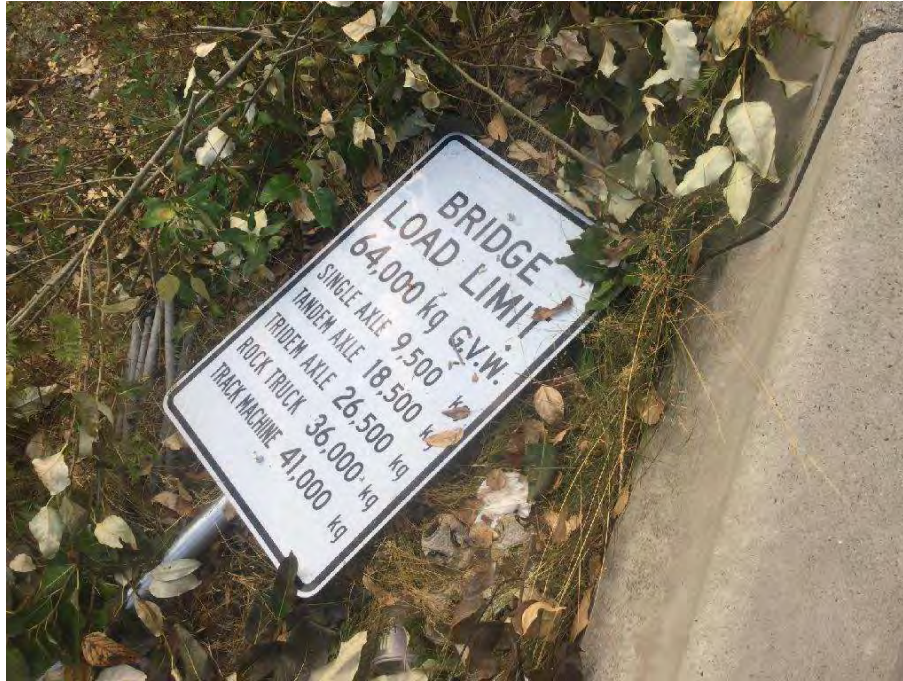
**Photo 27**  
Right load rating signage knocked over

| | 13 | Suggested | High | \$ 0.00 | Replace load rating and bridge ahead signs |

| Item No. | Description | Priority |
|---|---|---|
| 1 | Replace load rating signage | High |

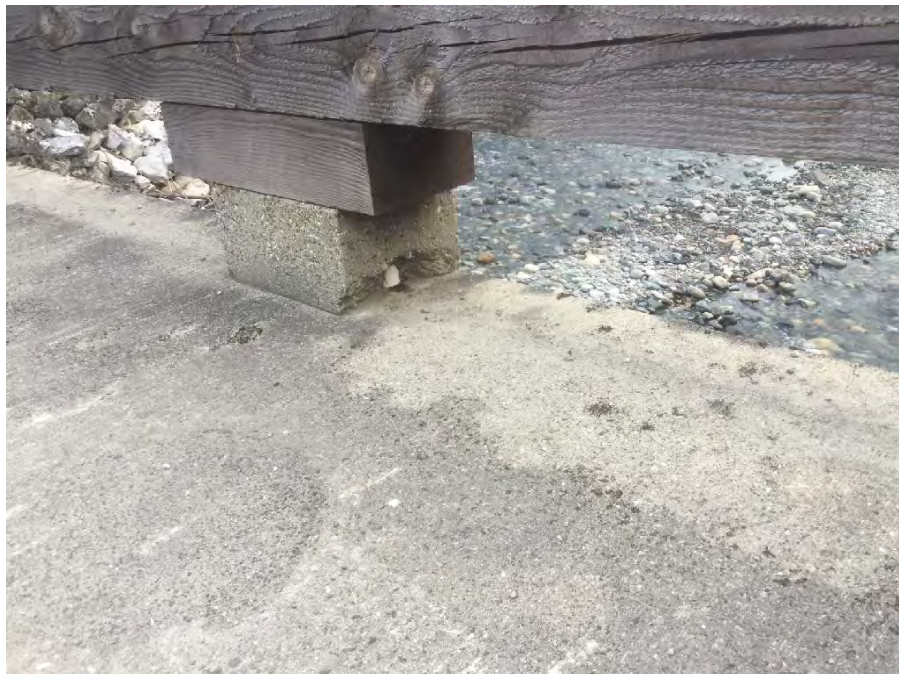
| Site #: | CK-2213 | Structure Name: | CK-2213 | Road Name: | PEERS | Inspection Date: | 2022/08/21 |
|---|---|---|---|---|---|---|---|
| Curb Rail/Blocks/Posts | | Fair | damage noted to concrete curb riser downstream location | | | | |

**Photo 28**  
Concrete curb riser spalling

| | 15 | Suggested | Low | | Repair spalled concrete on edges of deck panels and curb risers |

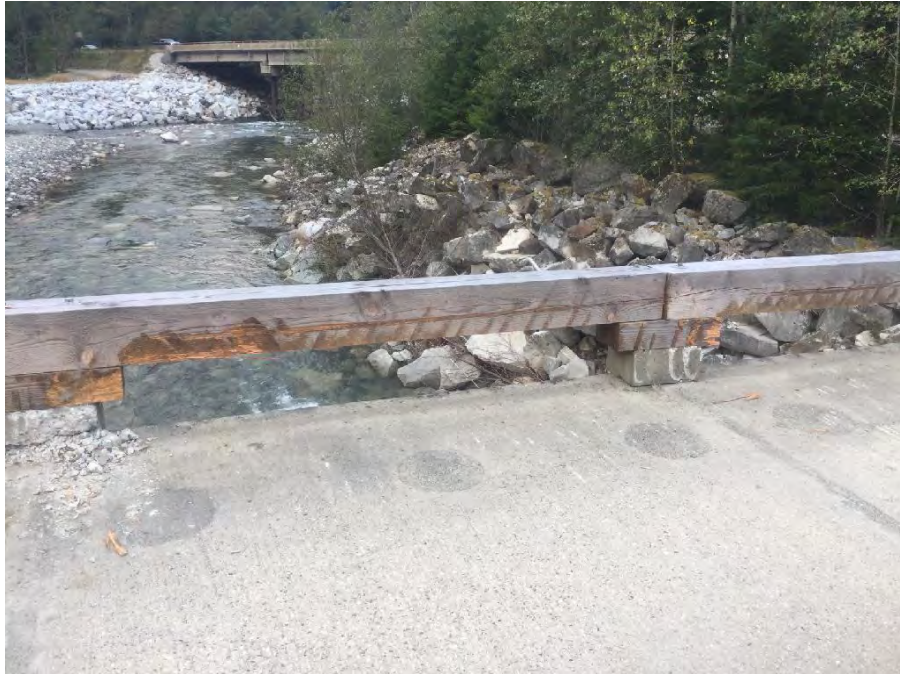
**Photo 29**  
Curb mechanical damage

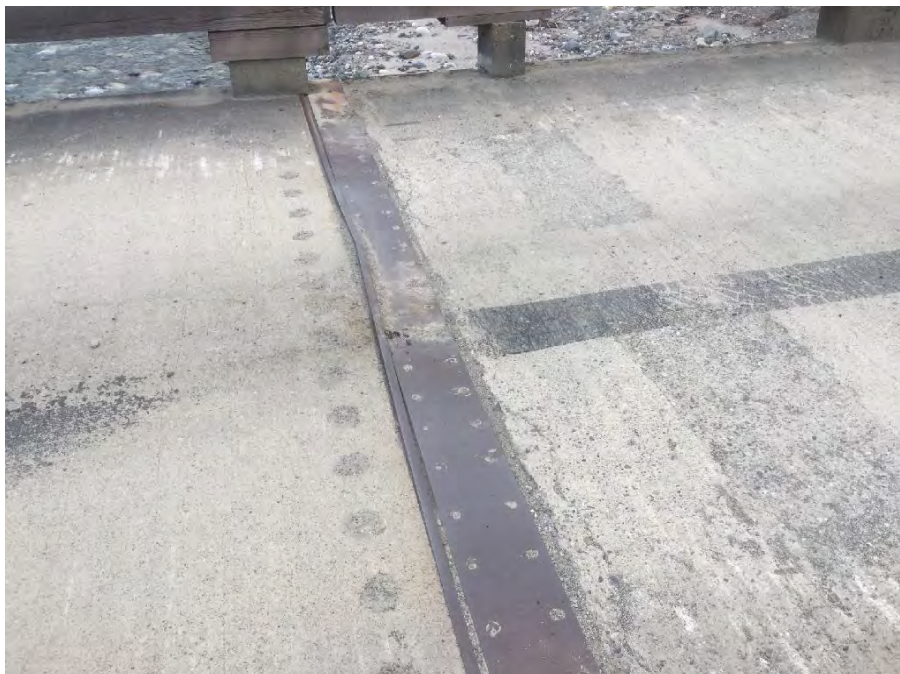
| Site #: | CK-2213 | Structure Name: | CK-2213 | Road Name: | PEERS | Inspection Date: | 2022/08/21 |
|---|---|---|---|---|---|---|---|
| Deck Joints | | Fair | expansion joint over pier 2 has mechanical damage to the embedded steel plate and delamination along the left deck panel; however appears to be functioning as intended | | | | |

**Photo 30**  
Expansion joint damage over pier 2

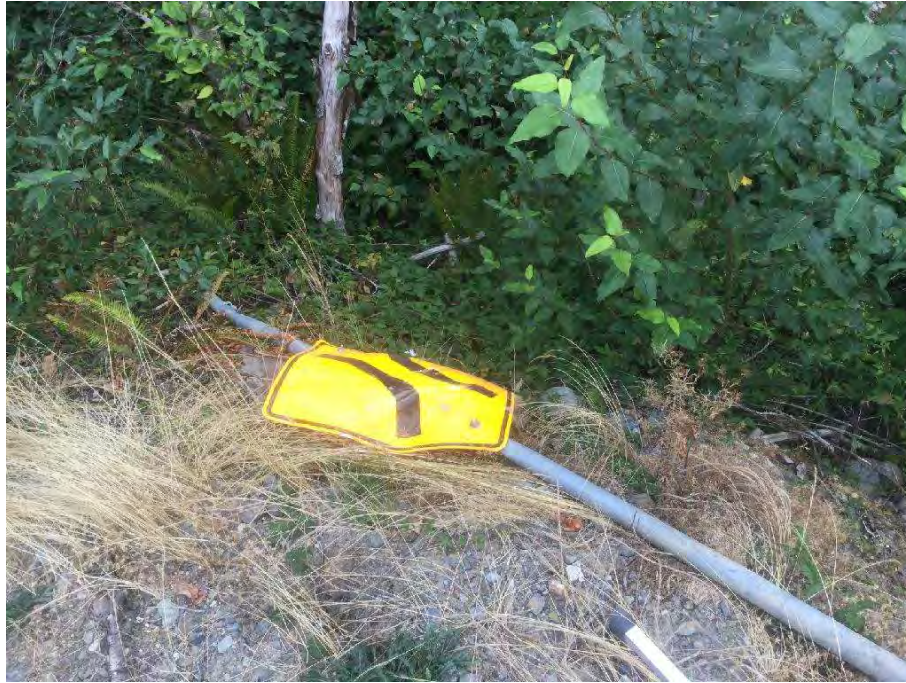
**Photo 31**  
Left 'Narrow Road Ahead' sign knocked over

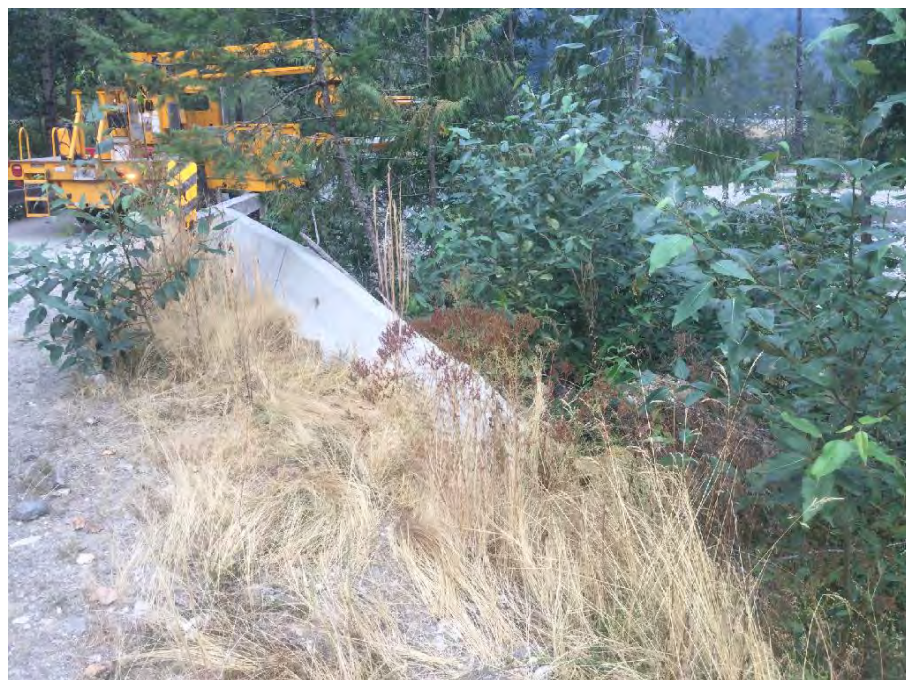
| Fender Condition | Fair | realign upstream left bank barriers |

**Photo 32**  
Left upstream barrier falling down embankment

| | 16 | Suggested | Medium | | Realign the upstream left bank concrete no post barriers |

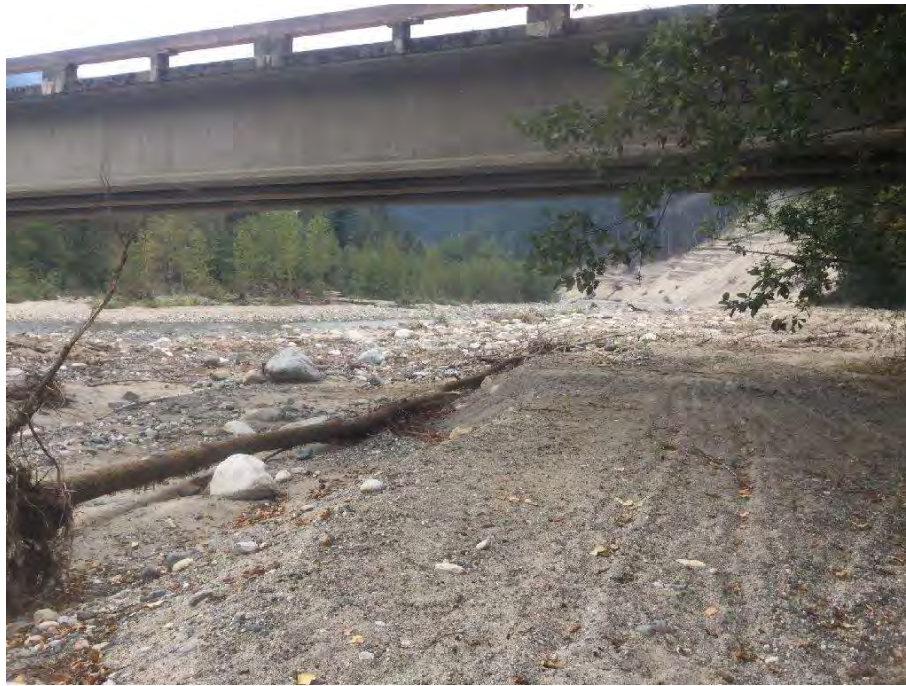
| Comment: | significant channel deposition as a result of recent high flow events | | | | | | | | |

**Photo 33**  
Channel looking upstream

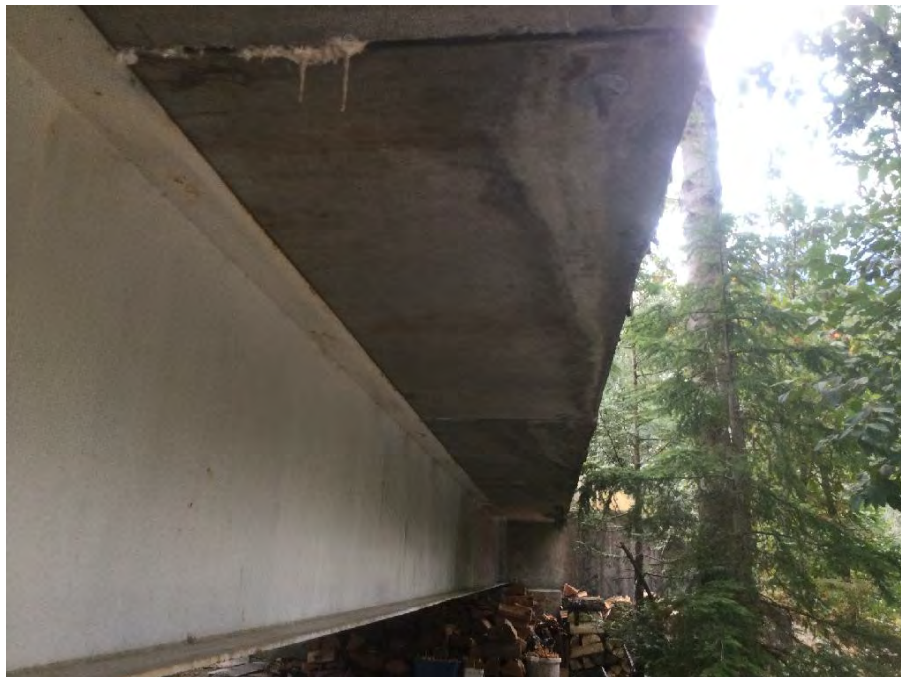
**Photo 34**  
Exterior soffit condition showing efflorescence

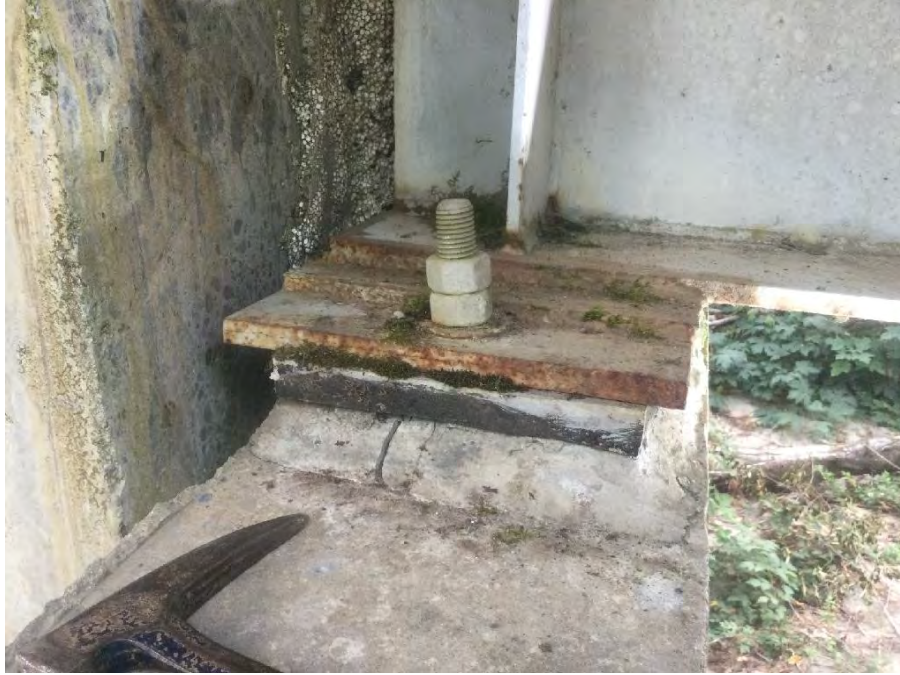
**Photo 35**

| Site #: | CK-2213 | Structure Name: | CK-2213 | Road Name: | PEERS | Inspection Date: | 2022/08/21 |
|---|---|---|---|---|---|---|---|
| Bearings | | Fair | span 1 girder 2 bearing grout cracked; anchor bolts for girders 1 and 2 on span 1 are leaning but have not failed | | | | |

Pier 1 span 1 girder 2 bearing grout cracked

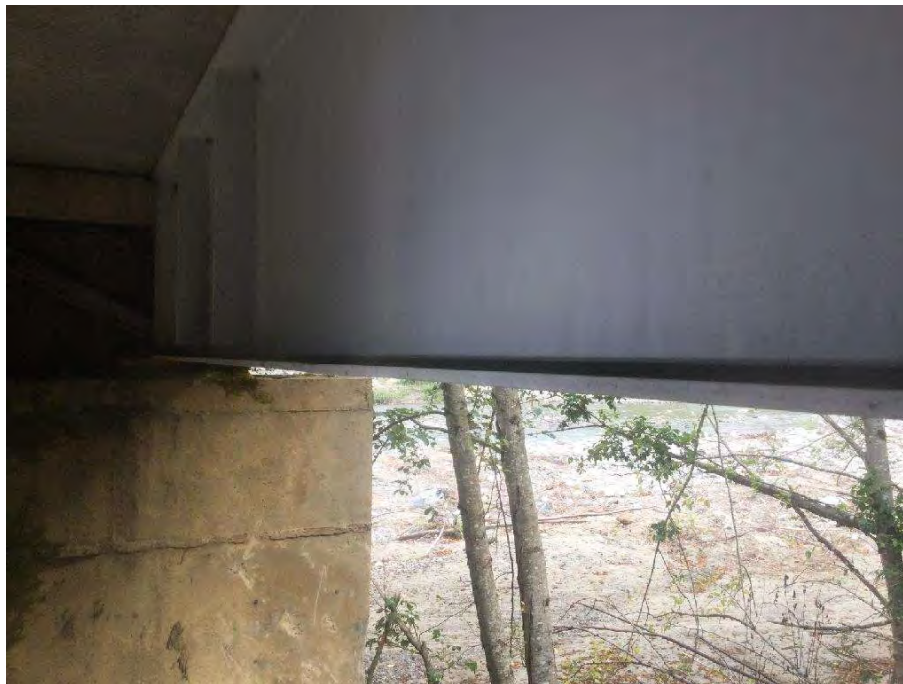
**Photo 36**

Span 1 girder 1 minor warp in bottom flange

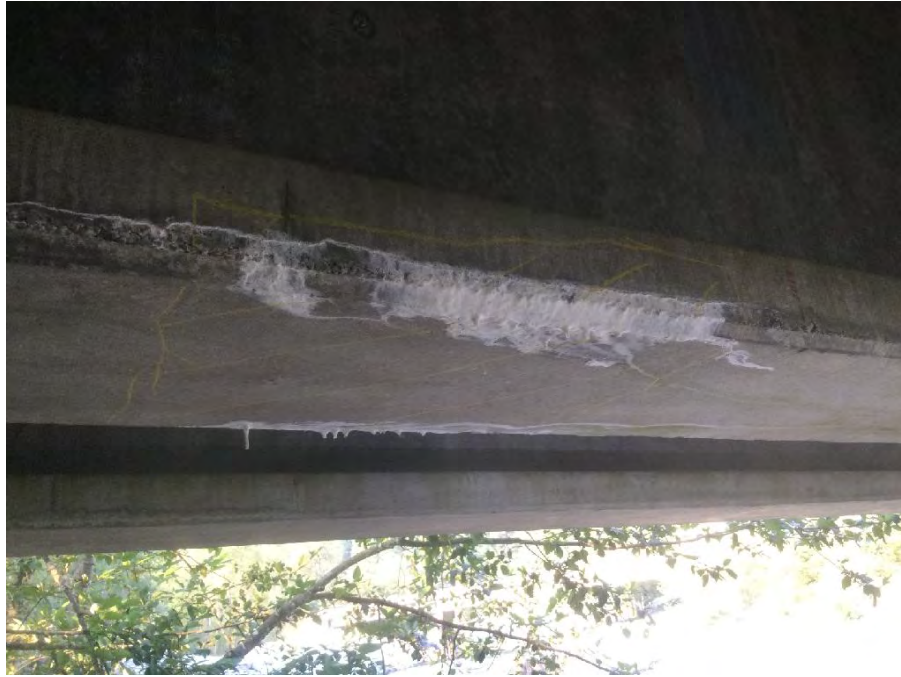
**Photo 37**

| Girders | Fair | girder 2 has 2 locations with hairline cracks along bottom flange with efflorescence, developing into spalling and delamination; girder 3 has spalled and is delaminating |

- The girders are in fair condition.
- Span 2 girder 2 has a crack along the bottom flange of the girder with efflorescence, indicating water ingress within the girder. The bottom flange of the girder is starting to delaminate (600

mm x 800 mm area noted) indicating corrosion of the reinforcing steel due No clear source of water ingress in the girder.

Efflorescence and delamination on girder 2 span 2

| | 5 | monitor concrete spalls, cracks, and delamination in girders on span 2 |

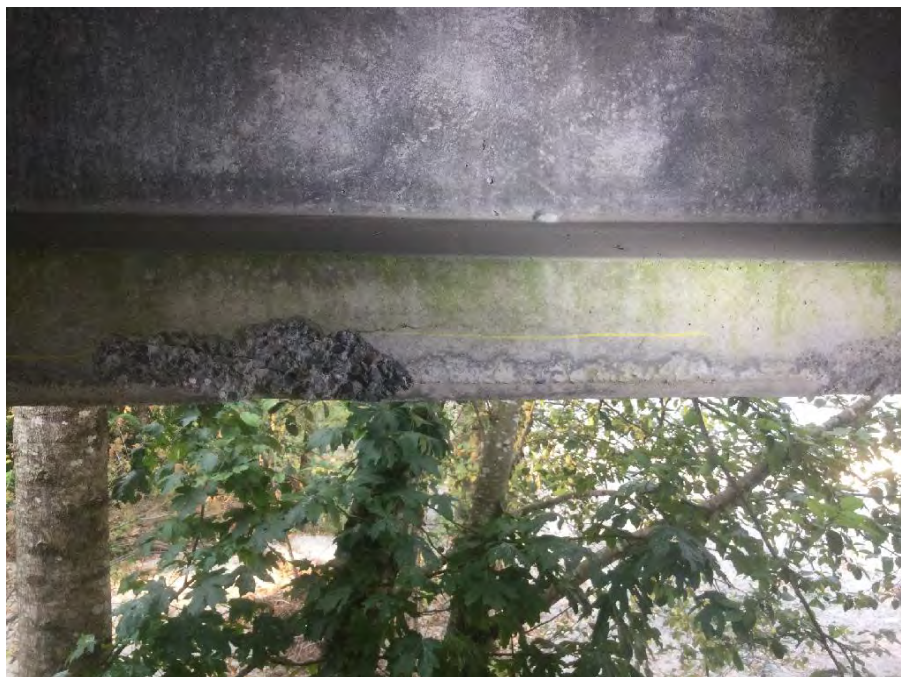
**Photo 38**

Span 2 girder 3 at pier 1 spall and delamination

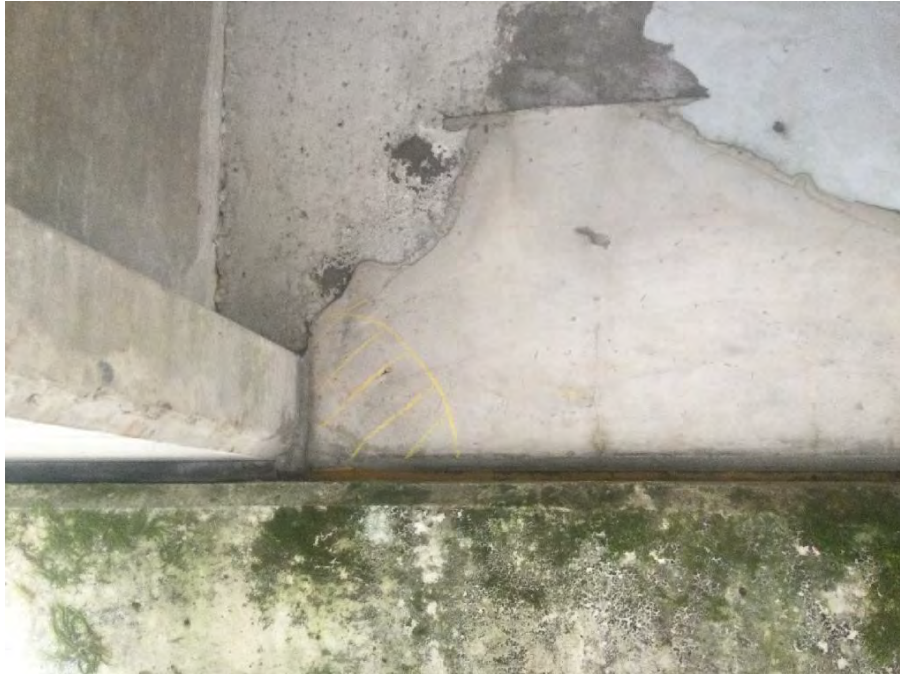
**Photo 39**

| Diaphragms | Fair | end diaphragm at pier 2 has 150mm x 150mm delamination between girder 2 and 3 |

Span 2 end diaphragm at pier 2 delamination between girders 2 and 3

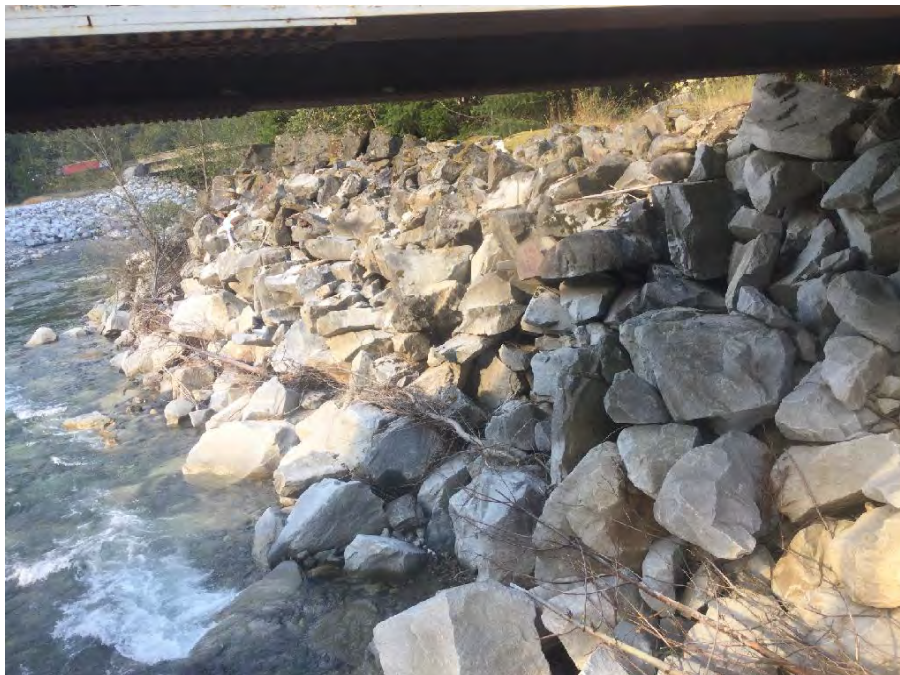
**Photo 40**

| Riprap | Fair | right bank over-steepened but appears adequately sized and functioning well |

Over steepened right bank riprap

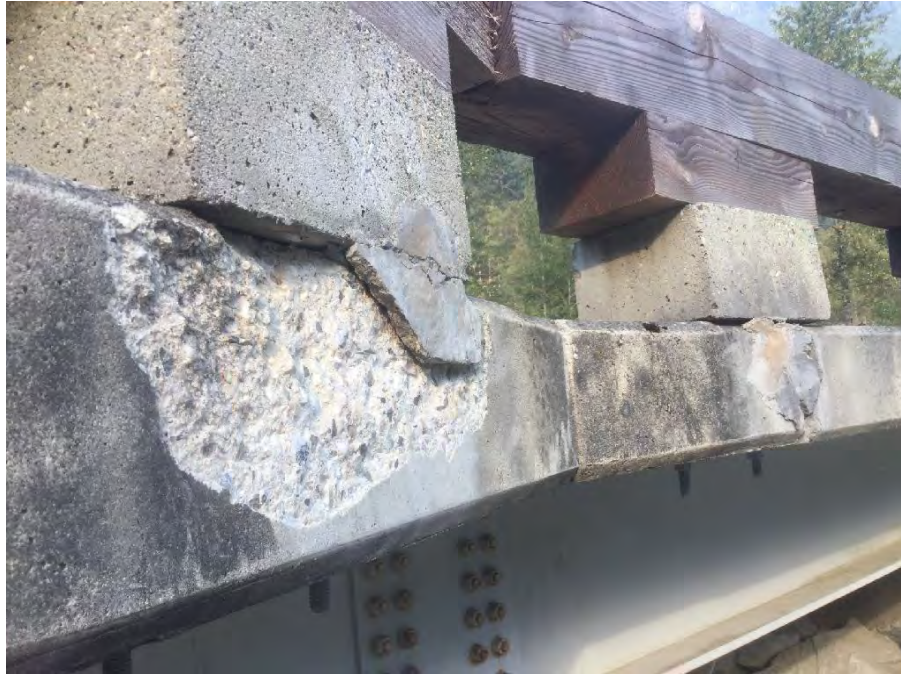
**Photo 41**

| Concrete Deck | Fair | deck panel edges have spalled at various locations, typically where concrete risers are anchored |

Deck spalling at curb rail anchorage location

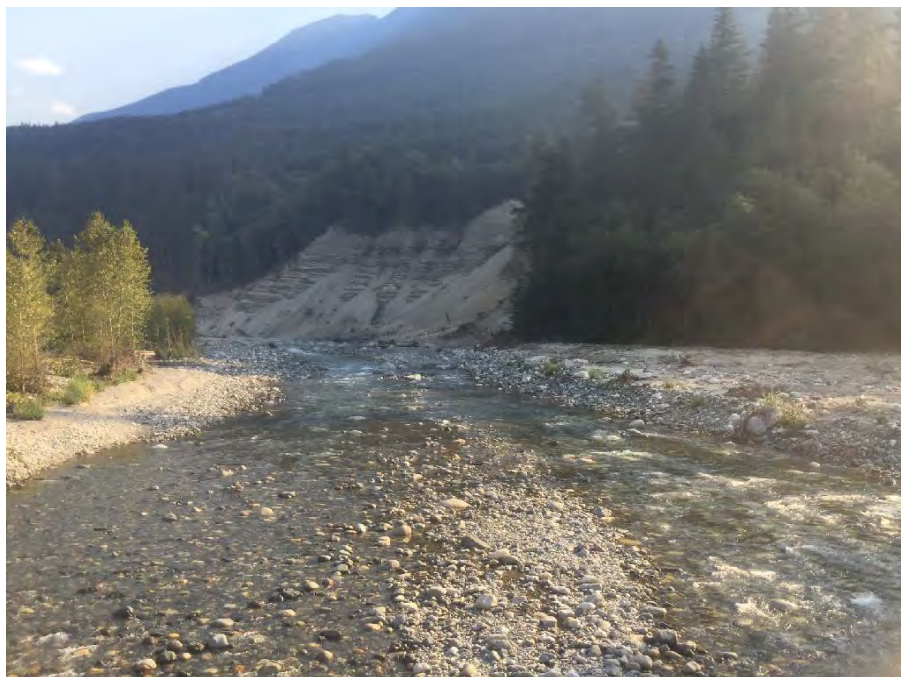
**Photo 42**

Slope failure upstream of the crossing
