CK-2224  
CK-2224

PITT RIVER 23km

2022 Inspection

Crossing Name Shale Creek

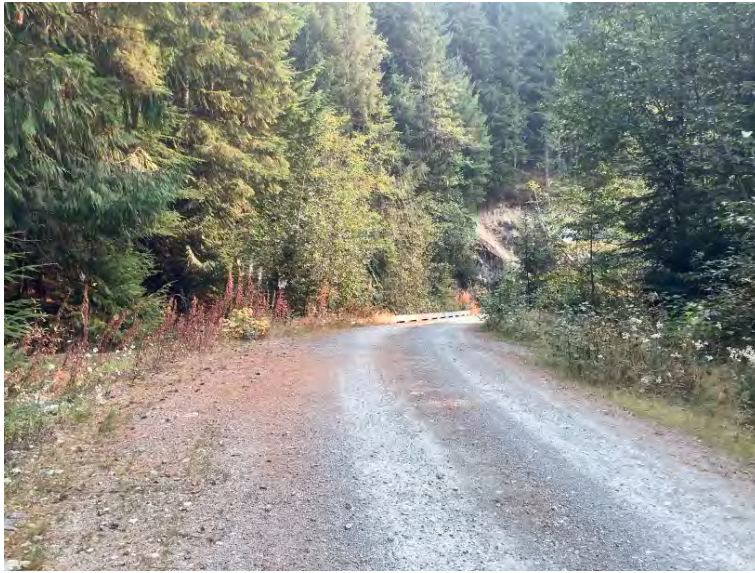
Old rotten logs. Downstream left is boulders

Approach from Right Bank when facing downstream

| Repair Item | Repair Description |
|---|---|
| 1 Approach. Approach fenders (install). # of units. Priority:Medium | Install 600mm x 6.0m guidelogs all 4 corners |

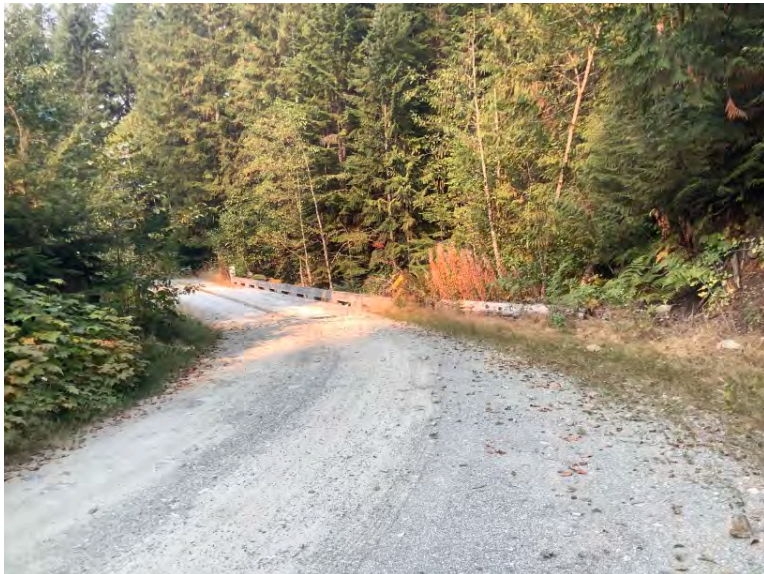
Minor potholes, cutslope on left approach depositing rocks onto road.

Approach from Left Bank when facing downstream

| Repair Item | Repair Description |
|---|---|
| 3 Approach. Approach surfacing grading. m. Priority:Low | Remove rocks on left approach prior to industrial activity |

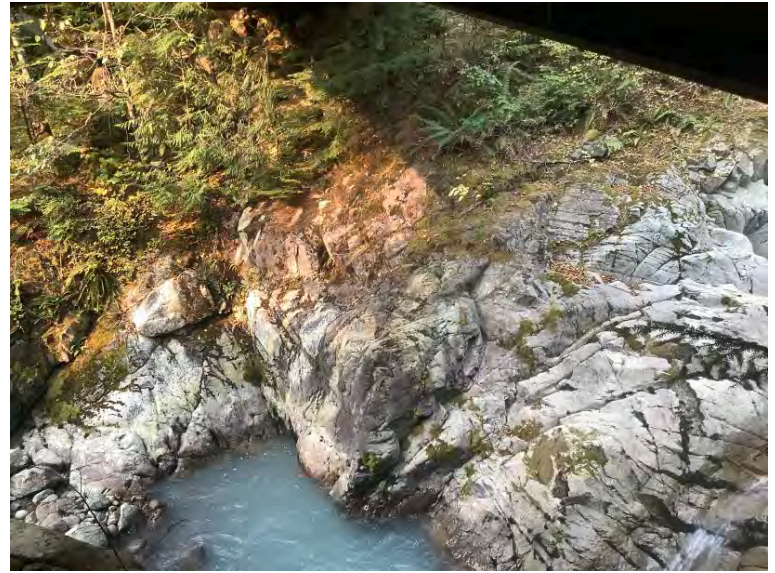
4x crib face logs with 30mm rot. Crack upstream right bank top crib log similar to dimension stated in 2020 report, still no crushing.

Right Bank Abutment when facing downstream

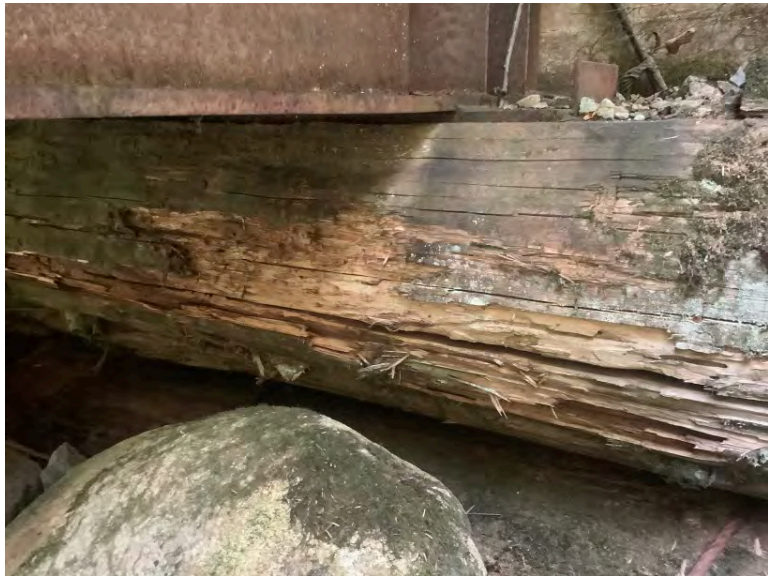
Upstream right bearing crack

| Item | Monitor Description | Frequency |
|---|---|---|
| 1 | Crack upstream right crib log. | Routine Inspection |
