CK-2226  
CK-2226

BOISE 0.3km

2022 Inspection

Crossing Name Pitt River

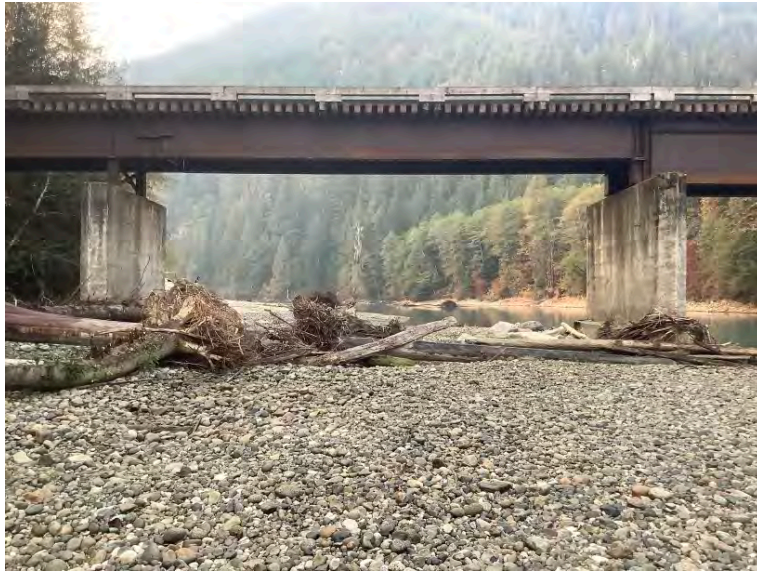
Pier **Good** 2 cip piers have woody debris accumulating

Debris around 2 left bank piers

| Item | Monitor Description | Frequency |
|---|---|---|
| 1 | Debris accumulation around left bank CIP piers | Routine Inspection |

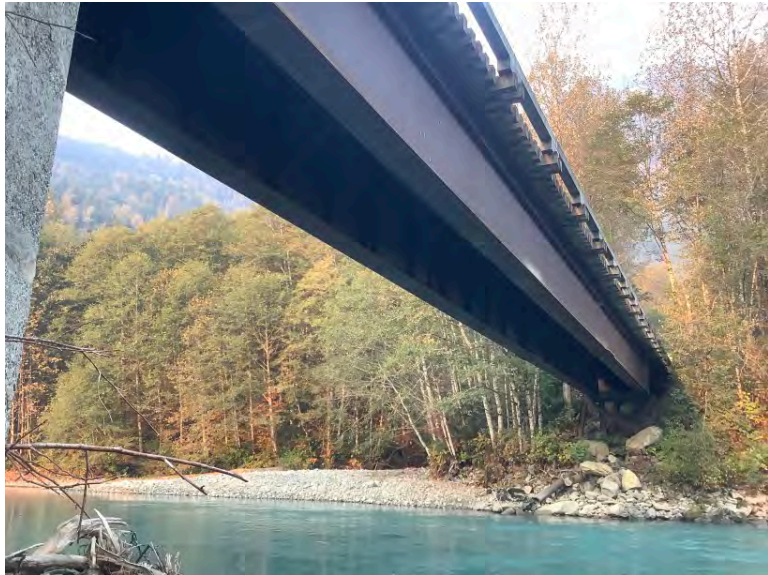
Superstructure

Girders Good Minor corrosion
