CK-2228  
CK-2228

BOISE 3.2km

2022 Inspection

Crossing Name Side Creek

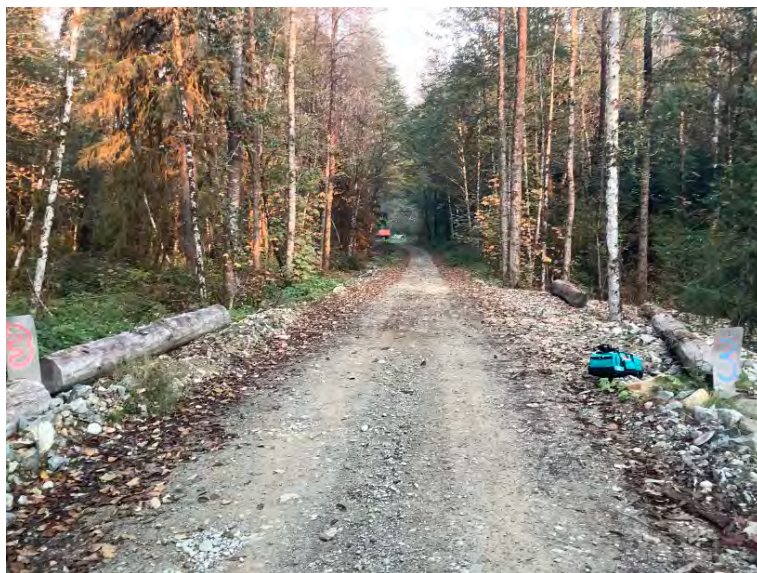
Bridge Ahead Signs  
Missing ☐ 0 ☐ 1 ☒ 2

Approach from bridge deck of Left bank approach when facing downstream

1 Approach. Bridge Ahead  
Signs. # of signs.  
Priority:Low

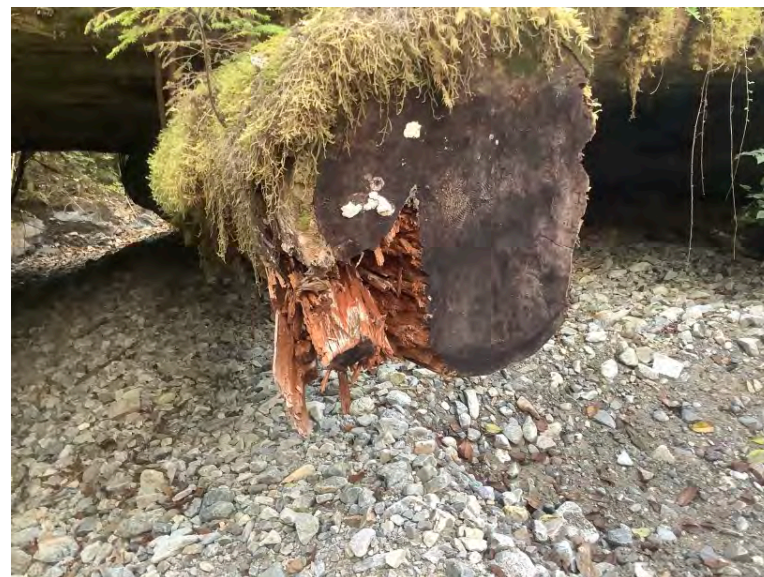
Needle Beam Fair

Poor-Rotten

Needle beam down stream end

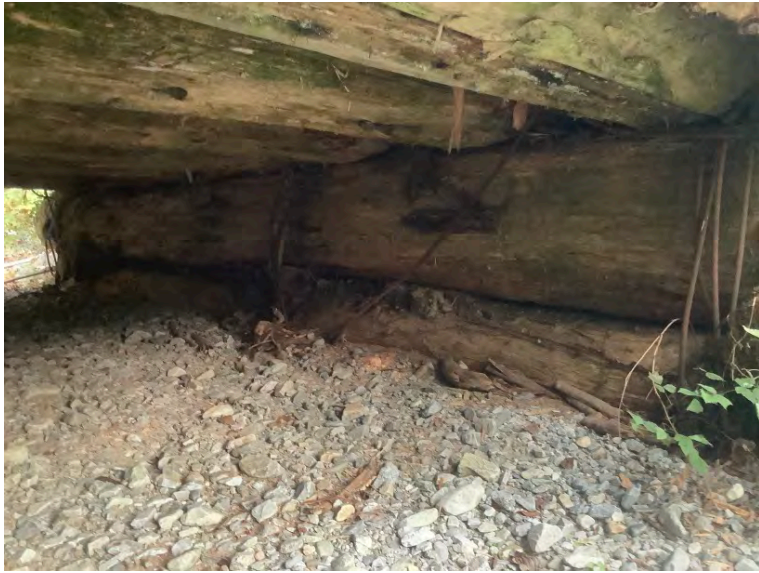
Log/Timber Cribs **Fair** Fair to poor. Right bank settling, gap between crib face logs. 3 crib face logs visible. Left bank 2 visible.

Left Bank Abutment when facing downstream

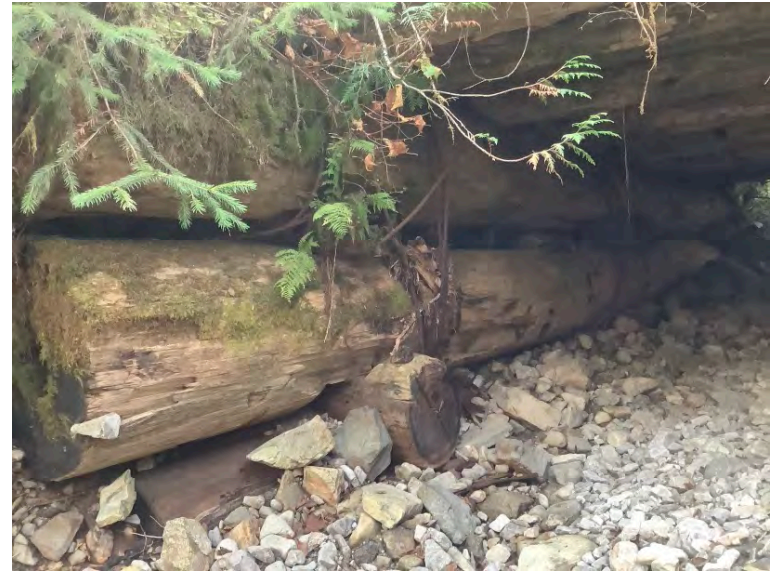
Tie Backs **Fair** Fair to poor. Rotten, though cribs still vertical

Right Bank Abutment when facing downstream

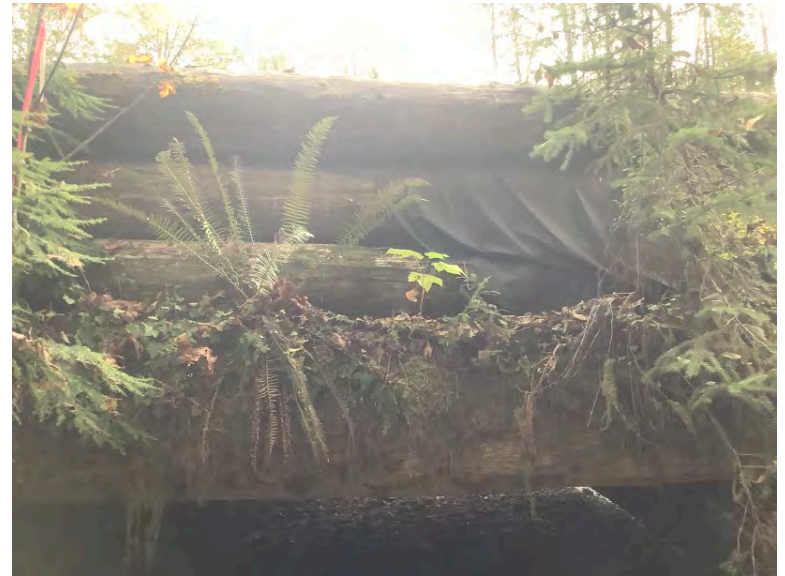
Comments: Some indication of rot in upper layer of fir stringers, however cannot fully assess and load rating very sensitive to small increases in rot. Whole structure should be replaced soon.

Comments Downstream of channel appears to have been recently excavated. Mid span to left crib is infilled with gravels. 1.2m of dry freeboard. Right bank has scoured exposing the 3 crib face log and resulting in settling and gaps between crib face logs. 2 layers of stringers. 8.5m downstream, span and 8.3m upstream span. 200mm gaps between lower stringers, rocks/stringers above filling gaps. Some fruiting bodies visible on upper stringers through gaps in lower stringers.

Multiple stringer layers

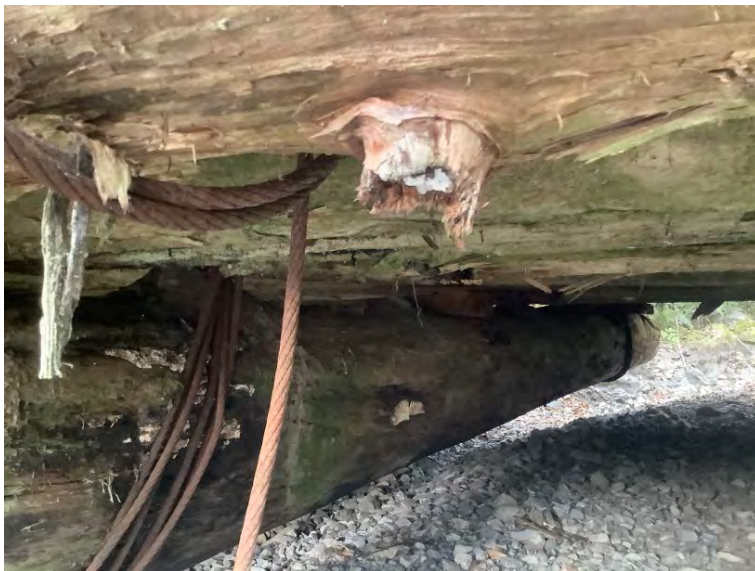
Hardware **Poor** Loose lashing. Needle beam not effective.

Needle Lashing/  
Shimming Fair

Poor-Loose, not in contact with stringers

Needle beam, loose lashing not contacting stringers

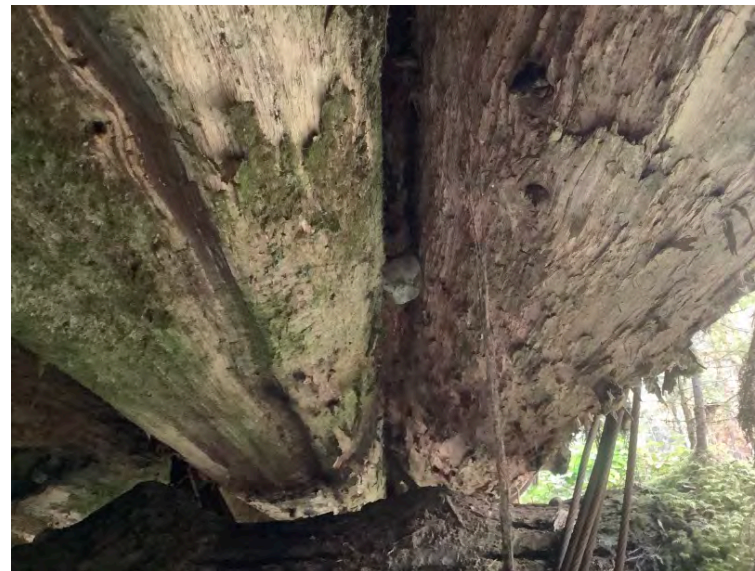
Stringers

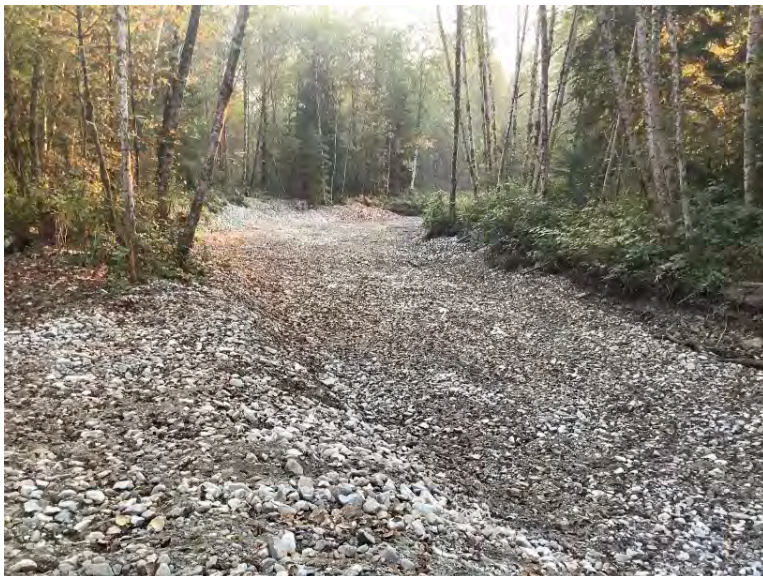
Downstream channel work

| Item | Monitor Description | Frequency |
|---|---|---|
| 1 Aggradation | | Routine Inspection |
