CK-2230  
CK-2230

BOISE 7.6km

2022 Inspection

Crossing Name Boise Creek

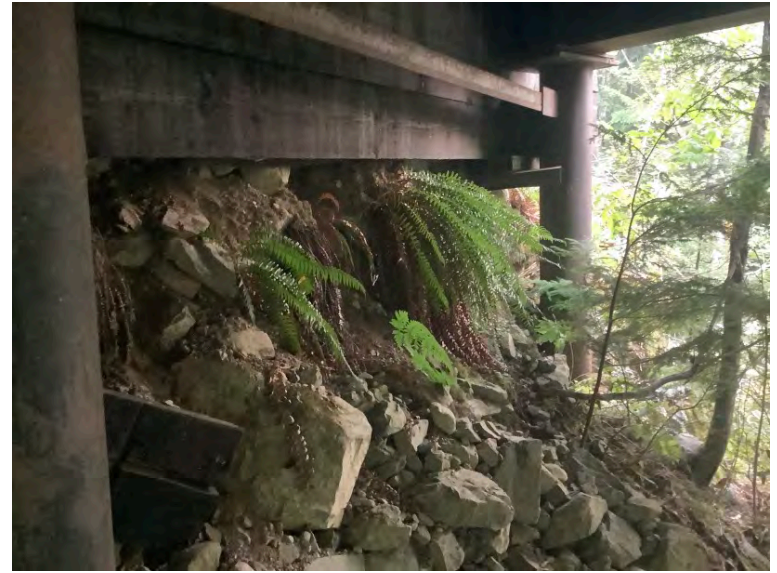
Ballast Wall Fair

Creosote timber with some fill starting to migrate beneath

| Item | Monitor Description | Frequency |
|---|---|---|
| 1 | Potholes at each end due to material loss under ballast walls | Routine Inspection |

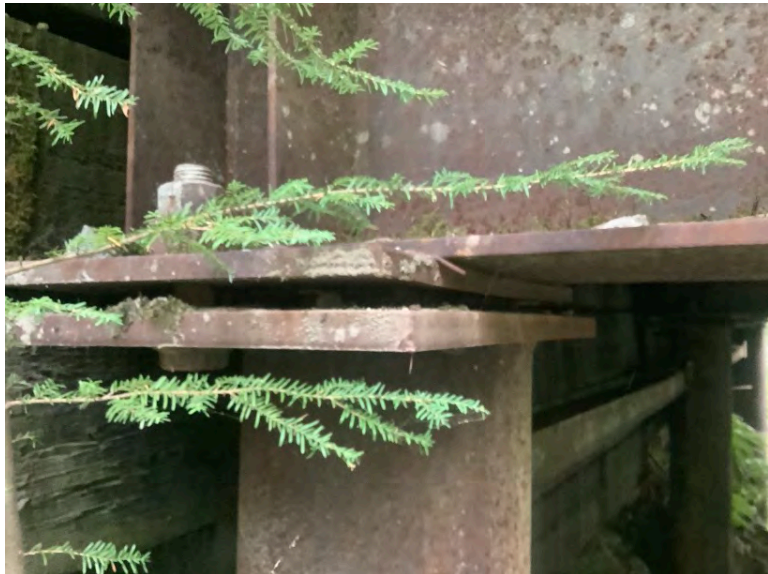
Bearing

Bearings Fair

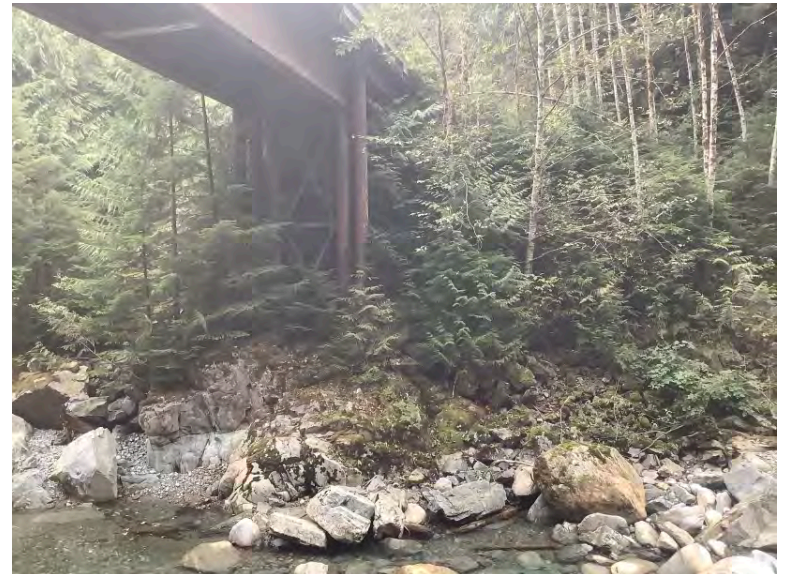
Right Bank Abutment when facing downstream

Oversteepened, right bank appears to be bedrock. Left bank rests on piers.

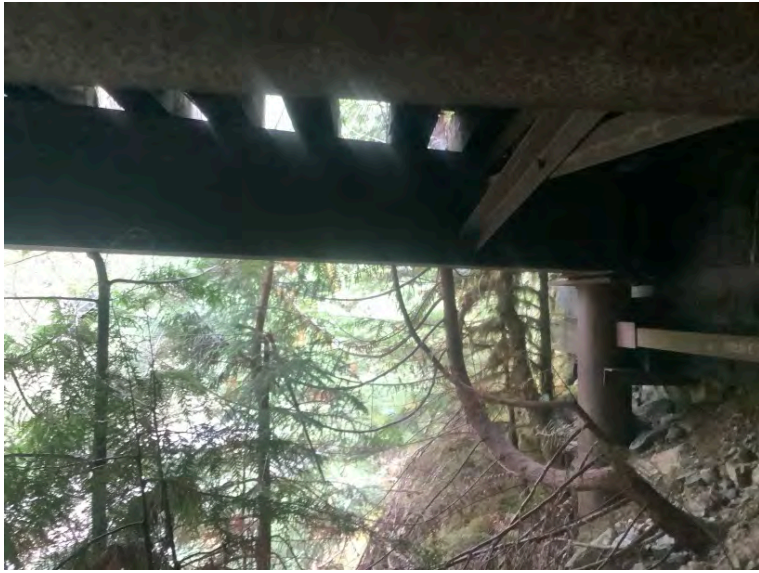
Right downstream flair girder

Jump spans have 3 girders to pick up flair. 5 pile each pier location. 2 main span girders. Minor corrosion throughout entire structure
