## BUCKLIN 3km

2022 Inspection

Crossing Name Bucklin Creek

Structure Class Temporary Bridge

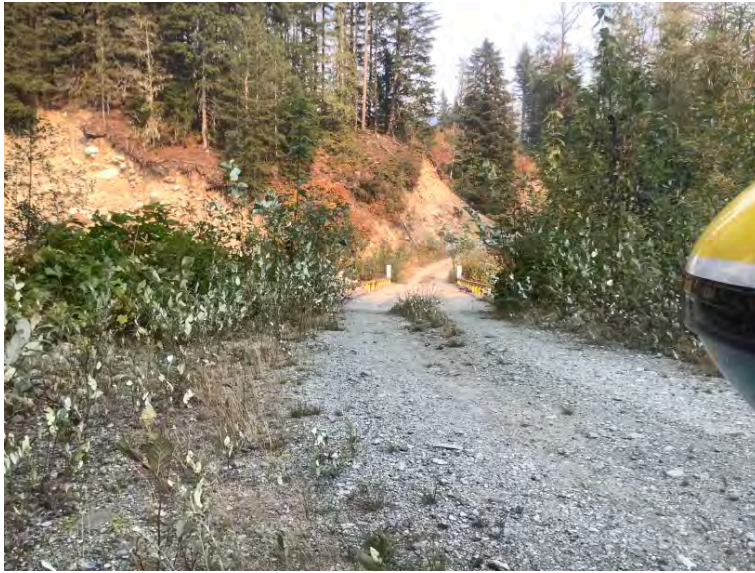
HC right approach, vc left approach

Approach from Right Bank when facing downstream

1 Approach. Area/sight line  
brushing. m².  
Priority:Medium

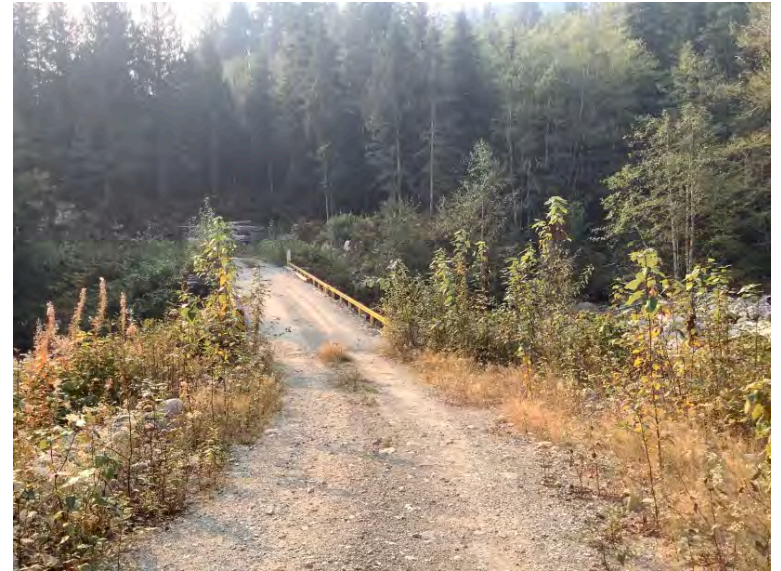
Approach from Left Bank when facing downstream

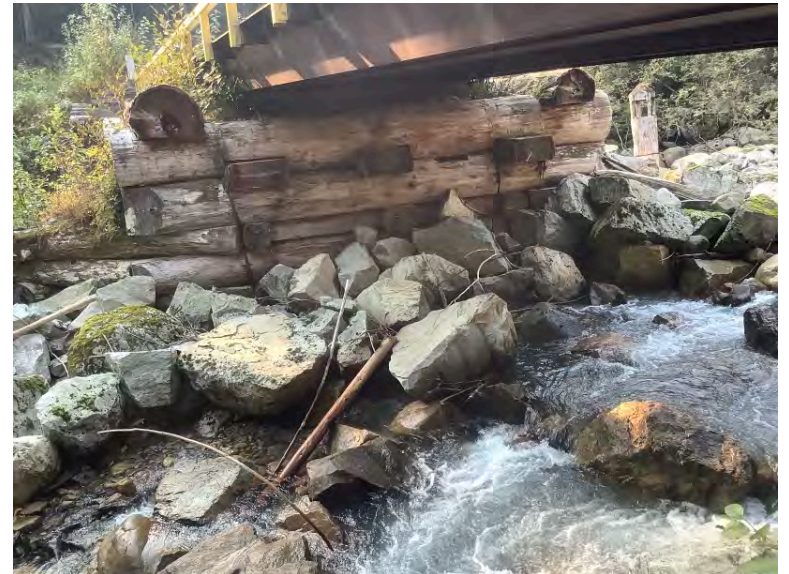
Midspan cribbing viewing from left bank

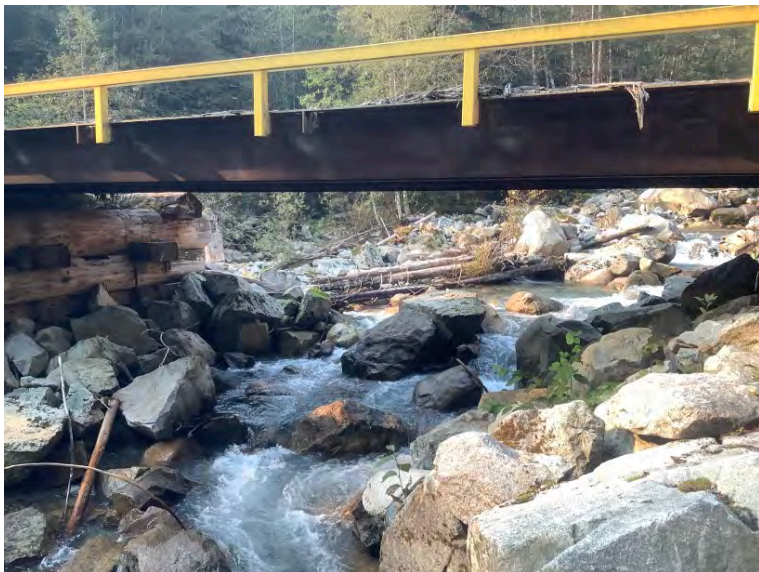
Upstream profile, 15.24m left span

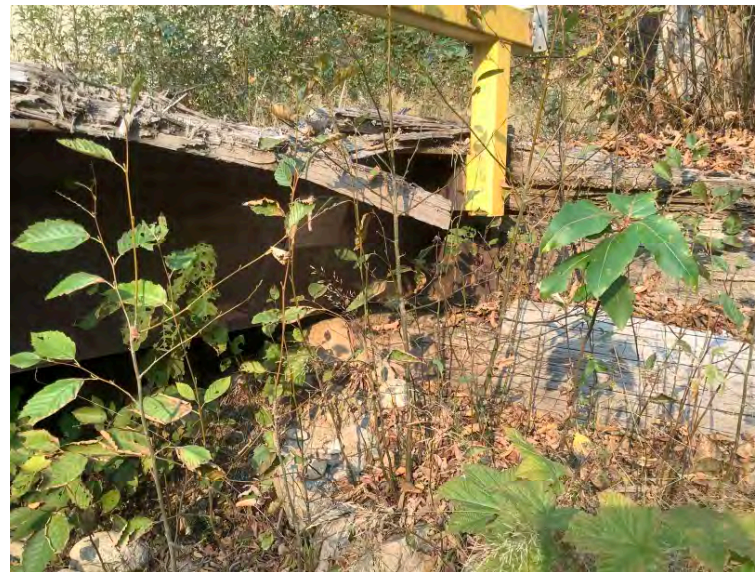
5 high on right bank abutment. Appears bearing sill and top 3 tie backs newer. All steel appears to bear on crib. Left bank, bears on single sill behind old crib. 4 high timber crib mod

Left bank single sill bearing

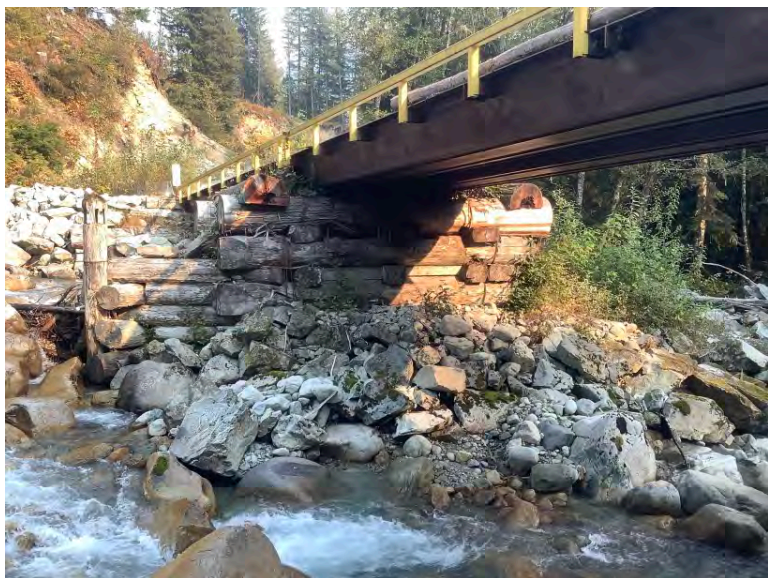
Midspan cribbing viewing from right bank

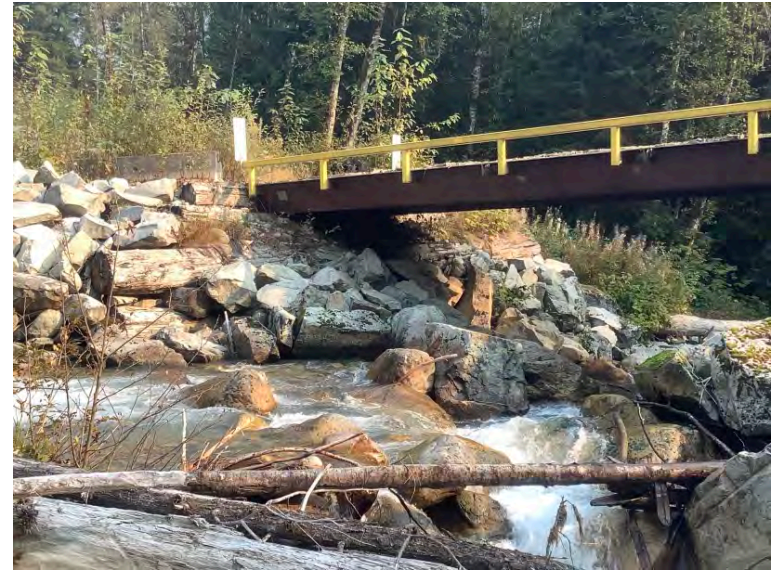
Left Bank Abutment when facing downstream

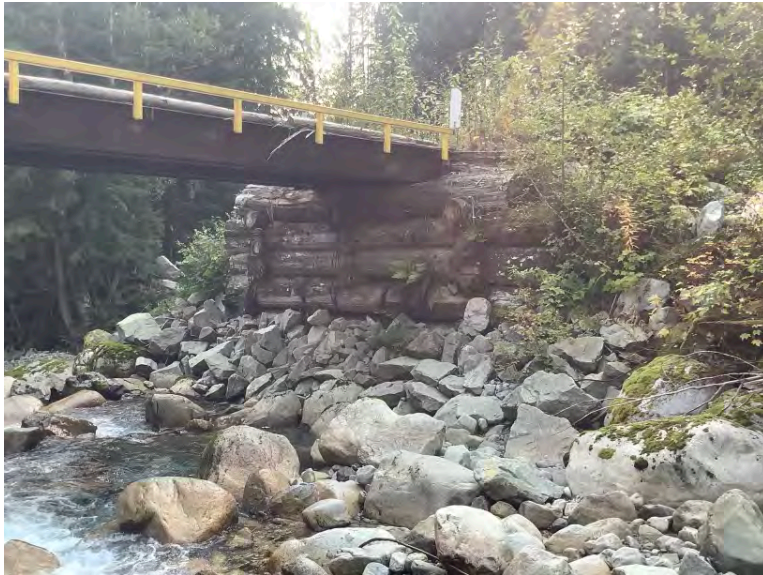
Right Bank Abutment when facing downstream
