CK-2233  
CK-2233

STEVE 0.7km

2022 Inspection

Crossing Name Steve Creek

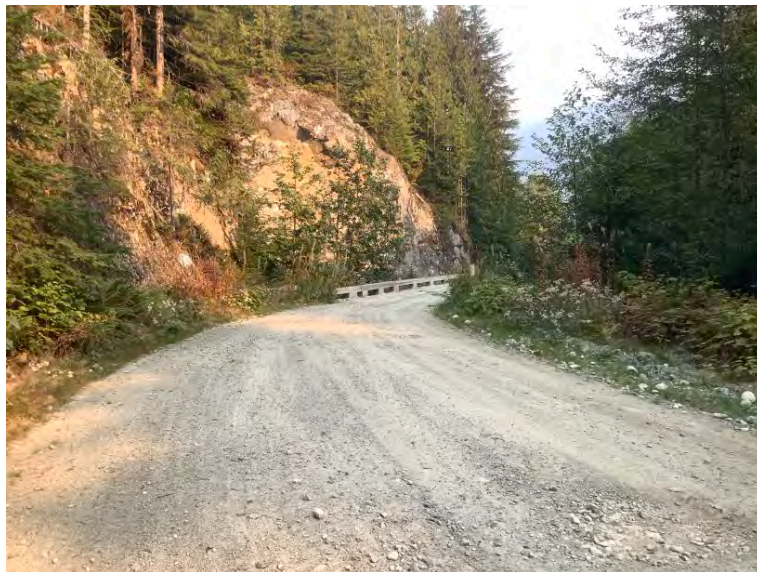
HC right approach

Approach from Right Bank when facing downstream

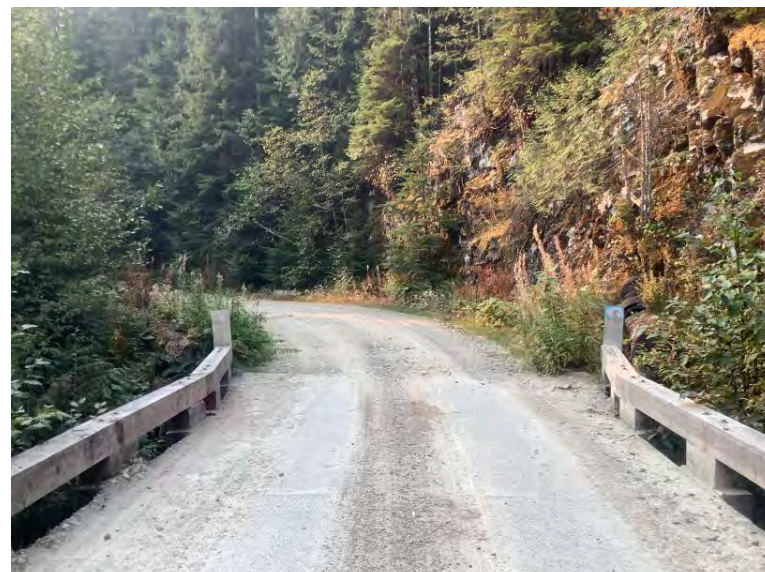
Approach from bridge deck of Right bank approach when facing downstream

Brush approaches and post bridge ahead signs. The current load rating of L120 or 109 tonnes to continue.

1 Approach. Area/sight line  
brushing. m². Priority:Low

2 Approach. Bridge Ahead  
Signs. # of signs.  
Priority:Low

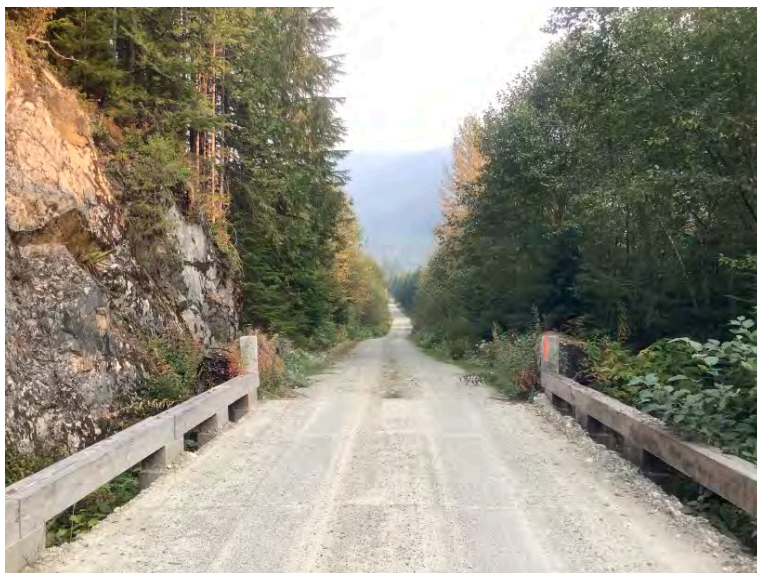
Approach from bridge deck of Left bank approach when facing downstream

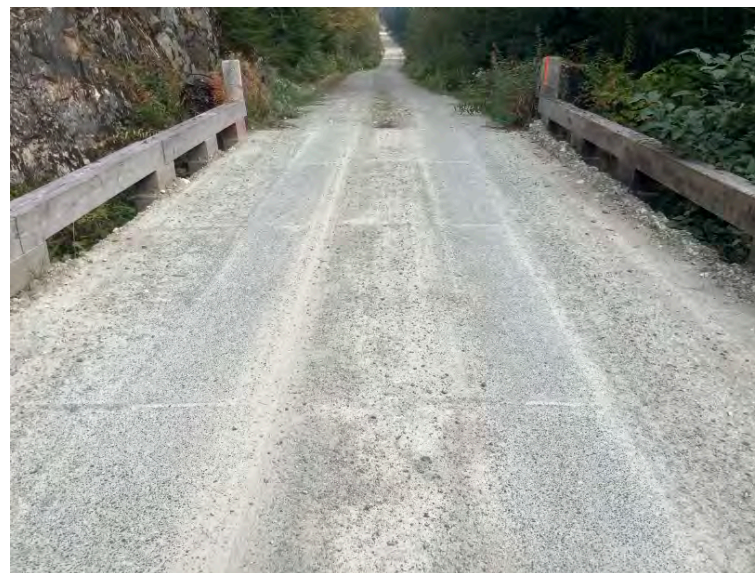
Running Surface      Fair      Potholes on approaches

Concrete Deck      Fair      Minor damage from tracks

Deck

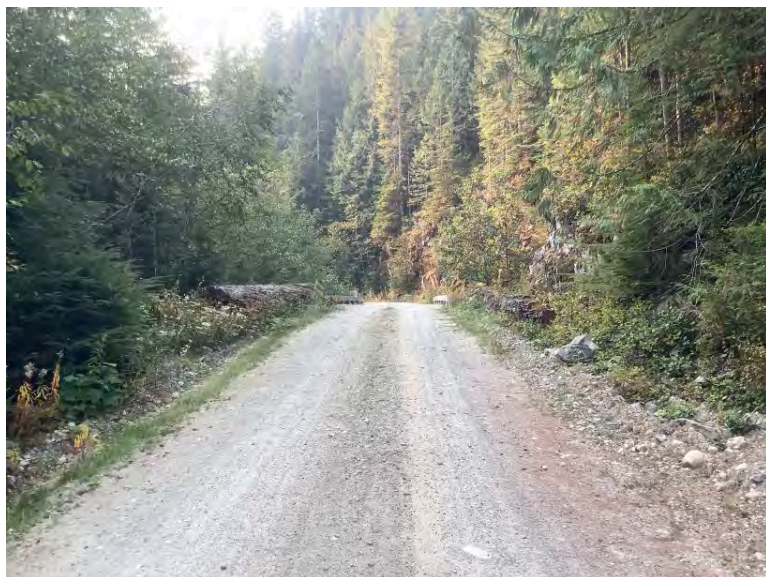
Approach from Left Bank when facing downstream

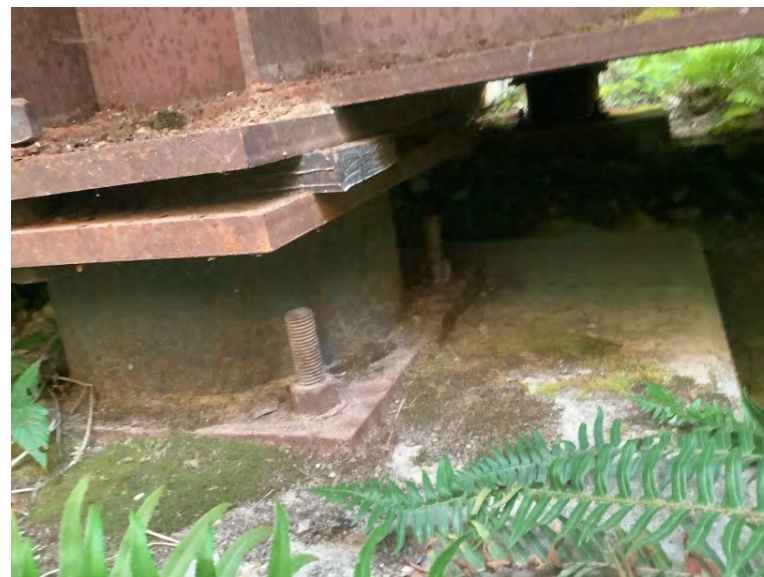
Bearings Fair

Bulging rubber

Bearing

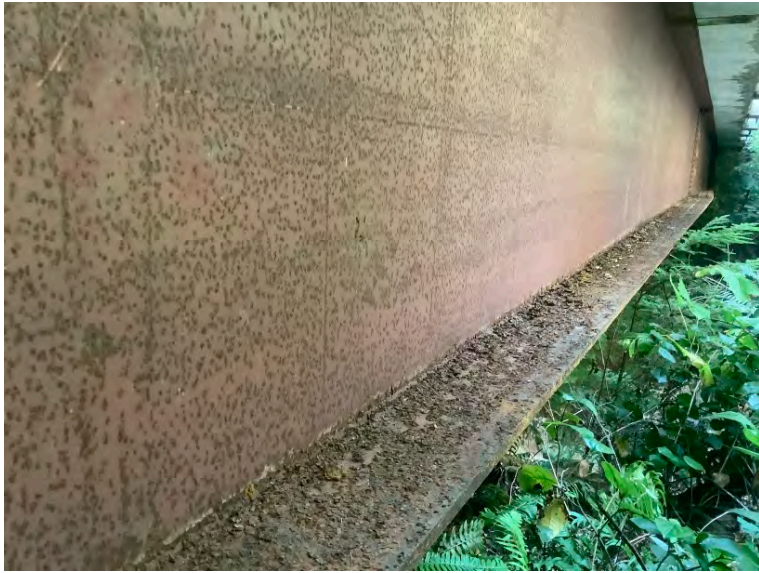
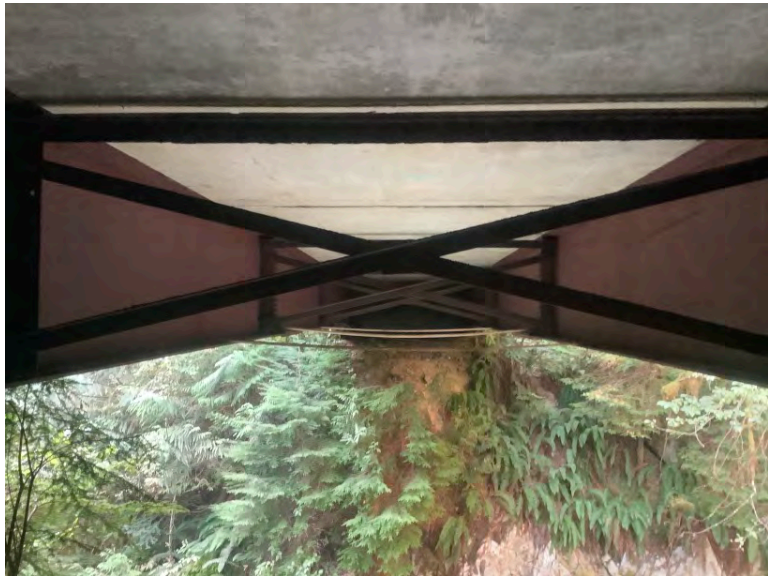
Girders Fair

Scaling

5 bolted bays with minor corrosion

Minor corrosion

Superstructure

| Item | Monitor Description | Frequency |
|---|---|---|
| 1 | Scaling of girders | Routine Inspection |

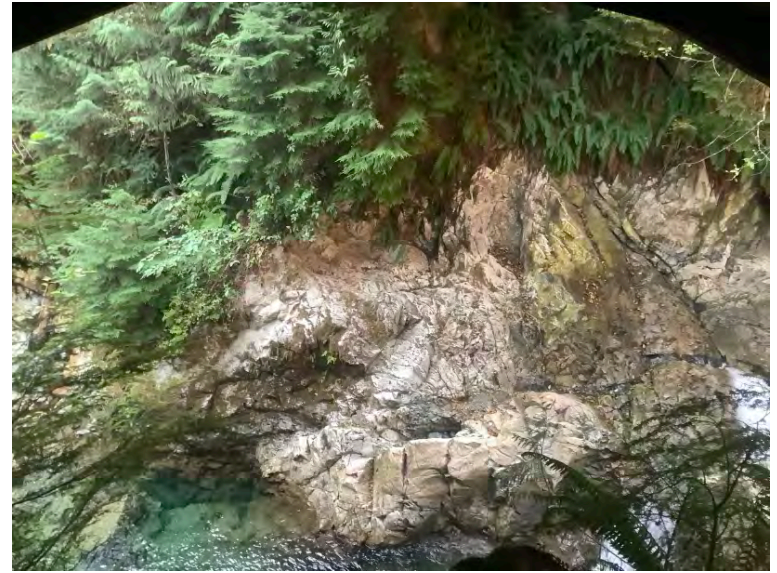
Right Bank Abutment when facing downstream

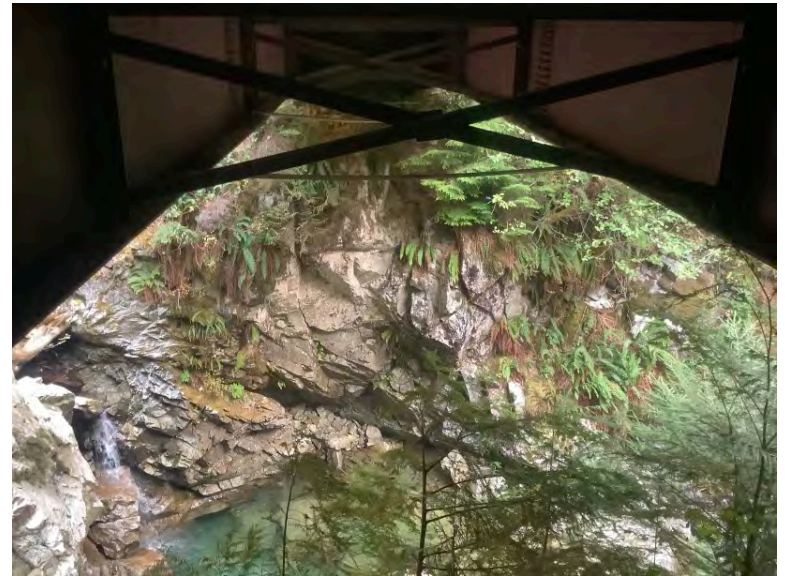
Left Bank Abutment when facing downstream

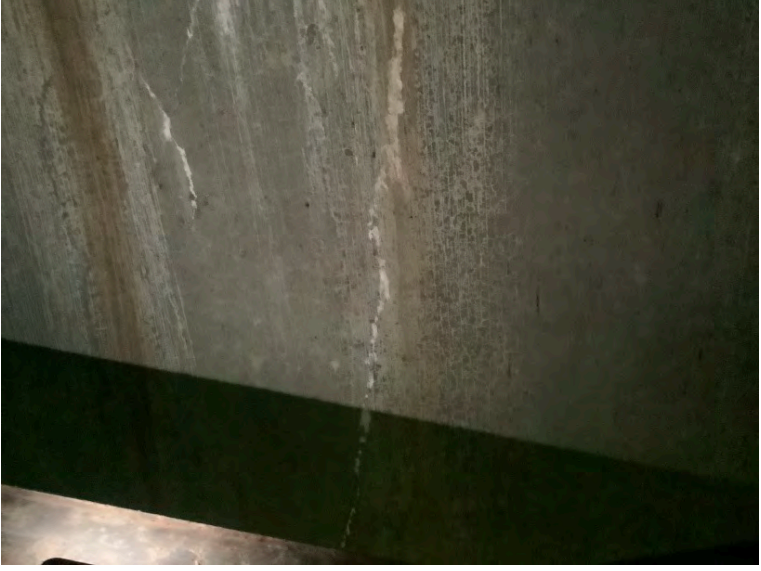
Ballast Wall Fair

Crack In right ballast wall. Doesn't appear to be progressing. Slight damage to both at wheel tracking locations

Ballast Wall
