CK-2236  
CK-2236

## SOWAQUA 9.6km

2022 Inspection

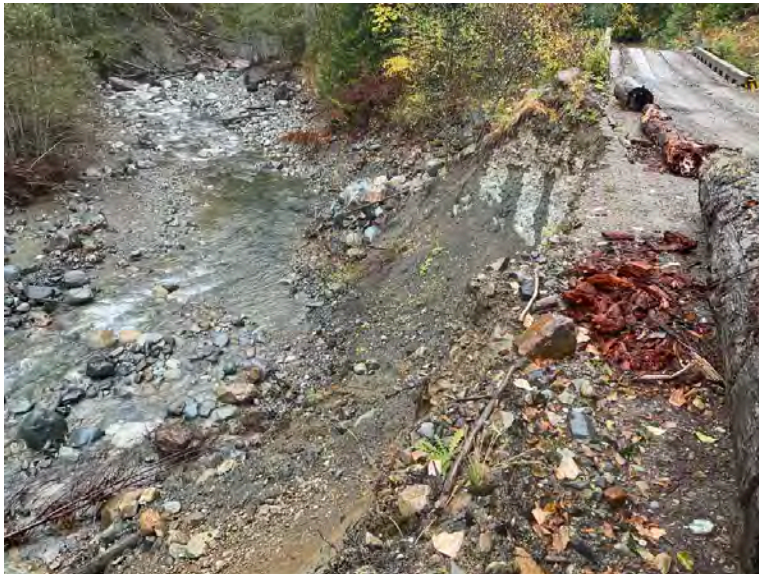
The left bank road approach material was significantly eroded and is susceptible to further erosion putting the safe use of this bridge in question. Both abutments have round rock with voids used as riprap, which has eroded and is highly susceptible to further erosion. There is large diameter transportable organic material laying across the stream channel immediately above the bridge that should be removed prior to use. The Sowaqua FSR sustained major damage as a result of the November 2021 storm event and industrial traffic is not expected until the repair works are undertaken. The Ministry is currently working on repair plans for the FSR, and a replacement structure for this site is being considered. Until those plans are finalized limit loading to L10 or 9 tonnes.

Left bank approach fill slope severely eroded

| Repair Item | Repair Description |
|---|---|
| 2 Approach. Approach fill repair. m³. Priority:High | Left bank road approach requires significant erosion control placed and fill imported |

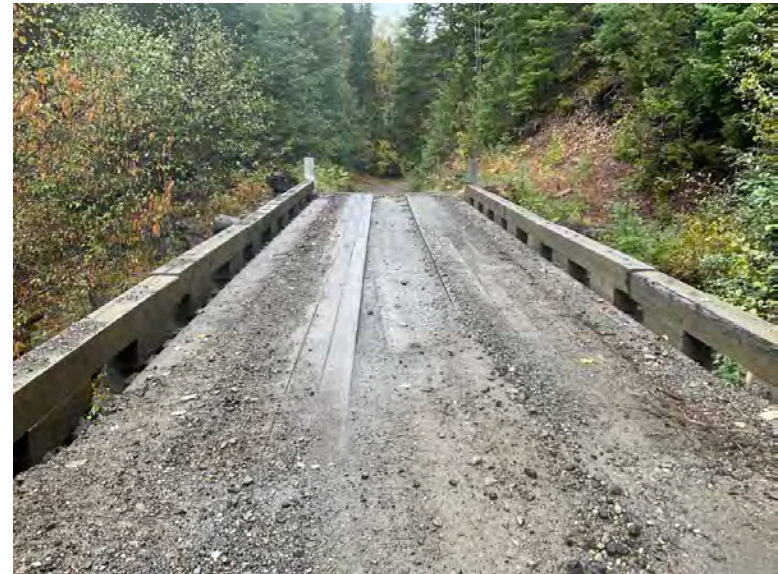
Overall Deck Condition      Fair

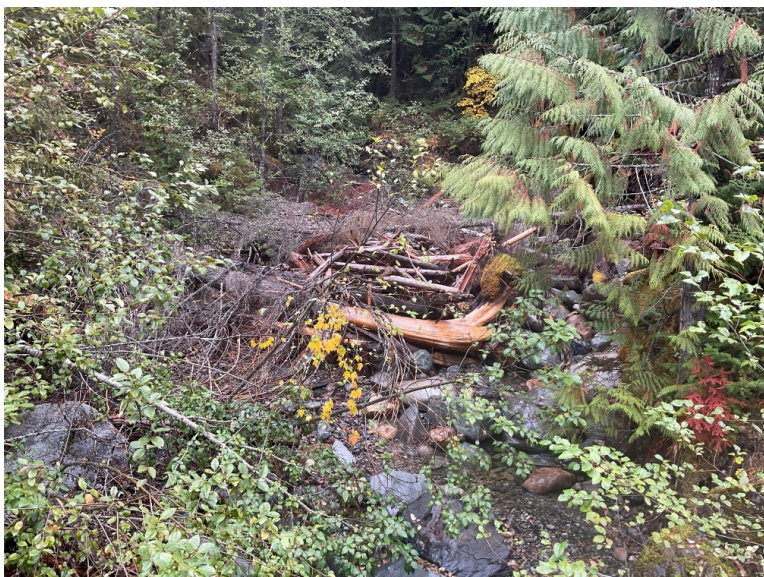
Debris accumulation upstream

| Repair Item | Repair Description |
|---|---|
| 1 Channel. Debris removal. # of sites/items. Priority:High | Remove debris upstream of bridge |

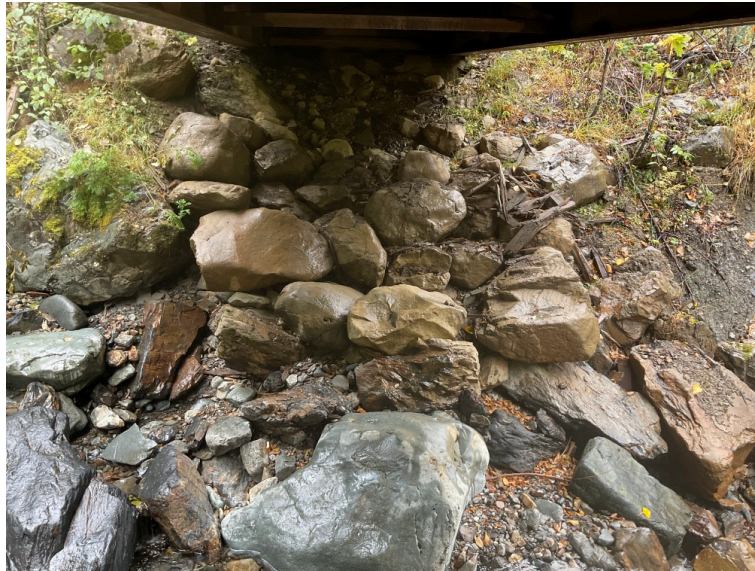
Left Bank Abutment when facing downstream

Caps or Sills Fair Single log sills, left bank up to 50mm sap rot

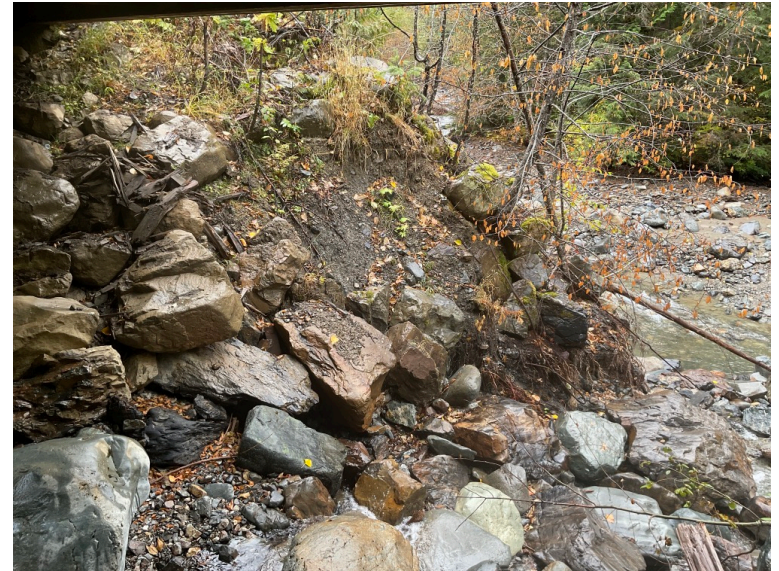
Riprap Fair Round, not well graded, or properly keyed together or into the stream banks. Both banks have scoured as a result of the November 2021 storm event

Riprap erosion downstream left bank

| Repair Item | Repair Description |
|---|---|
| 3 Channel. Add Riprap (placed). m³. Priority:High | Both bank abutments require riprap repair |

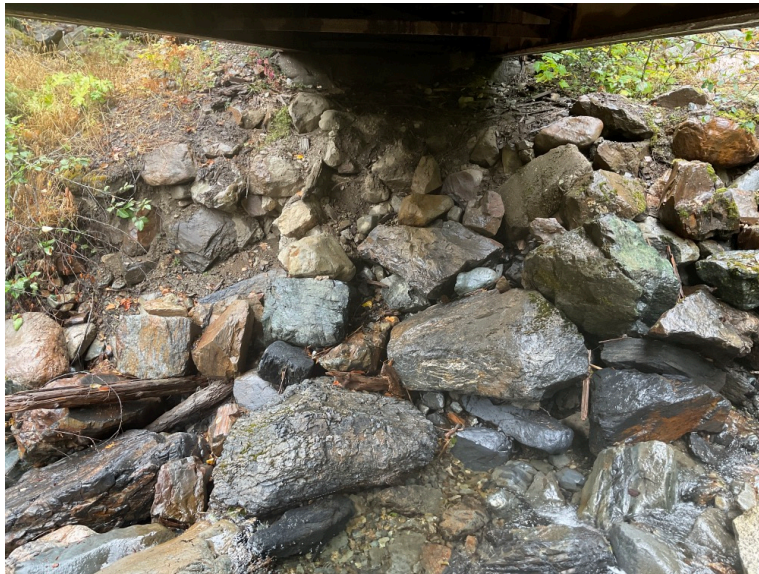
Right Bank Abutment when facing downstream

Ballast Wall Poor Right bank logs rotting but functional

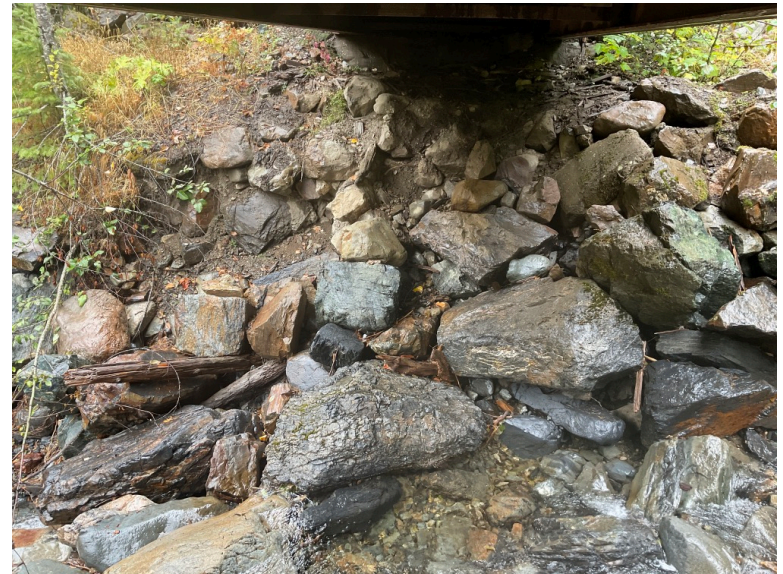
Riprap erosion at right bank

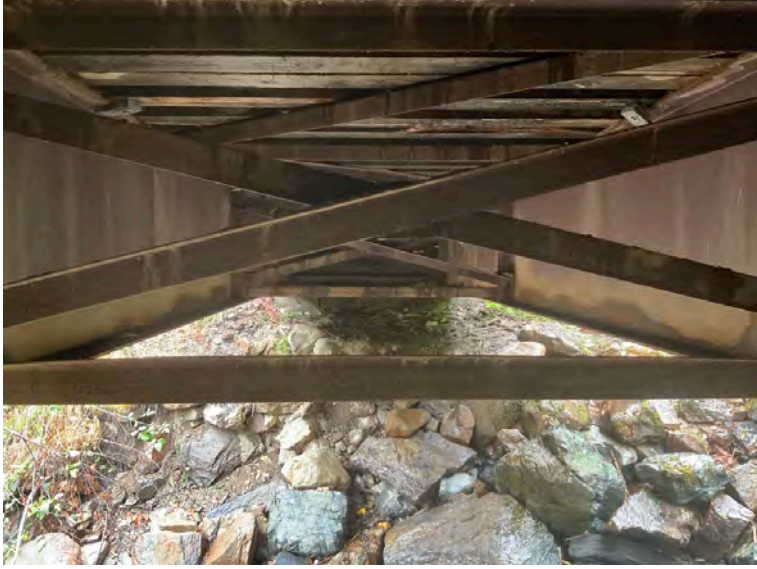
Superstructure

Minor corrosion

4 welded bays with minor corrosion. Both bottom chords at abutments slightly twisted
