CK-2237  
CK-2237

SOWAQUA 14.6km

2022 Inspection

Crossing Name Montigny Creek

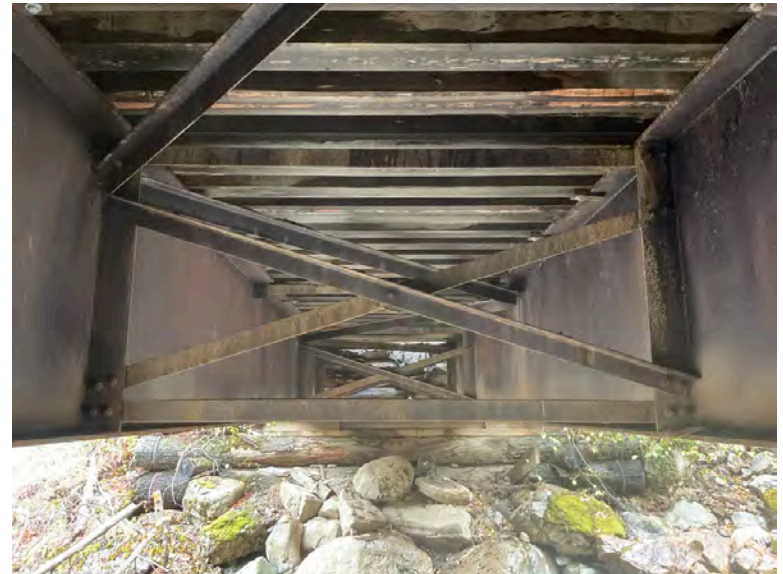
Superstructure

The bridge has washed out. The steel girders do not appear to have sustained damage and should be salvaged. A temporary access road has been constructed immediately below this structure; however, access over the bridge itself was not blocked on the right approach (Town Approach). I recommend blocking access over the bridge on the Town Approach and posting the bridge as washed out, 0 tonnes load rating.
