CK-2239  
CK-2239

## SOWERBY 6.5km

2022 Inspection

Crossing Name Sowerby Creek

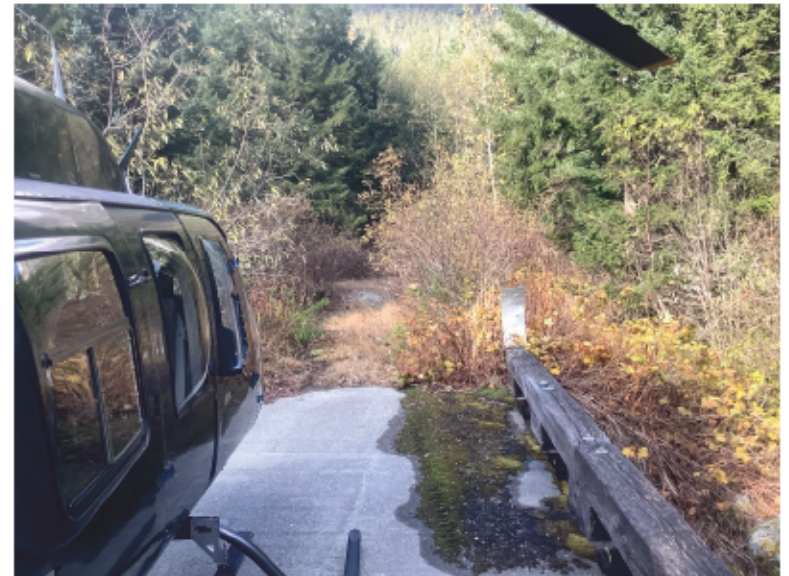
Approach from bridge deck of Left bank approach when facing downstream

Road Surface Fair Fair at approaches. Washed or and eroded on way to structure

| Repair Item | Repair Description |
|---|---|
| 1 Approach. Approach surfacing grading. m. Priority:Low | Road deactivation required to get to structure. Brushing, grading etc. |

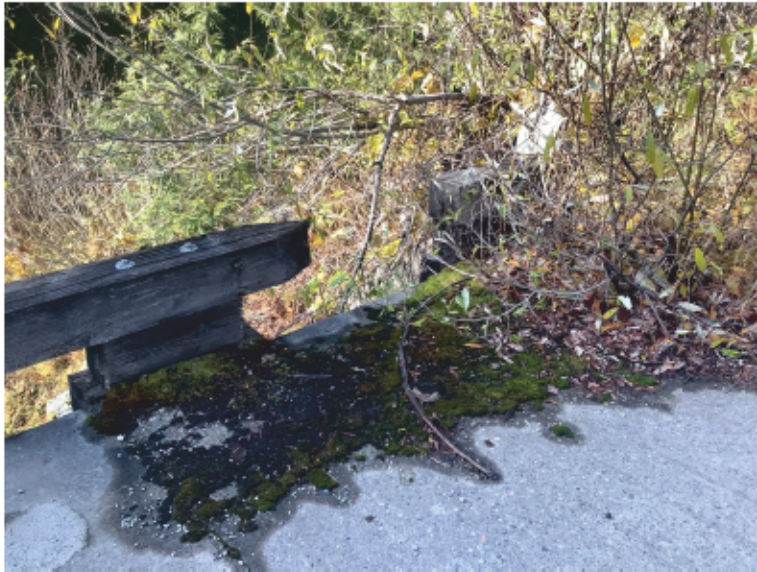
Guard Rail

Comments: Continue 0 tonne load rating due to vehicle access restrictions and guard rail condition. Monitor bearing pads and deck joints.

Curb Rail/Blocks/Posts Fair Poor-rotten

Hardware Fair Poor-loose

Overall Deck Condition Fair Poor due to railing

| Repair Item | Repair Description |
|---|---|
| 2 Structure. Full Curb Replacement. . Priority:Low | Replace when road re opened. Post appropriate signs and signage then as well. Install guidelogs. |

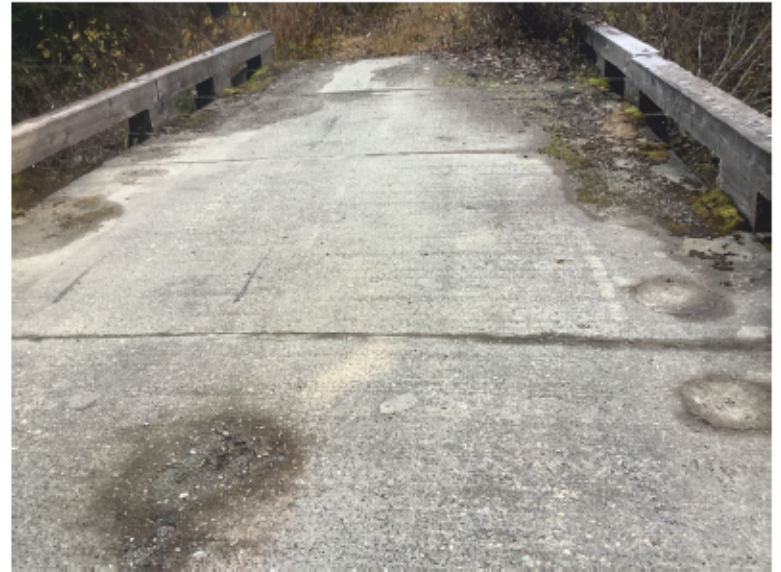
Concrete Deck Fair Minor damage centre of panel 4.

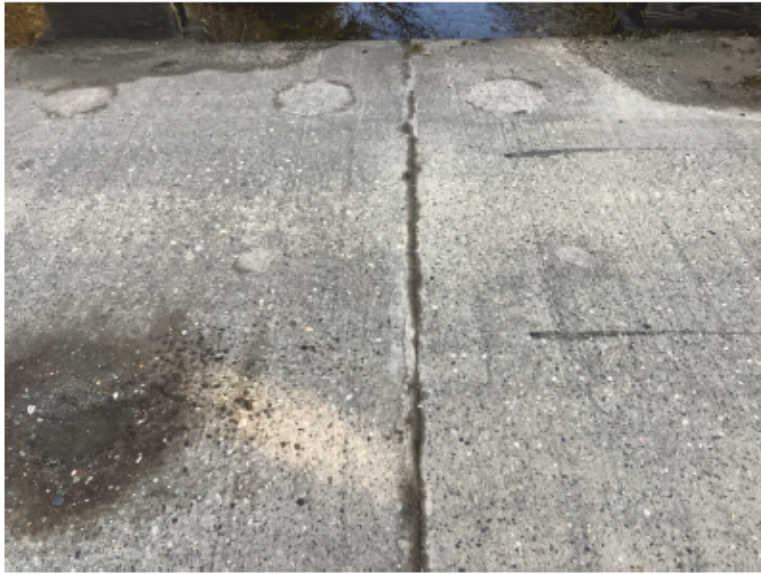
Deck Joints Fair Some cracking on all joints

Cracking deck joint

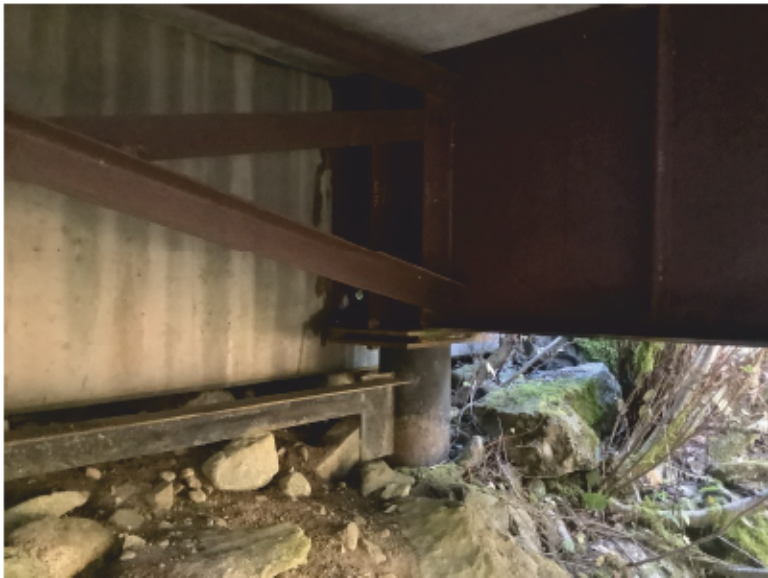
Bearing

Bearings Fair Bulging rubber.

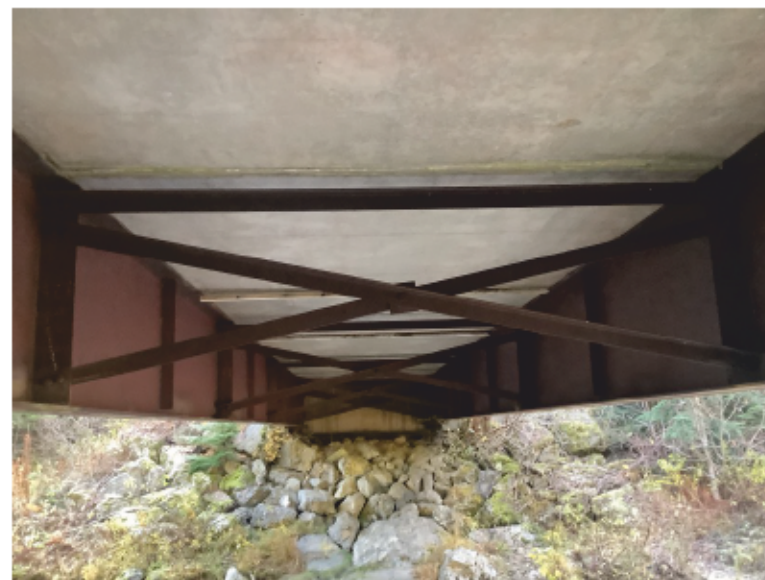
Superstructure

Girders Good

Diaphragms Good 5 bolted bays
