CK-2241  
CK-2241

SPUZZUM 25.4km

2022 Inspection

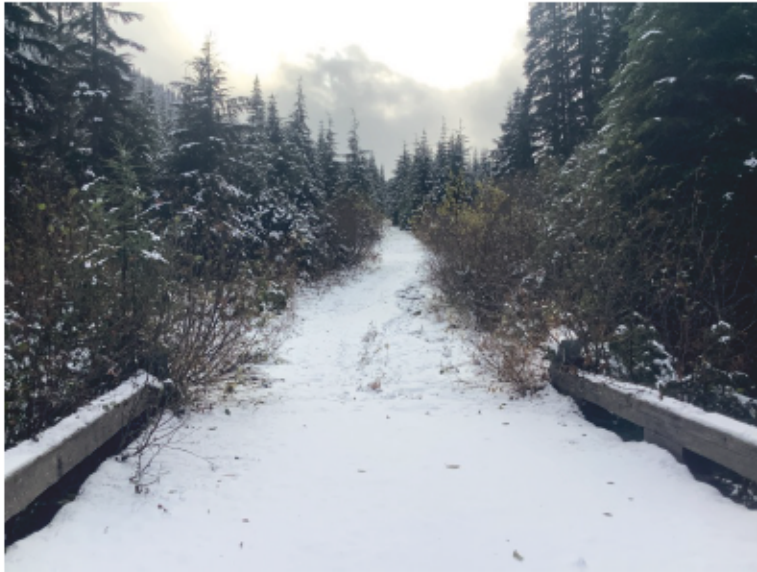
Approach from bridge deck of Right bank approach when facing downstream

Road Surface **Fair** Water drainage issues eroding prism on right approach

| Repair Item | Repair Description |
|---|---|
| 1 Approach. Approach surfacing grading. m. Priority:Low | Right approach also brush approaches |

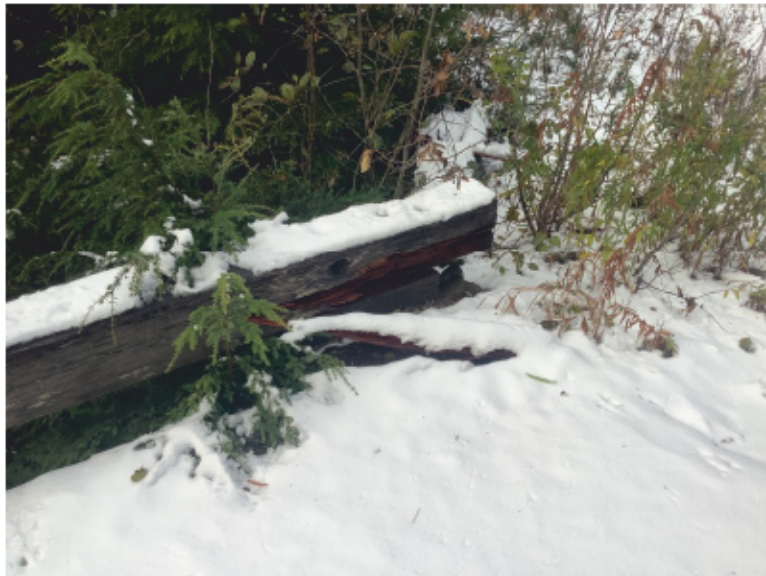
Guard Rail

Load Rated by: MoF, M.Lowe, RPF, PEng, February 16, 2023  
Load Rating: 5 Tonnes GVW  
Next Inspection: September 1, 2023  
Comments: Load rating only due to guard rail condition. Once guard rails replaced, original load rating can be returned.

Curb Rail/Blocks/Posts      Fair      Poor-rotten. Locks crushing

Overall Deck Condition      Poor      Due to guard rail

| Repair Item | Repair Description |
|---|---|
| 2 Structure. Full Curb Replacement. . Priority:High | |

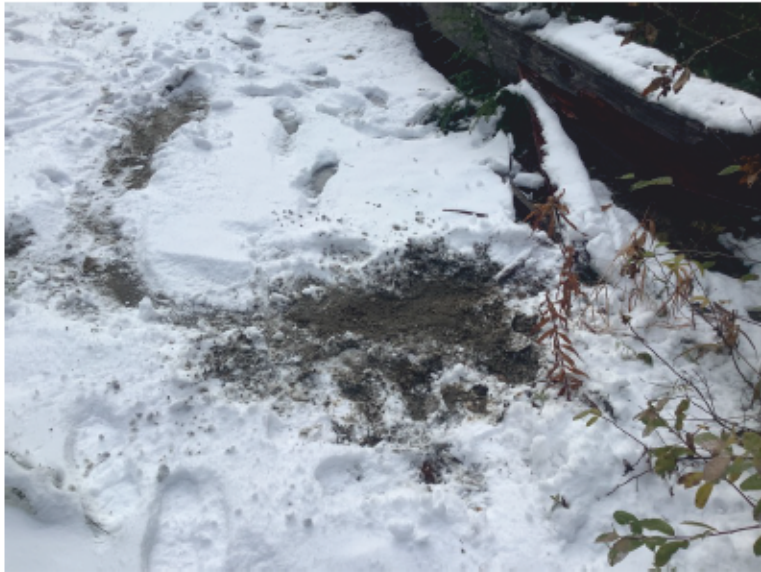
Ballast Wall **Fair** Left has damaged top

Ballast wall still sitting low of panel. Fix fro, previous inspection not complete

| Repair Item | Repair Description |
|---|---|
| 3 Structure. Concrete structural maintenance. m². Priority:Medium | Fix top of left ballast wall |

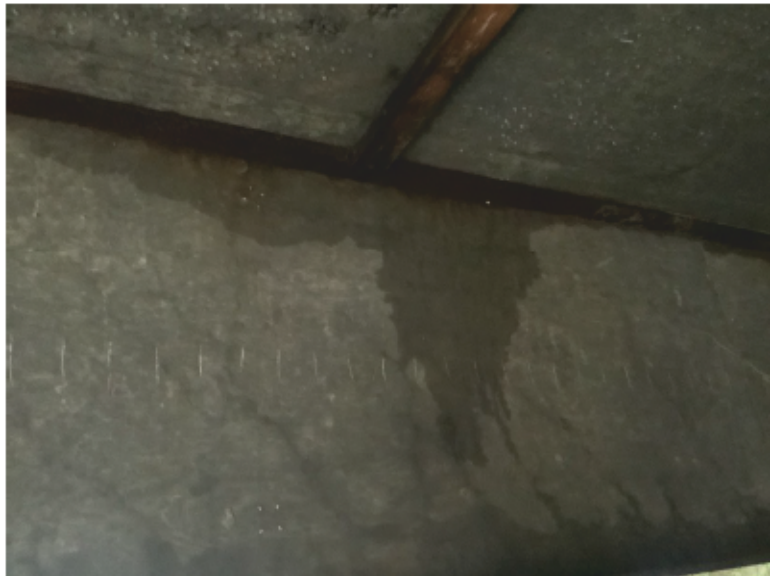
Evidence of leaking joint

| Item | Monitor Description | Frequency |
|---|---|---|
| 2 | Deck joints | Routine Inspection |

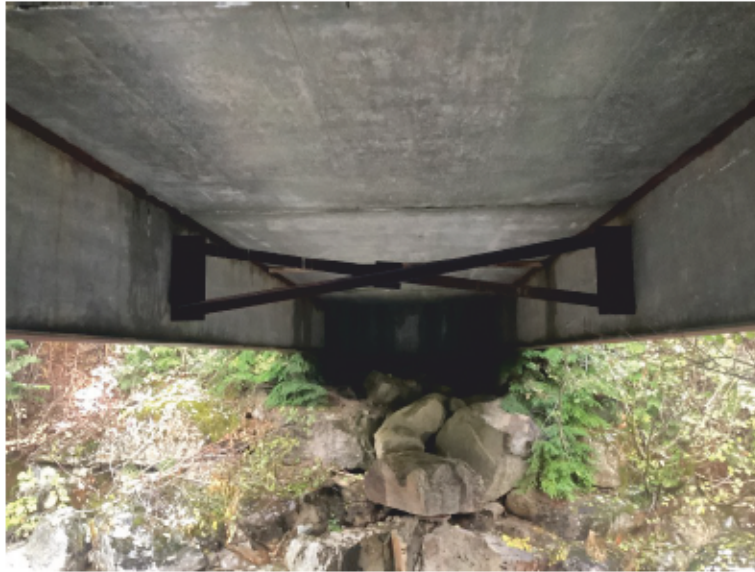
Superstructure

Girders Fair

Compo with minor corrosion throughout

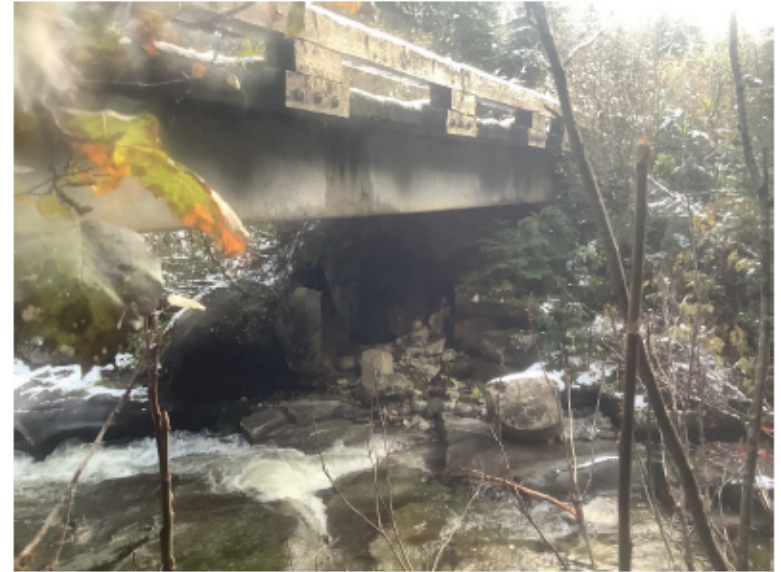
Right Bank Abutment when facing downstream

Riprap **Fair** Right bank appears to have shifted

| Item | Monitor Description | Frequency |
|---|---|---|
| 1 | Monitor right bank riprap | Routine Inspection |
