CK-2249  
CK-2249

SPUZZUM 16000 5.4km

2022 Inspection

Crossing Name Side Creek

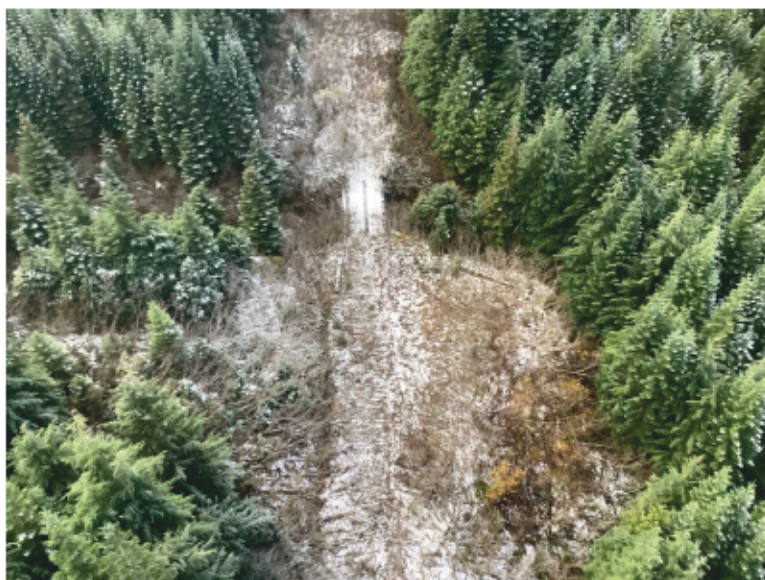
Aerial

Appears guard railing is actively falling off structure. No sub deck. Could not land within 2km due to vegetation height.

Comments: No access to site. Reinspect when next active.
