CK-2252  
CK-2252

SPUZZUM 17000 4km

2022 Inspection

Crossing Name Southwest Fork

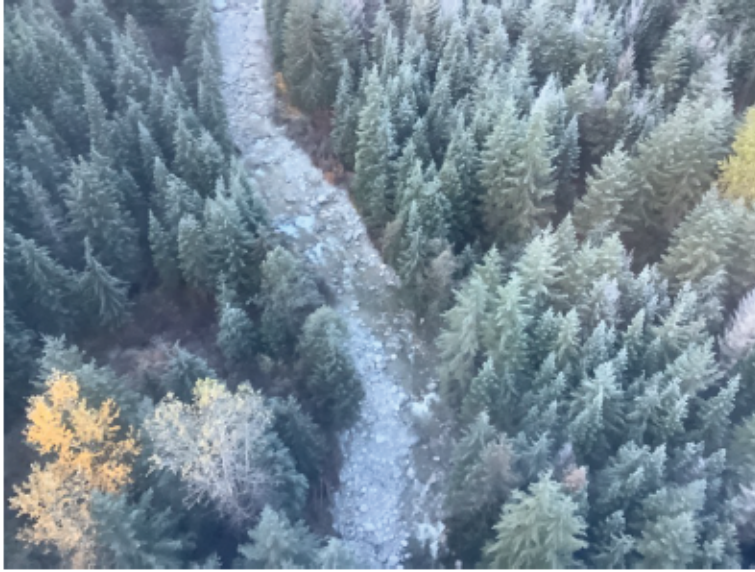
Structure has been blown out. No sign of structure at crossing location. Stringers visible downstream on stream edge.

Structure no longer exists. 2 stringers visible down stream. Not In photo

Comments: Consider changing structure/site status to deactivated.
