CK-2253  
CK-2253B

SQUEAH 3.2km

2022 Inspection

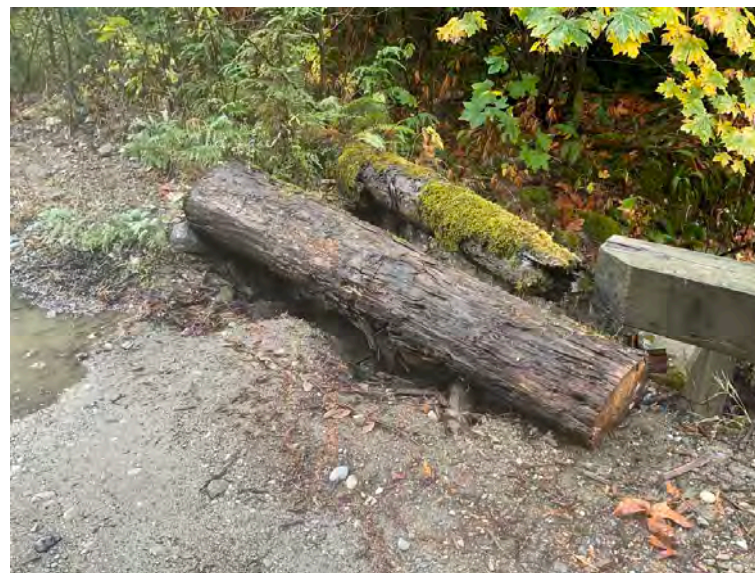
Fill **Poor** Failed downstream left bank

Downstream left bank erosion

| Repair Item | Repair Description |
|---|---|
| 1 Approach. Approach fill repair. m³. Priority:High | Repair downstream left bank fill slope |

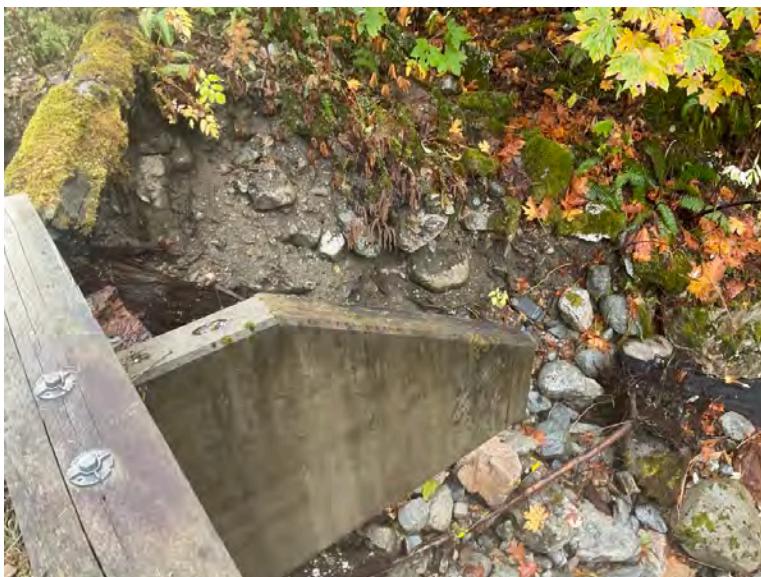
Downstream left bank erosion

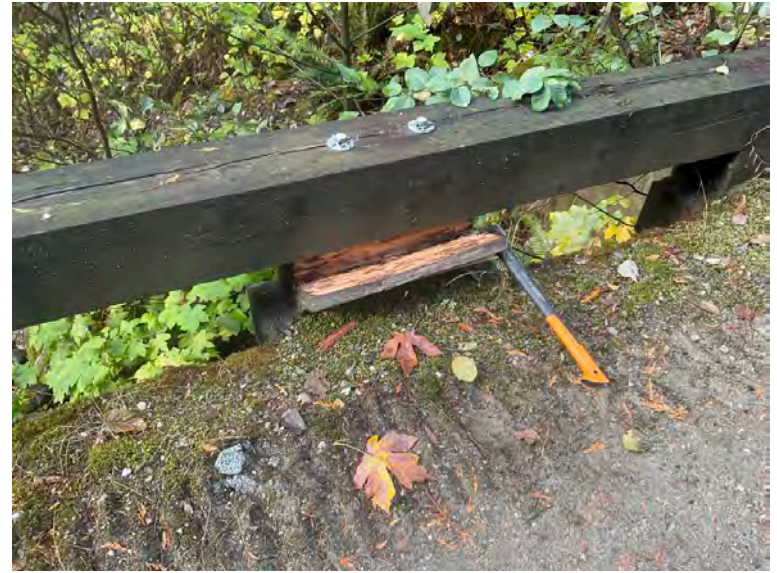
Curb Rail/Blocks/Posts      Poor      Sideblocks and risers are rotting

Riser condition

| Repair Item | Repair Description |
|---|---|
| 6 Structure. Full Curb Replacement. . Priority:Medium | Replace guardrail, risers, blocks and delineators |

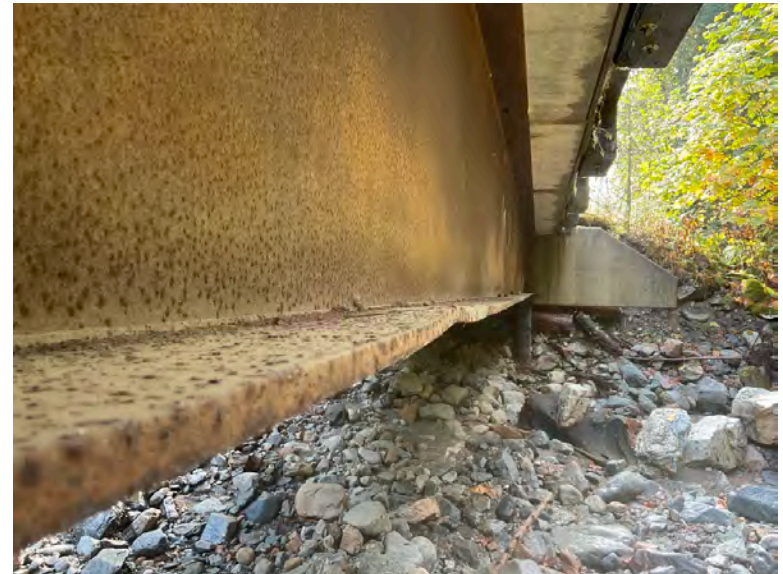
Minor damage noted along bottom flange

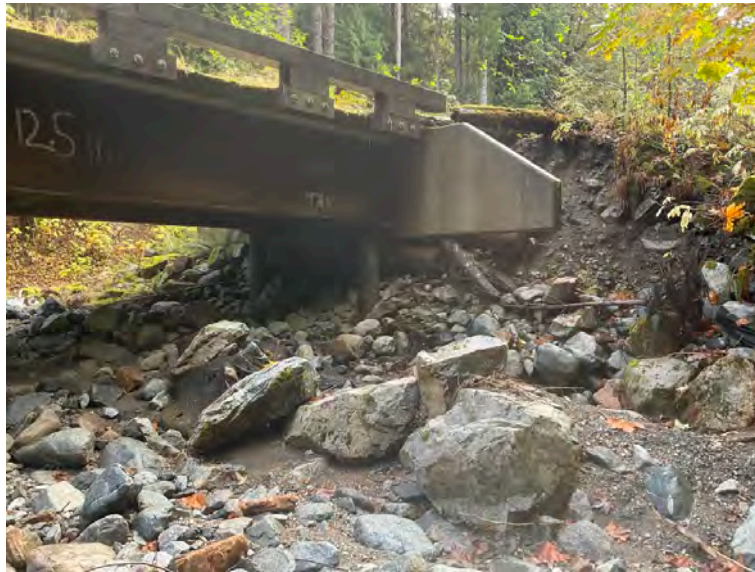
Riprap **Poor** Left bank completely eroded

Eroded riprap at left bank

| Repair Item | Repair Description |
|---|---|
| 2 Channel. Add Riprap (placed). m³. Priority:High | Replace eroded riprap left bank |

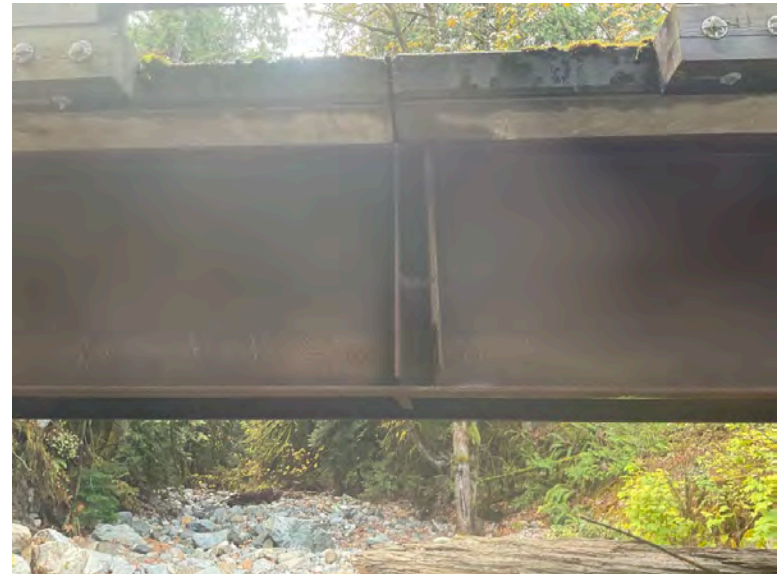
Upstream girder has stiffeners on upstream end

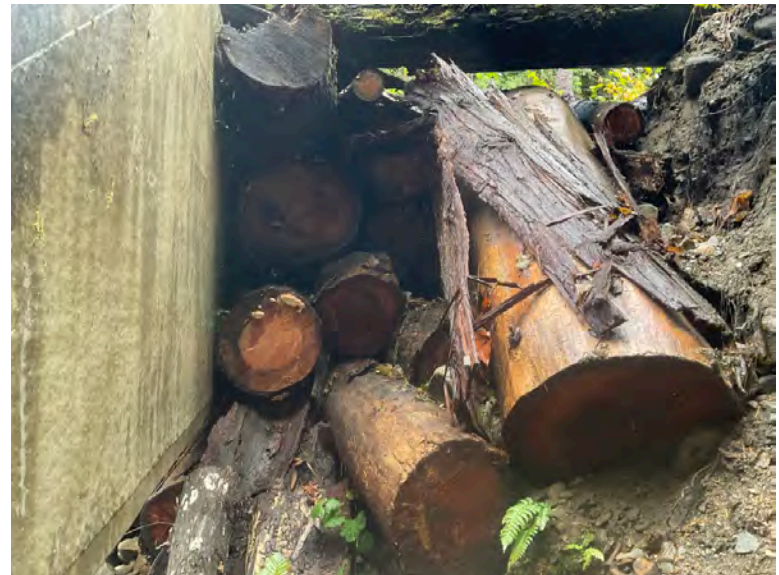
Organics in fill
