CK-2254  
CK-2254B

SQUEAH 6km

2022 Inspection

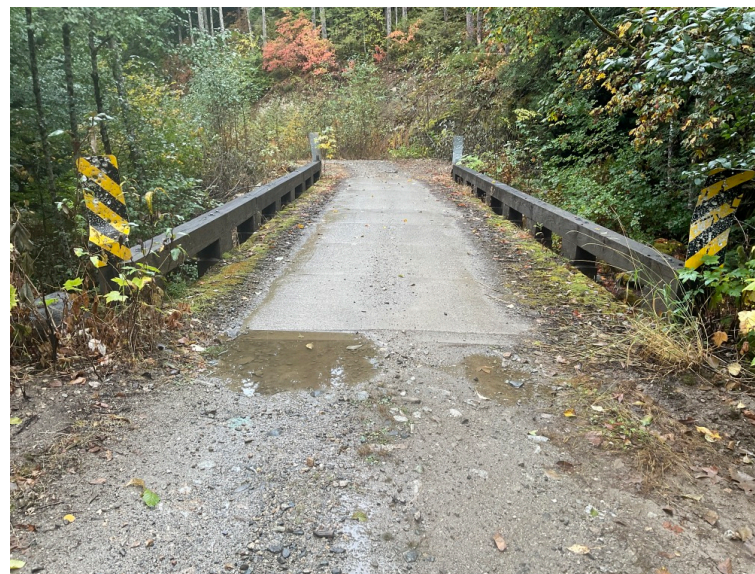
Running Surface      Fair      Sediment on deck

Deck

| Repair Item | Repair Description |
|---|---|
| 4 Structure. Clean Deck. # of delineators. Priority:Medium | Clean deck |

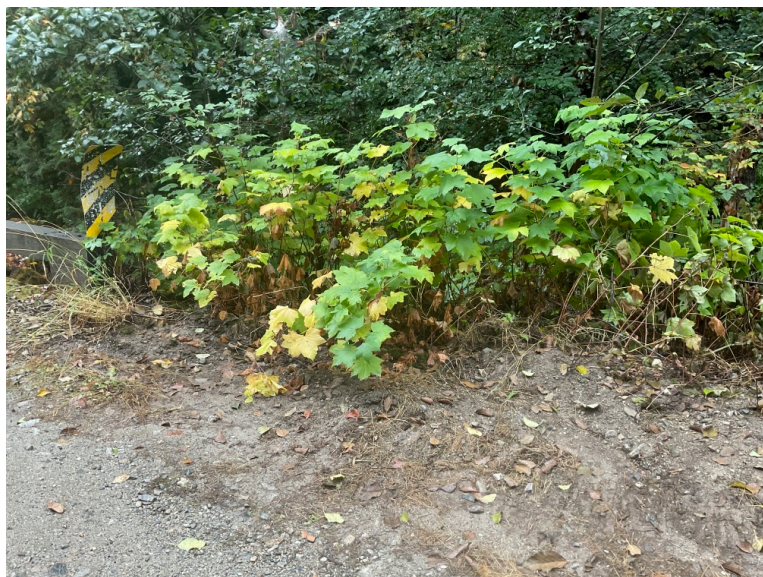
Missing upstream left approach

Missing upstream left bank fender

Replace upstream left bank log fender with a minimum 6m long x 500mm diameter. Brush and grade approaches. Clean sediment from deck. Monitor riprap erosion. The current load rating of L75 or 68 tonnes to continue.

| Repair Item | Repair Description |
|---|---|
| 3 Approach. Approach fenders (install). # of units.<br>Priority:Medium | Replace upstream left bank fender |

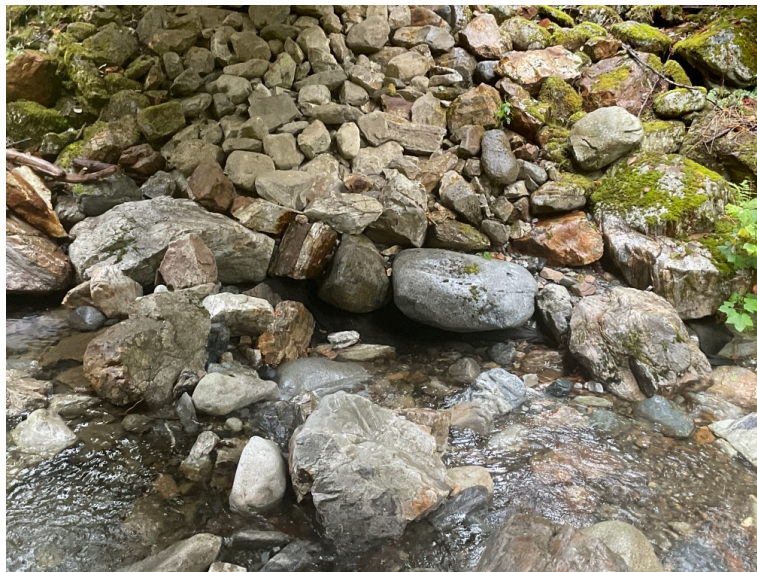
Riprap Fair Both banks have started to erode

Erosion noted on left bank riprap

| Item | Monitor Description | Frequency |
|---|---|---|
| 1 | Riprap erosion | Routine Inspection |

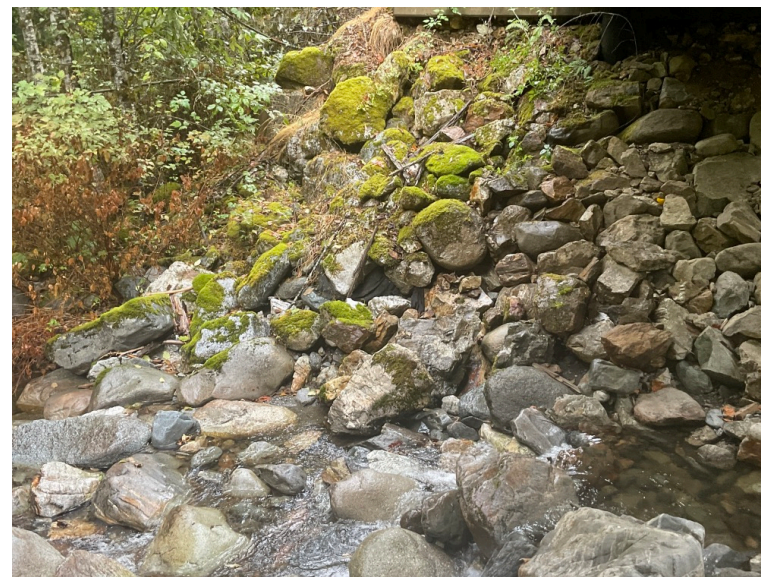
Downstream right bank riprap erosion

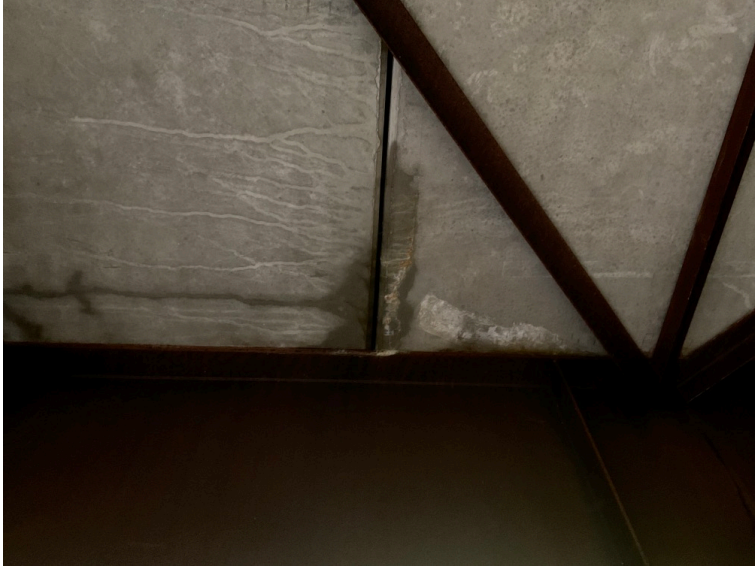
Panel 2 on left bank, efflorescence
