CK-2273  
CK-2273

STAVE 29km

2022 Inspection

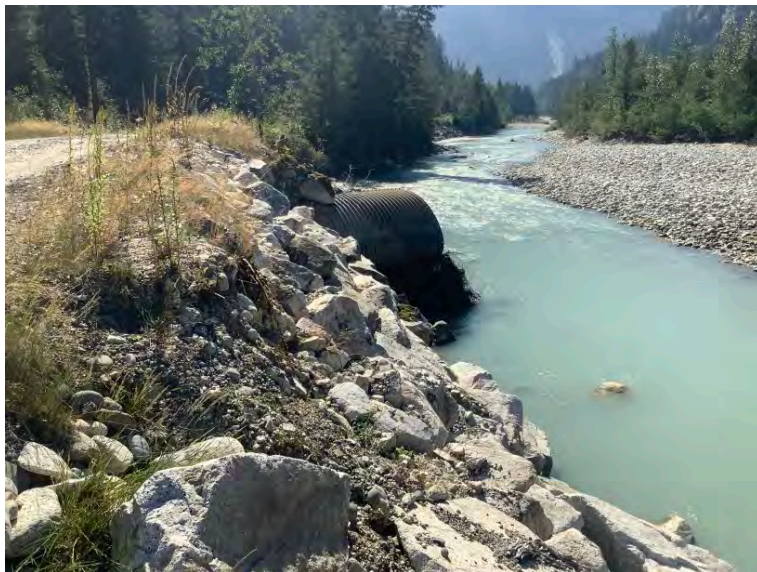
The outlet of the culvert is improperly supported and appears to have unbalanced embankment fills. Ensure the base of the culvert is fully supported and the embankment fills are properly balanced. The current load rating of L75 or 68 tonnes to continue; however restrict all live loads to the inside road edge until these items are addressed. Inspect again next year to ensure no further damage to the culvert.

Outlet      Poor      1.0 drop and last 6m unsupported

| Repair Item | Repair Description |
|---|---|
| 1 Structure. Bearing maintenance. # of items. Priority:High | Support final 6 meters of pipe to limit sagging |

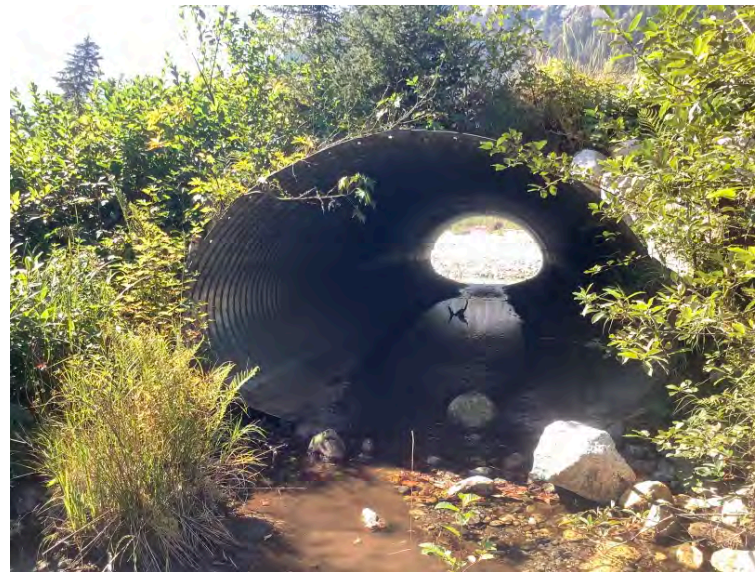
Inlet      Good

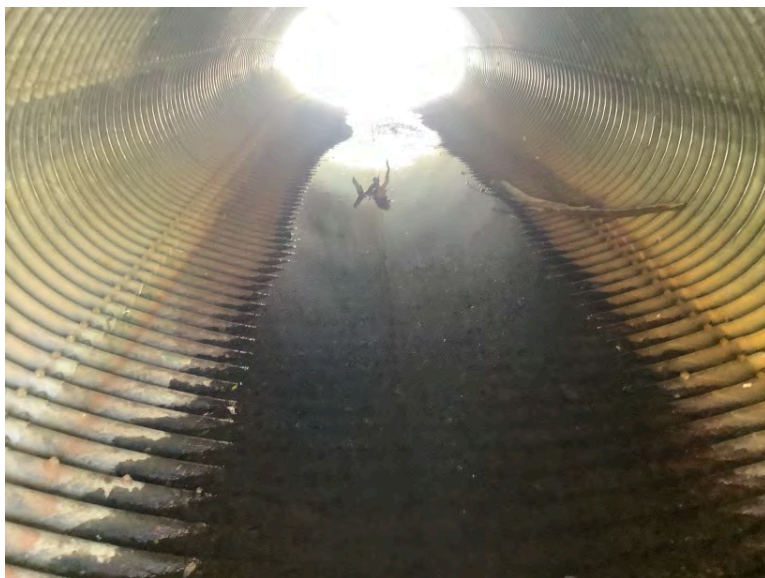
Culvert Floor

Coating      Fair      Minor throughout, floor is consistently moderate

Floor      Fair
