CK-2274  
CK-2274

STAVE 29.4km

2022 Inspection

Crossing Name Side Creek

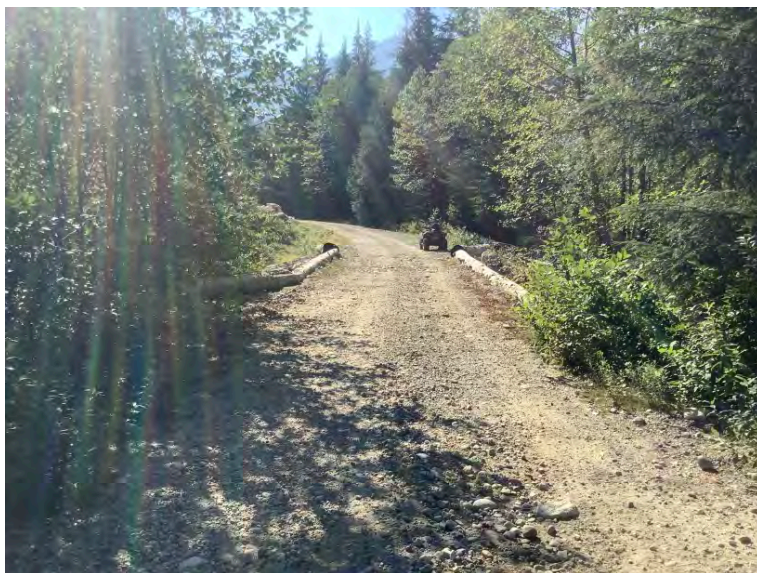
Approach from Right Bank when facing downstream

Road Surface Fair Potholes leading up to structure

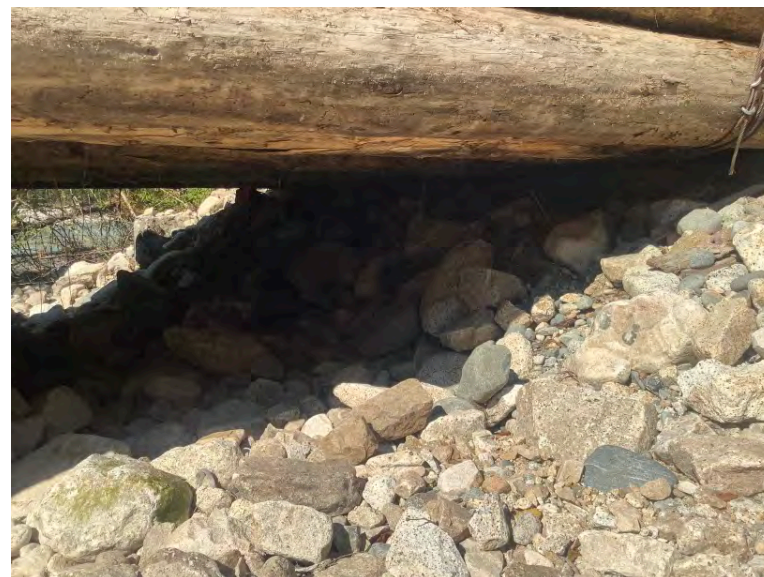
Right Bank Abutment when facing downstream

Caps or Sills Fair Single oversized sills

Riprap Fair Oversteepened on downstream ends

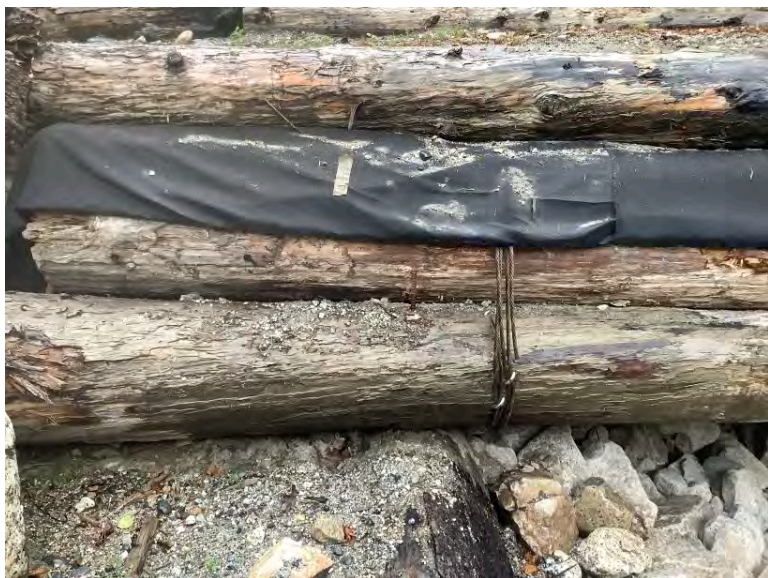
Outside stringer tied to sill

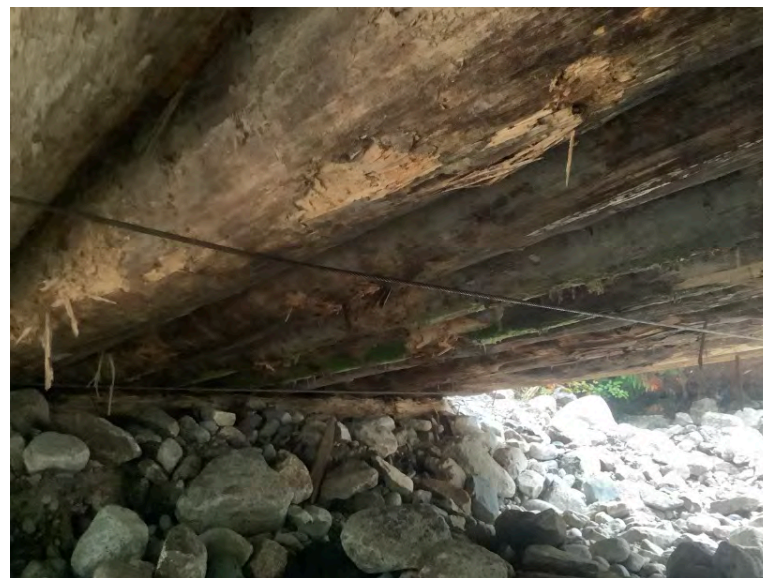
Hardware      Fair      3 belly lashing location. Mid span am 1m inset of sills. Lashing tight but not proper.

Belly lashing
