CK-2275  
CK-2275

STAVE 30.9km

2022 Inspection

Crossing Name Side Creek

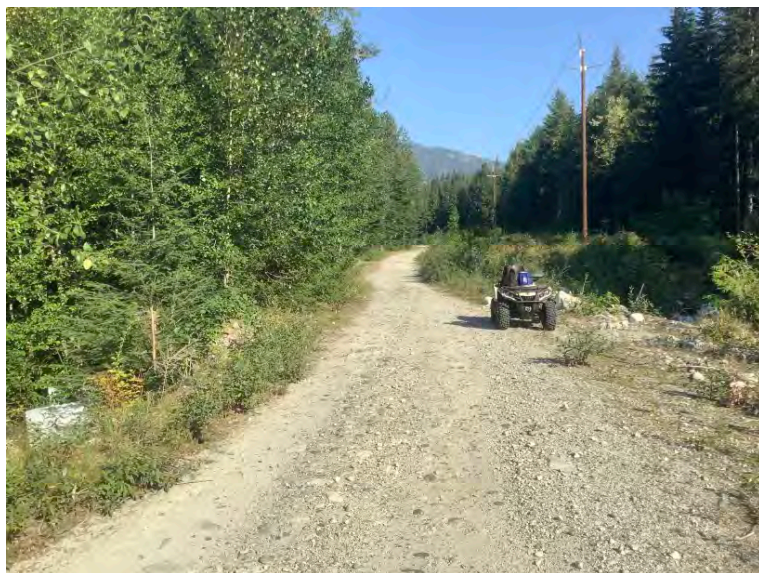
Approach from Left Bank when facing downstream

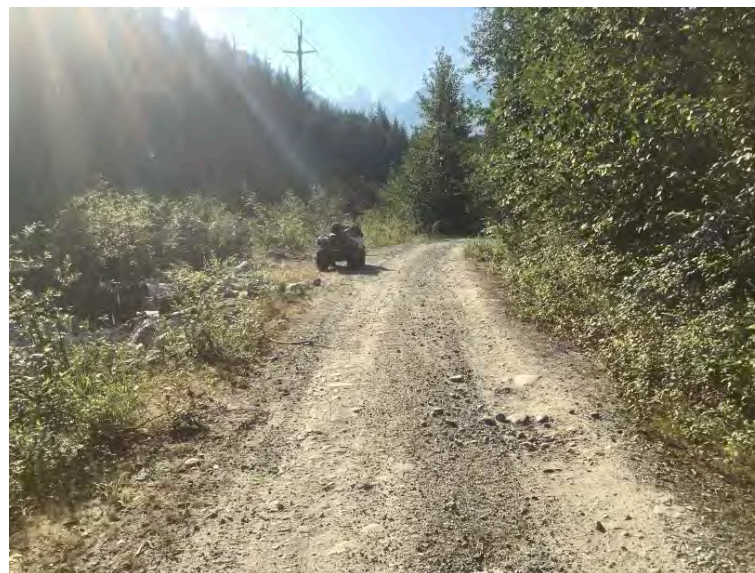
Approach from Right Bank when facing downstream

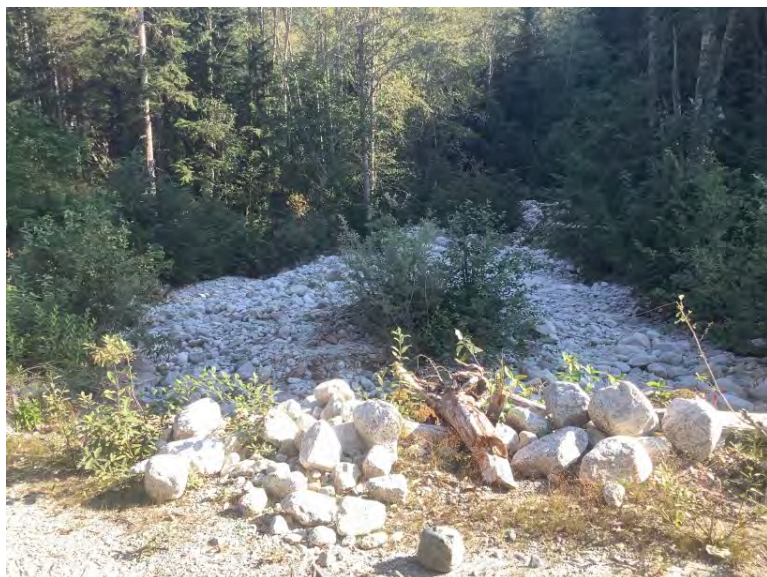
Upstream from Crossing

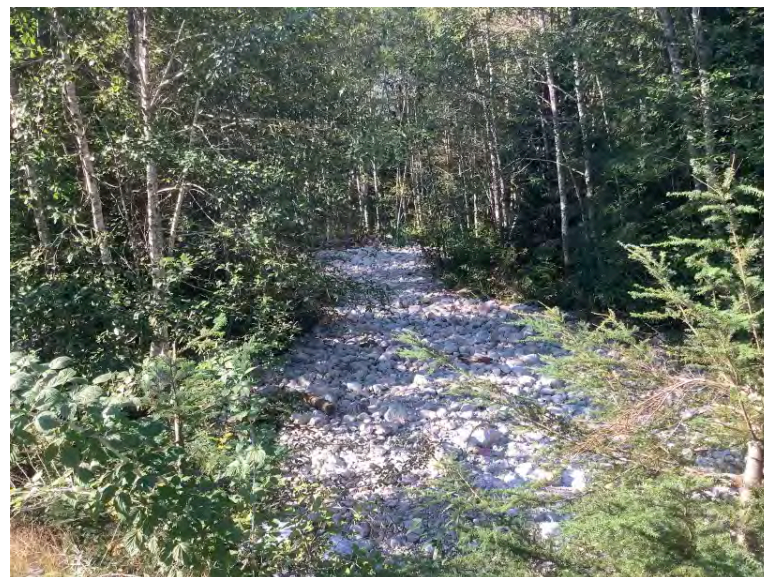
Downstream from Crossing

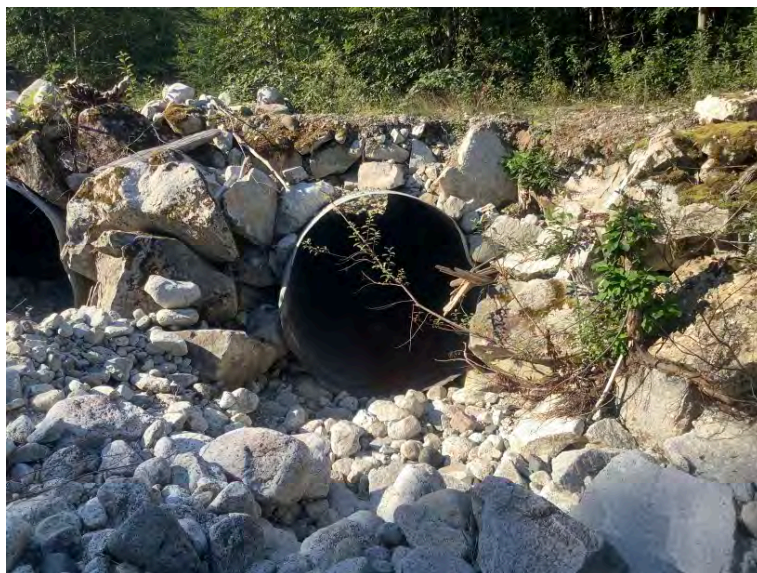
Inlet high chain

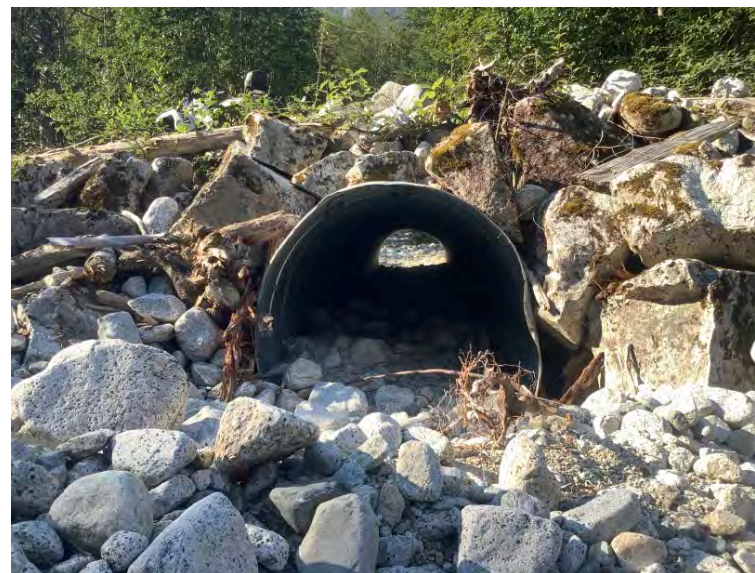
| Item | Monitor Description | Frequency |
|---|---|---|
| 1 | Accumulation of material In low chain and middle pipe | Routine Inspection |

Inlet middle

| Repair Item | Repair Description |
|---|---|
| 1 Structure. Clean-out Culvert.<br># of panels. Priority:Medium | Clean out culverts |

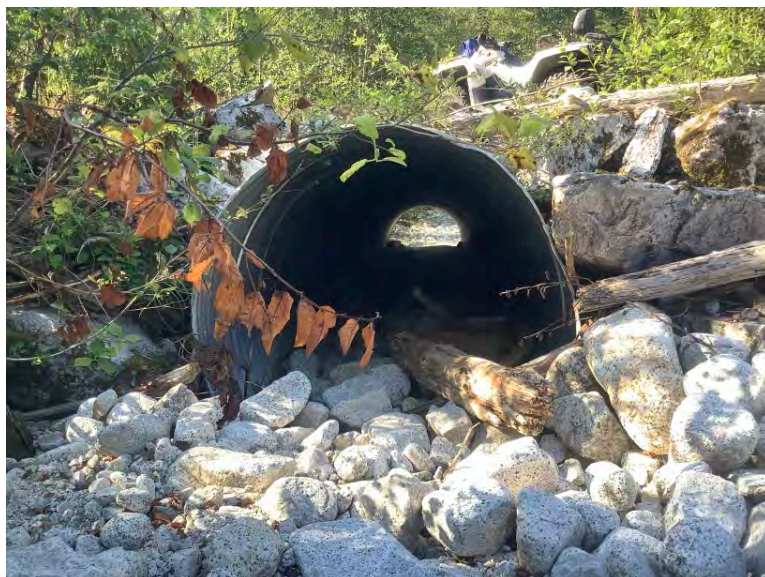
Inlet low chain

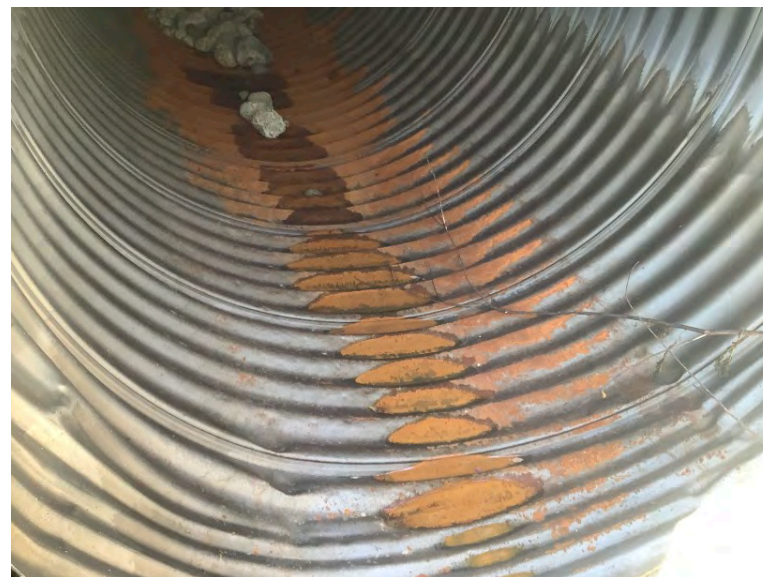
Floor Fair

Culvert Floor

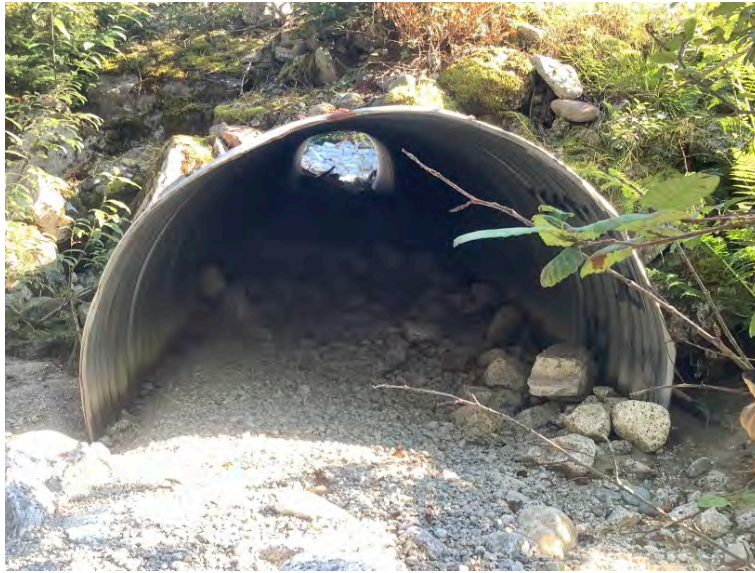
Outlet low chain

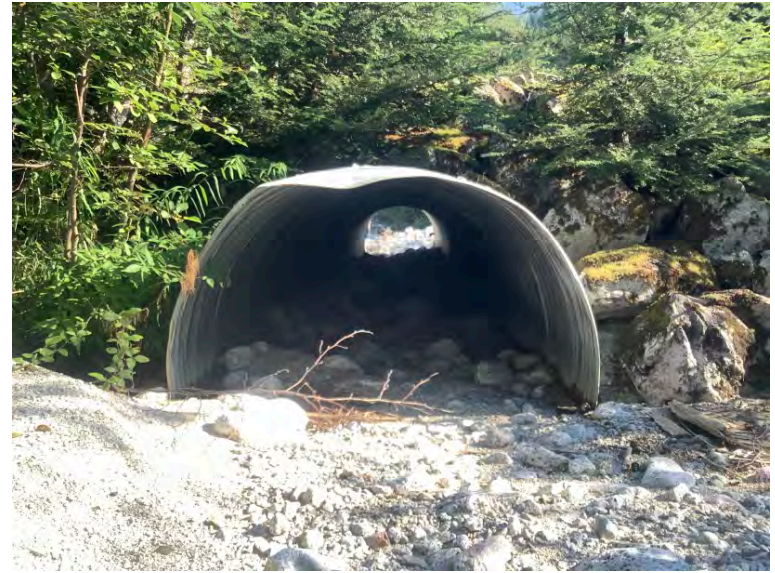
Outlet middle

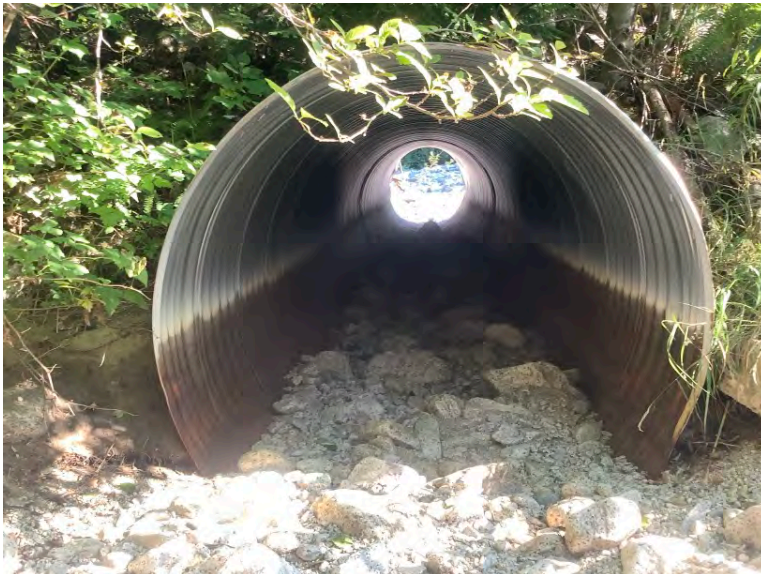
Outlet high chain

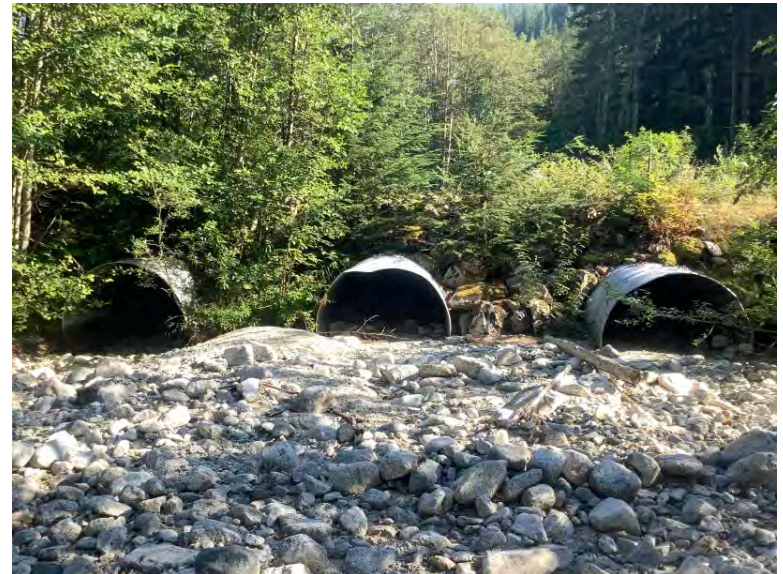
Outlet Fair

Outlet

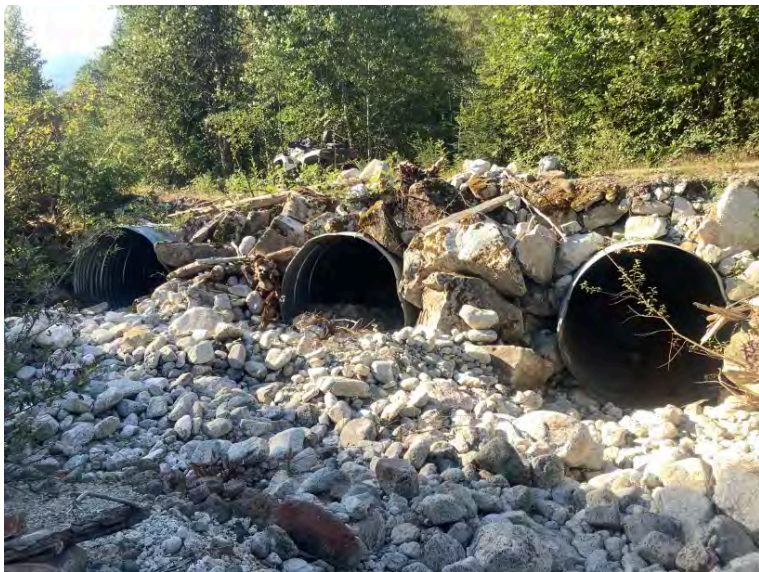
Inlet Fair

Inlet

Remove the aggraded materials from within the culverts and install a large sump at the inlet. Monitor the debris accumulations and the material being deposited at the inlet and within the culverts. The current load rating of L75 or 68 tonnes to continue.

| 2 Channel. Add Erosion<br>Control Measure. m².<br>Priority: | Install sump |
