CK-2316  
CK-2316

FOLEY 12.7km

2022 Inspection

Crossing Name Foley Creek

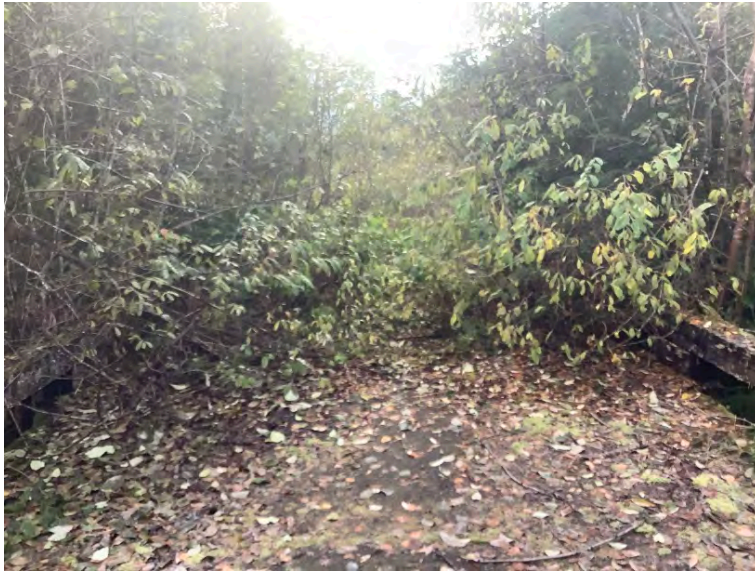
Approach from bridge deck of Right bank approach when facing downstream

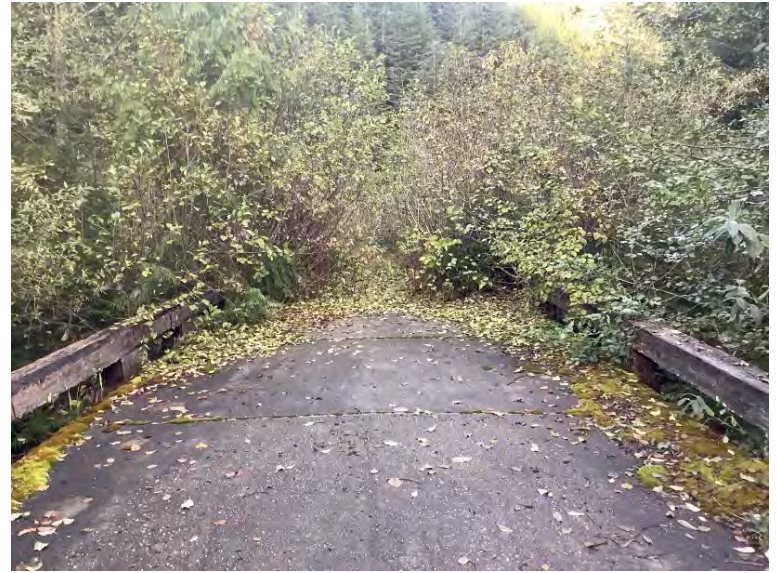
Approach from bridge deck of Left bank approach when facing downstream

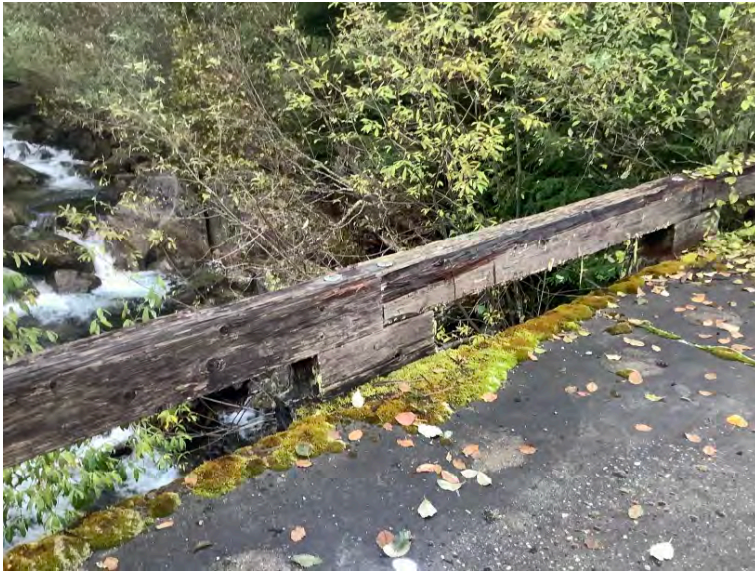
Curb Rail/Blocks/Posts Fair Poor-rotten

Hardware Fair Poor-loose

Overall Deck Condition Fair Poor-due to rail condition

Guard Rail

Load rated by: MoF Sasha Ward RPF, P.Eng Feb 15 2023  
Load rating: 0 tonnes due to flooding from beaver activity  
Comments: Notify when bridge accessible, complete inspection and replace all timber guard rails components prior to increasing load rating.  
Next inspection: 2024

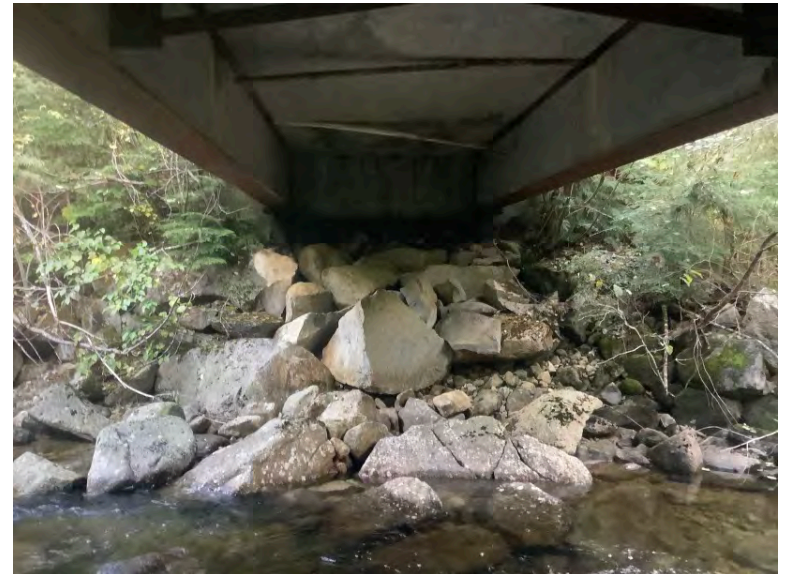
Left bank has toe scour starting. Large oversized rocks appear to have remained in place. Right bank large rocks do not appear to be keyed in. Slight scour noted.

Left Bank Abutment when facing downstream

| Item | Monitor Description | Frequency |
|---|---|---|
| 1 | Riprap both abutments. Left appears more at risk | Routine Inspection |

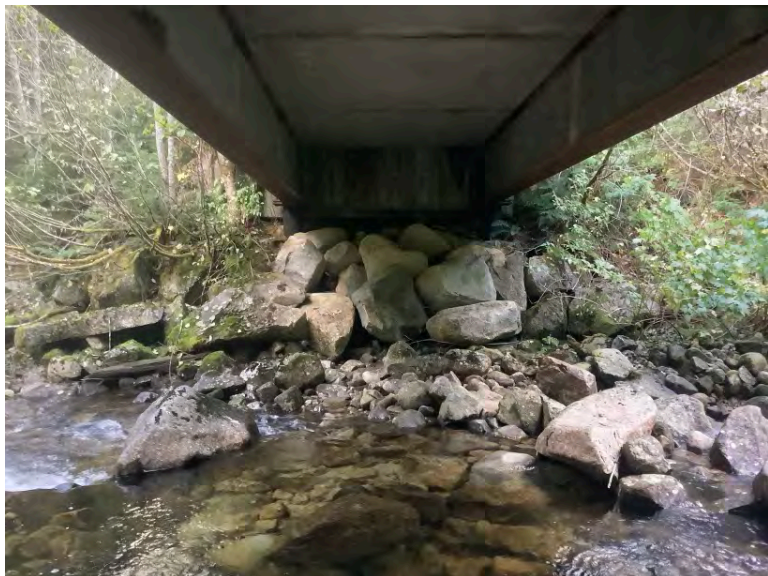
Right Bank Abutment when facing downstream

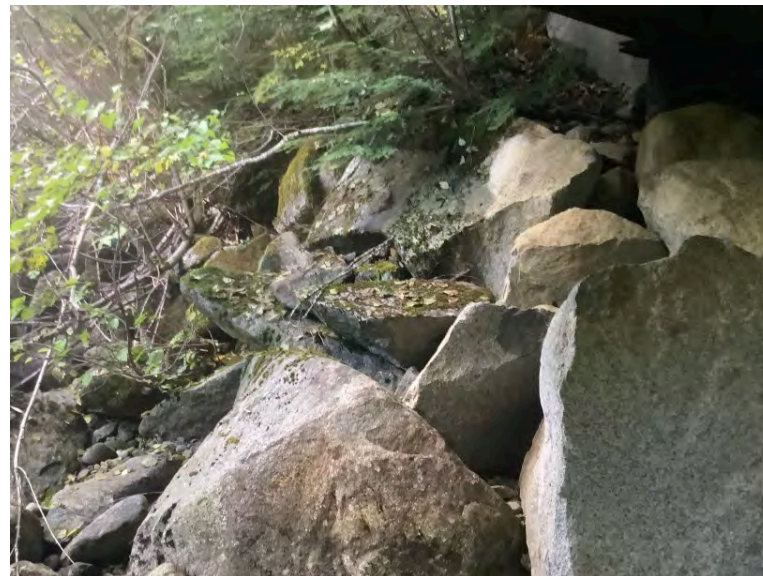
Left Bank Abutment when facing downstream

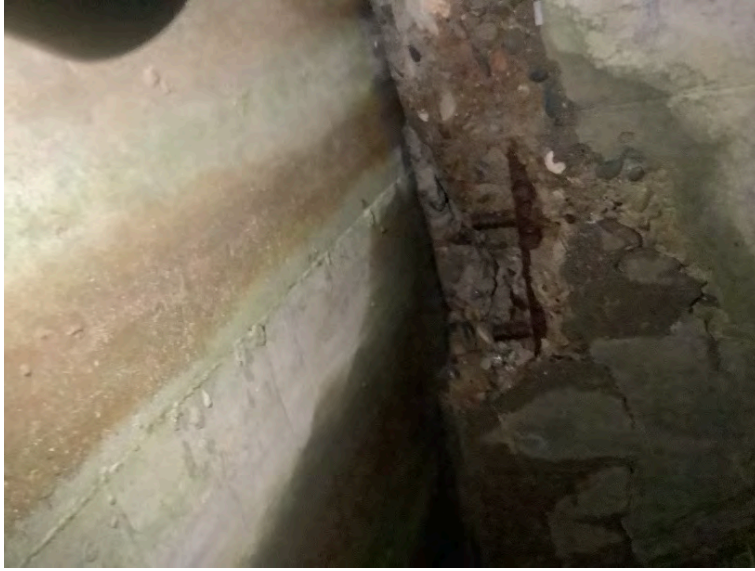
Underside of panel 1 da,age. Rebar exposed
