CK-2320  
CK-2320

NAHATLATCH 22.5km

2022 Inspection

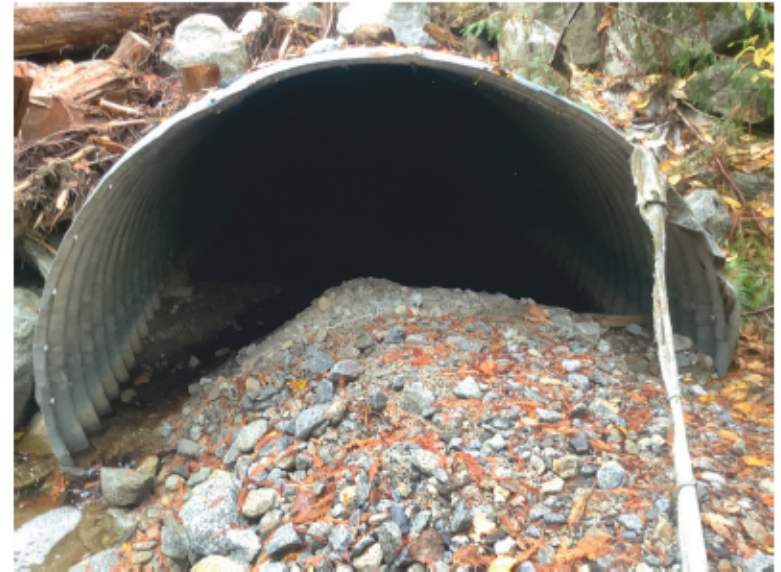
Outlet      Fair      Fair condition

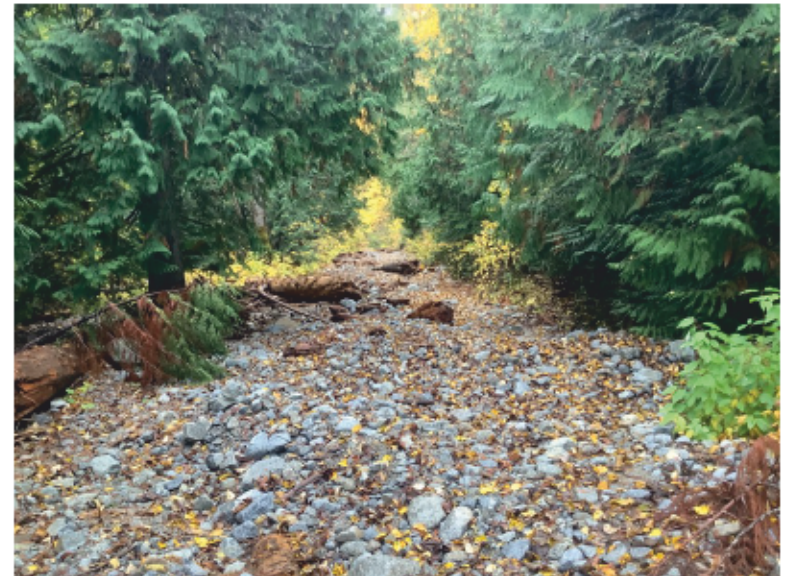
Poor-Pipe plugged, stream re router to right. 100 meters of right approach is rocky debris and timber

Right bank approach beyond new channel

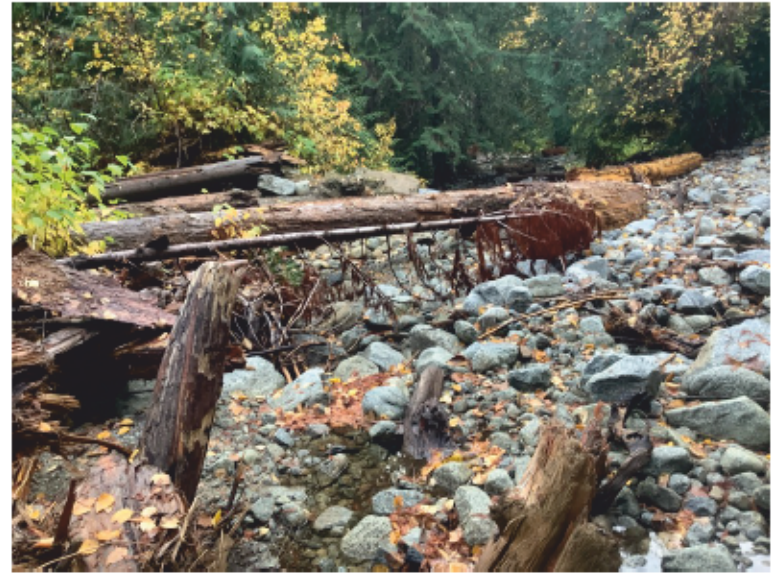
Inlet      Fair      Poor-Fully covered

Overall      Fair      Poor-Inlet plugged, stream re routed 15m to right bank

Comments: Full structure replacement required. Site survey and design prior to increase in load rating.
