CK-2329  
CK-2329

LOST 7300 1.1km

2022 Inspection

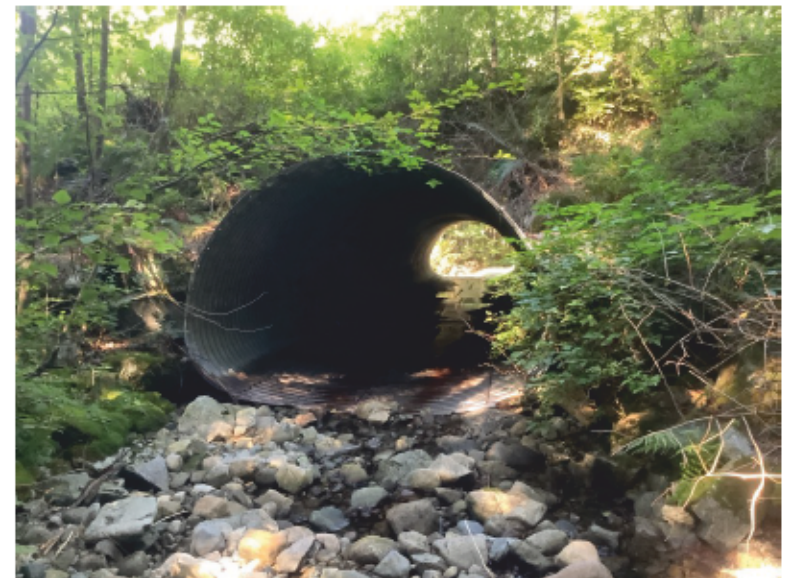
Inlet Good

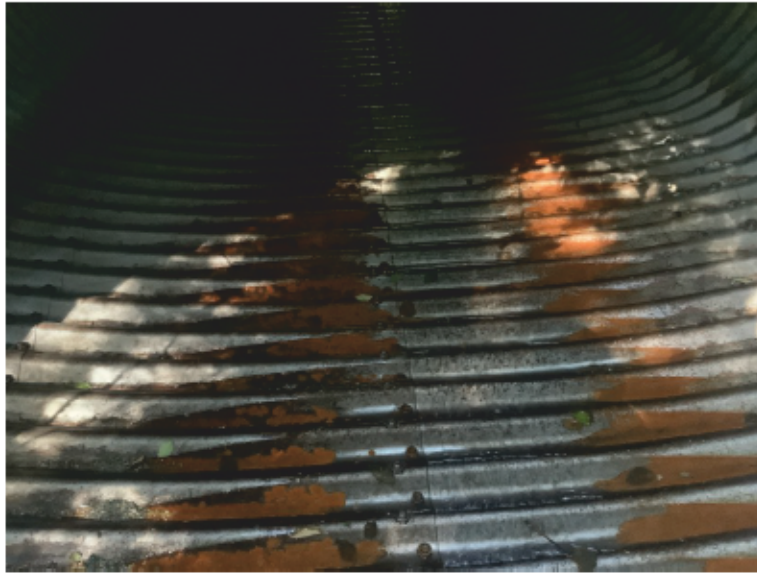
Culvert Floor

Bolted Connections Fair One hump at mid span, does not appear to be concern

Coupled Connections Fair Mid span hump In floor

Floor Fair

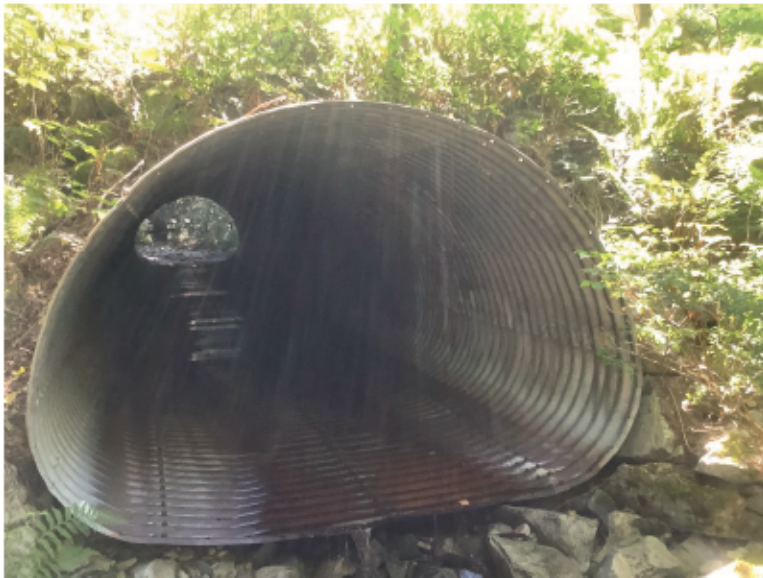
Outlet Good
