CK-2343  
CK-2343

STAVE 26.4km

2022 Inspection

Crossing Name Side Creek

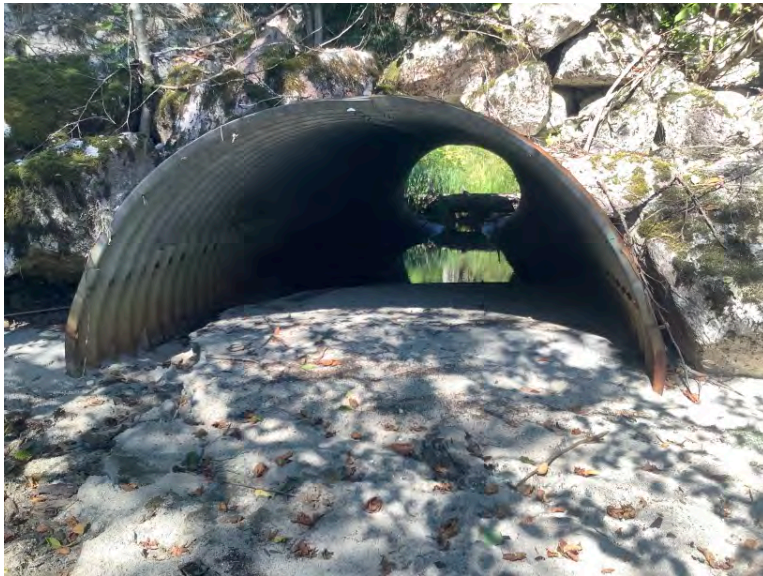
Outlet      Fair      Aggrading and partially obstructing flows. Also leads to standing water in culvert

| Comments | Fines built up from stave river back watering | | | | |

| Item | Monitor Description | Frequency |
|---|---|---|
| 1 | Monitor amount of aggrading material In outlet from backwatering events of the stave | Routine Inspection |

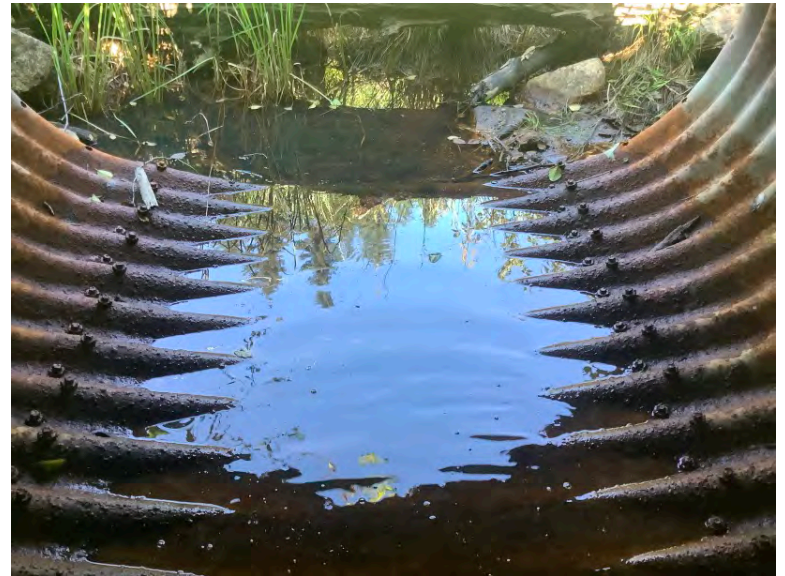
Culvert Floor

Coating      Fair      Floor is poor, rest of structure is fair

Floor      Poor      Rusting

| Item | Monitor Description | Frequency |
|---|---|---|
| 2 | Monitor the corrosion on floor of culvert | Routine Inspection |

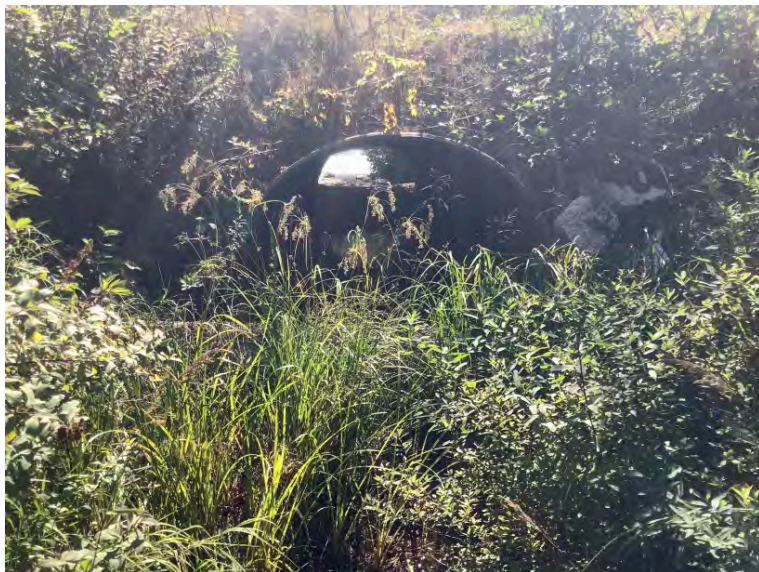
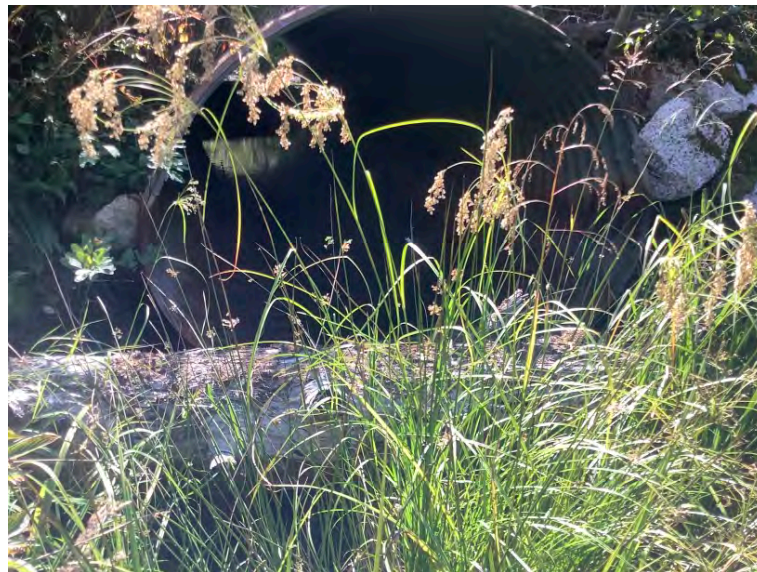
Inlet      Fair      Remove log across creek just upstream of inlet.

| Repair Item | Repair Description |
|---|---|
| 1 Channel. Debris removal. # of sites/items. Priority:Low | Remove log across channel directly upstream |
