CK-2348  
CK-2348

COGBURN 4.8km

2022 Inspection

Superstructure Steel I-beam

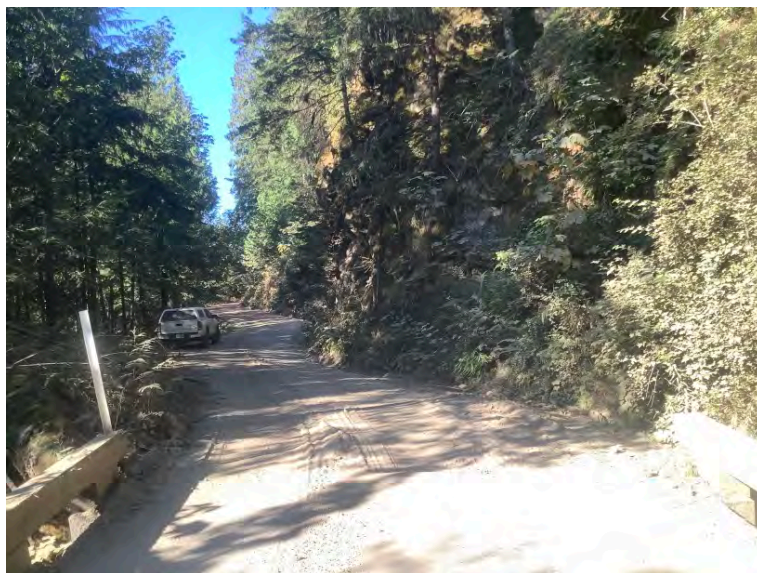
Approach from bridge deck of Right bank approach when facing downstream

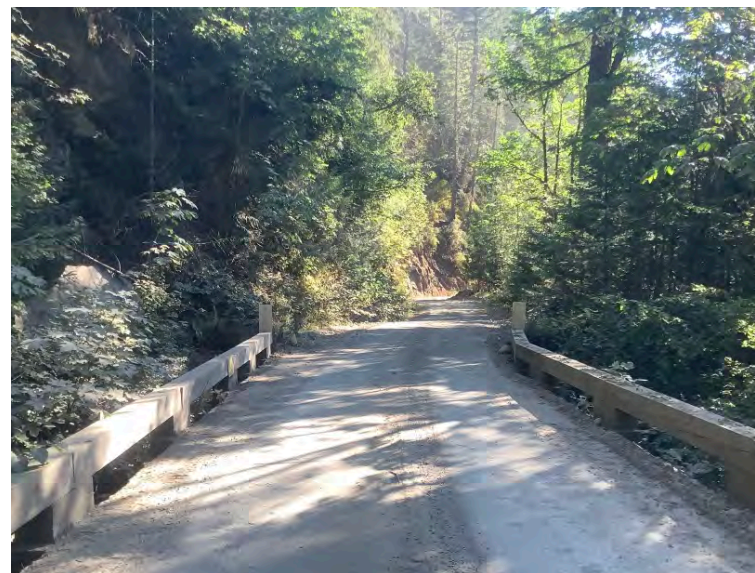
Approach from bridge deck of Left bank approach when facing downstream

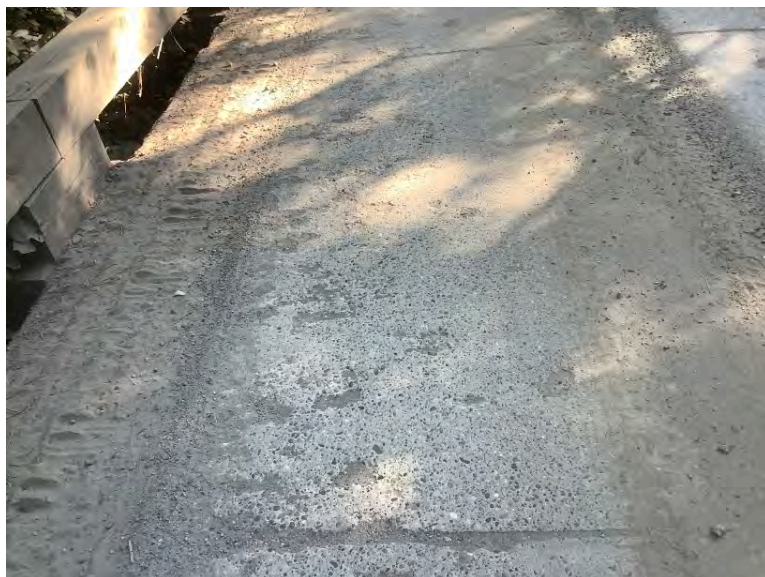
Concrete Deck Fair

Signs of tracked machines with picks walking across. Both ends flared. Sediment accumulating on deck.

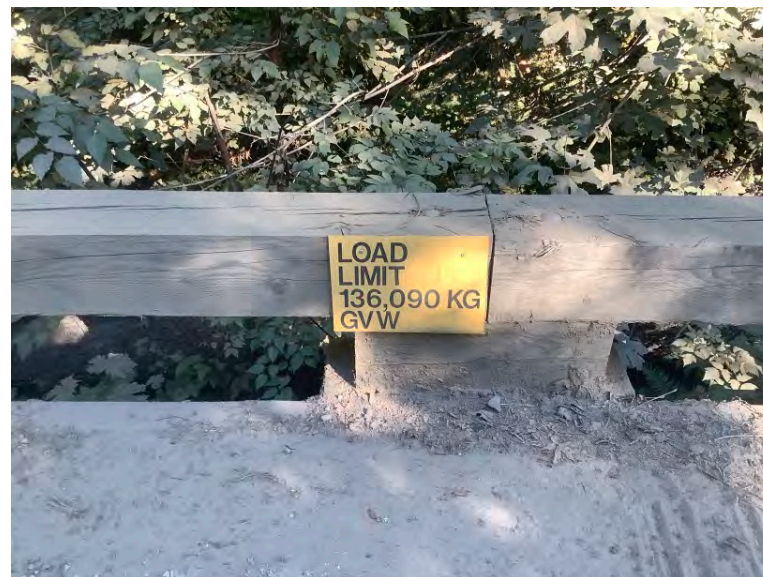
Load Rating Sign

Posted Load Rating 136090

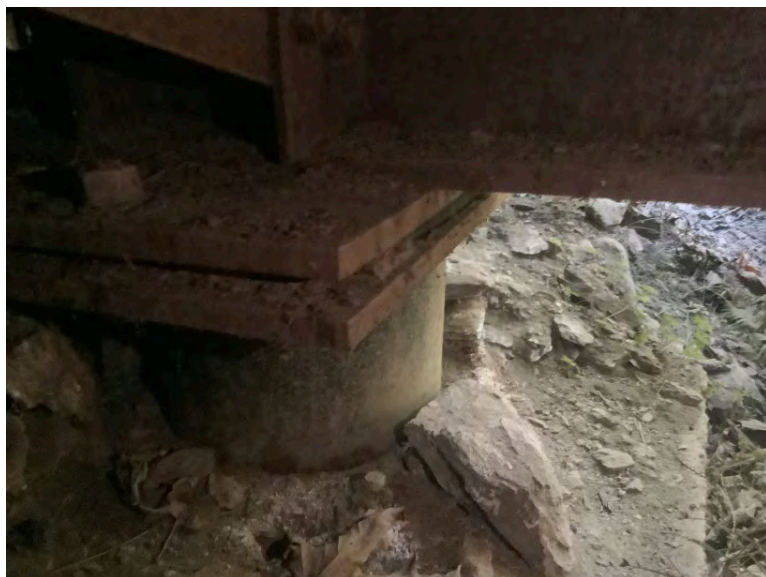
Bearing

Bearings Fair Minor deformation of rubber

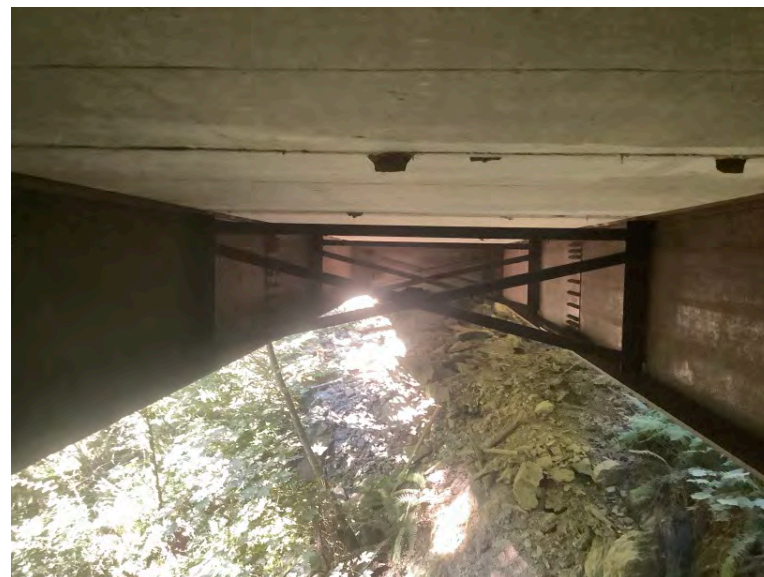
Superstructure

Girders Good One bolted splice

Diaphragms Good 5 bays
