CK-2363  
CK-2363

SPUZZUM 25.2km

2022 Inspection

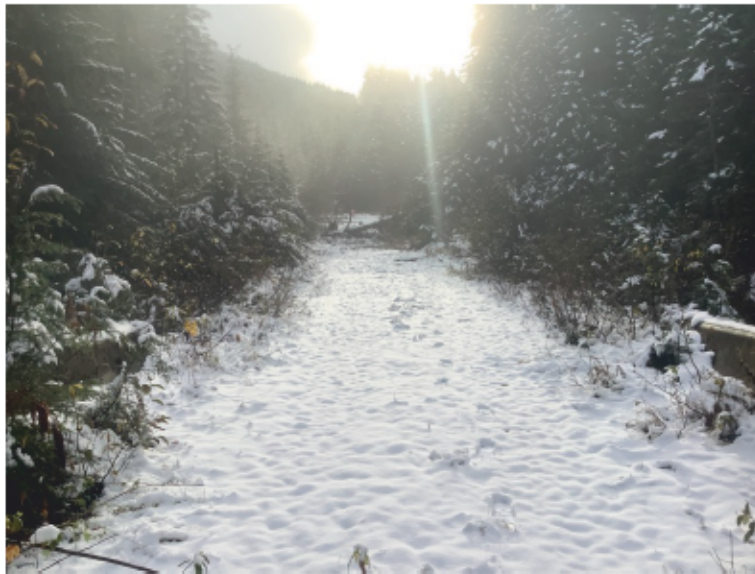
Approach from bridge deck of Right bank approach when facing downstream

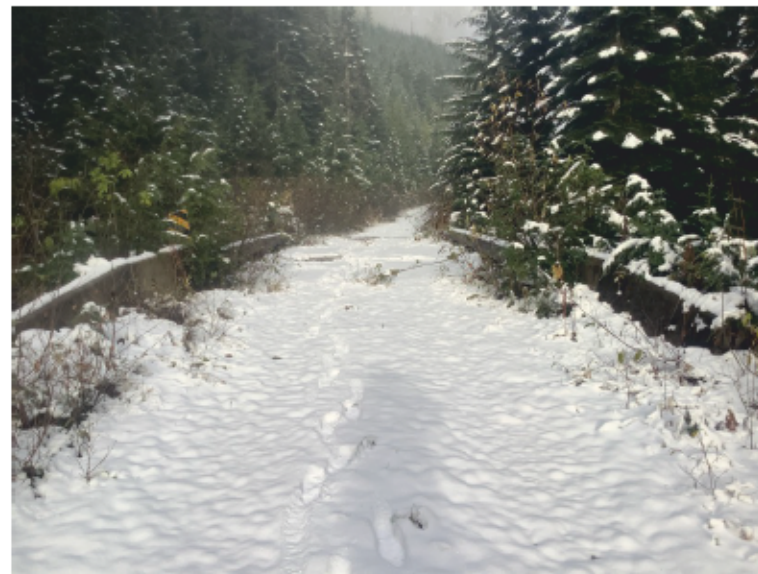
Approach from Right Bank when facing downstream

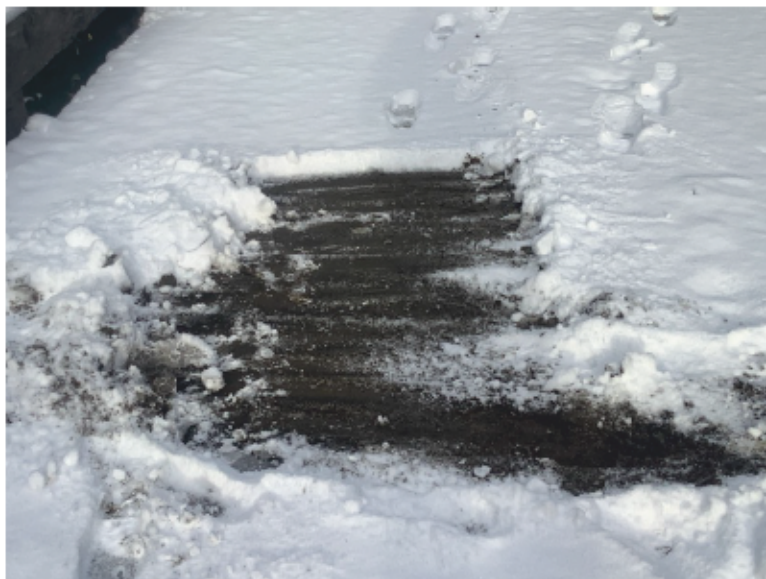
Concrete no posts . Bullnose downstream right requires reconnection.

Downstream right bullnose

| 3 Approach. Approach fenders (re-Install). # of units. Priority:Low | Connect bullnose |

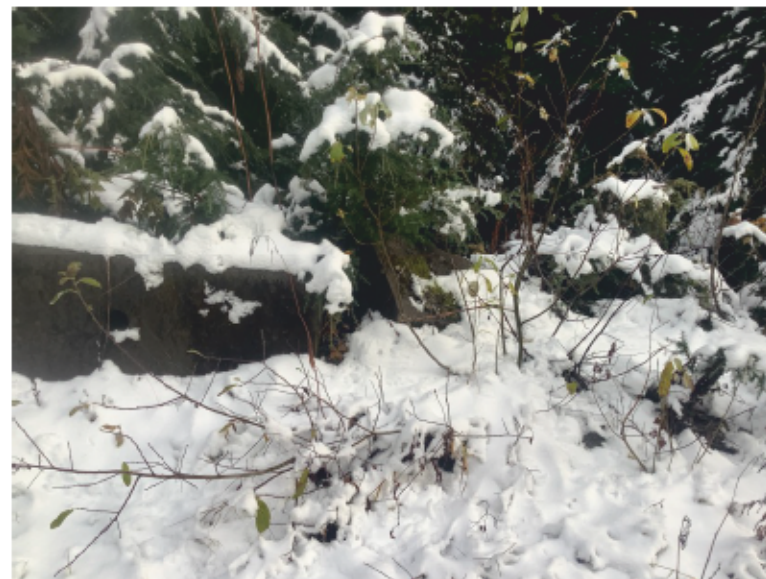
Load Rated by: MoF, M.Lowe, RPF, PEng, February 16, 2023  
Load Rating: 5 Tonnes GVW  
Next Inspection: September 1, 2025  
Comments: Load rating only due to guard rail condition. Replace rails prior to next use.

Curb Rail/Blocks/Posts      **Fair**      **Poor-rotten**

Overall Deck Condition      **Fair**      **Poor due to guard rail**

| 1 Structure. Curb Maintenance. # sites. Priority:Medium | Replace guard rail |

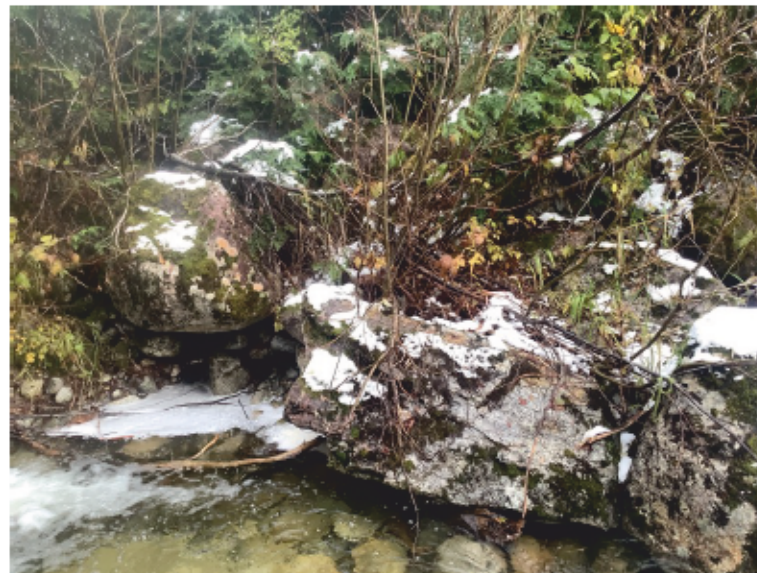
Upstream left and downstream right tone monitored

Upstream left bank riprap

| Item | Monitor Description | Frequency |
|---|---|---|
| 1 | Upstream left and downstream, right riprap | Routine Inspection |

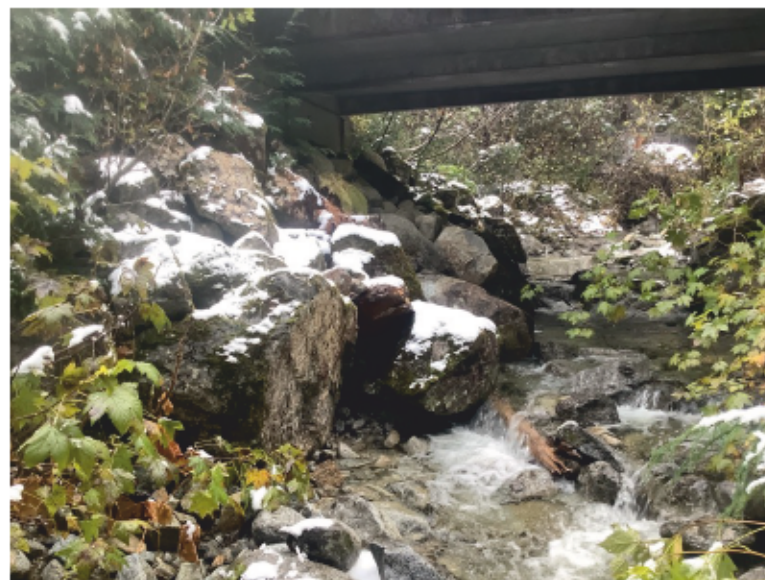
Scour ☒

Downstream right riprap scour

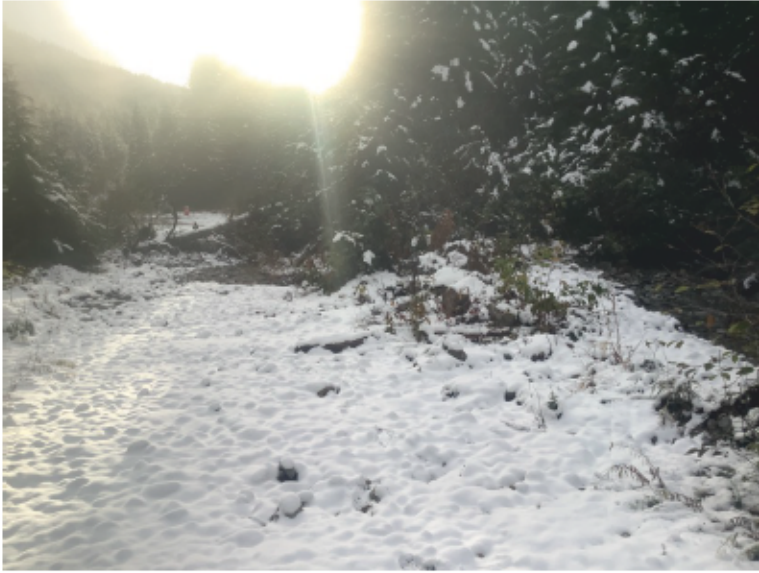
25 meters down right approach, either culvert fully plugged or new side channel has eroded road prism, flow currently running in ditch to upstream right of bridge. High flows overtop

High chain blow out
