CK-2369  
CK-2369

SPUZZUM 24000 2.3km

2022 Inspection

Structure Class Permanent Bridge

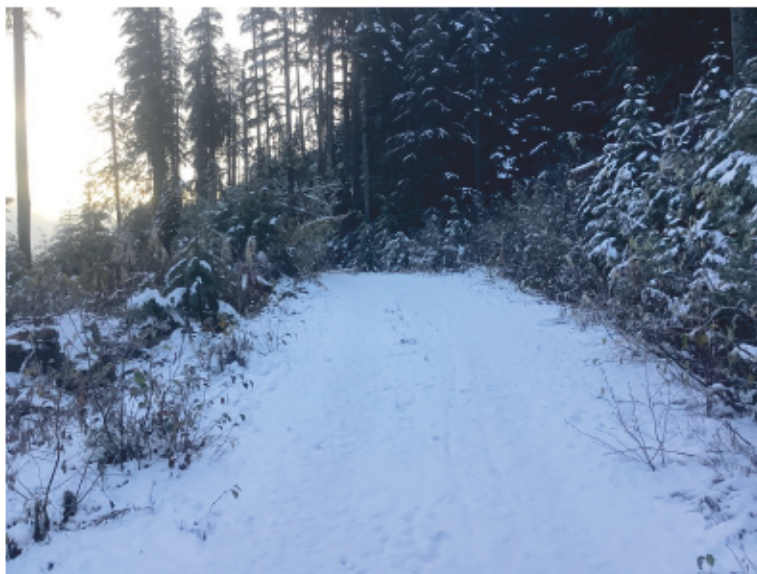
HC and vc left approach, HC right approach

Potholes each end

Approach from Left Bank when facing downstream

| Repair Item | Repair Description |
|---|---|
| 3 Approach. Area/sight line brushing. m². Priority:Low | Brush and grade |

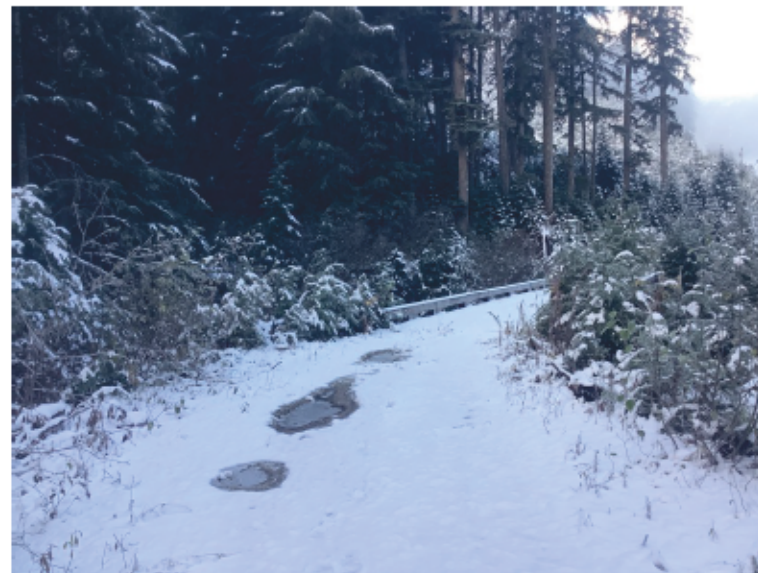
Approach from Right Bank when facing downstream

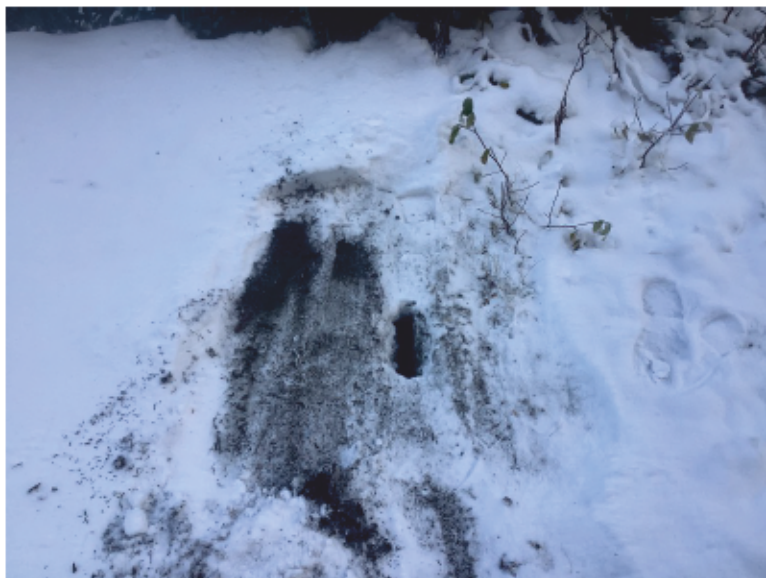
Ballast Wall Fair Damage at tops of both abutments

Concrete Deck      **Fair**      Various damage noted

Right bank panel 1 ballast wall and panel damage

| Repair Item | Repair Description |
|---|---|
| 2 Structure. Concrete structural maintenance. m².<br>Priority:Medium | Deck panels and ballast walls. Add ballast to each approach once complete to limit impacts. |

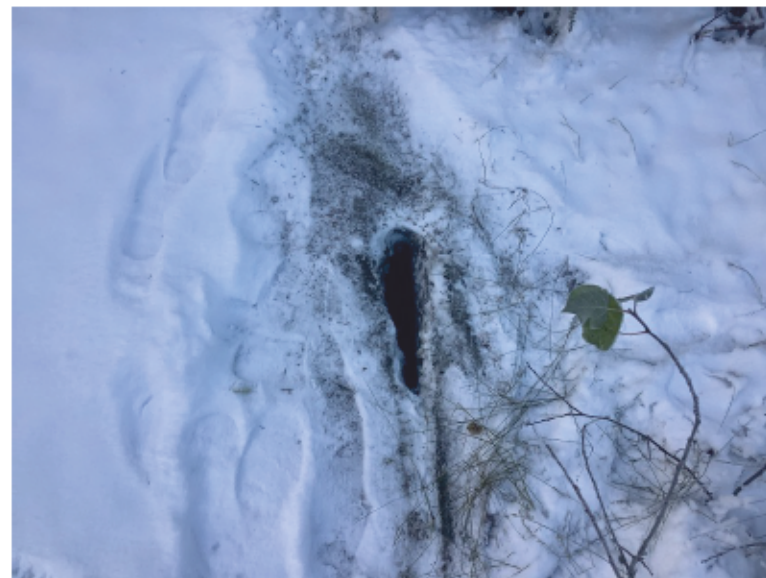
Left bank panel 1 ballast wall and panel damage

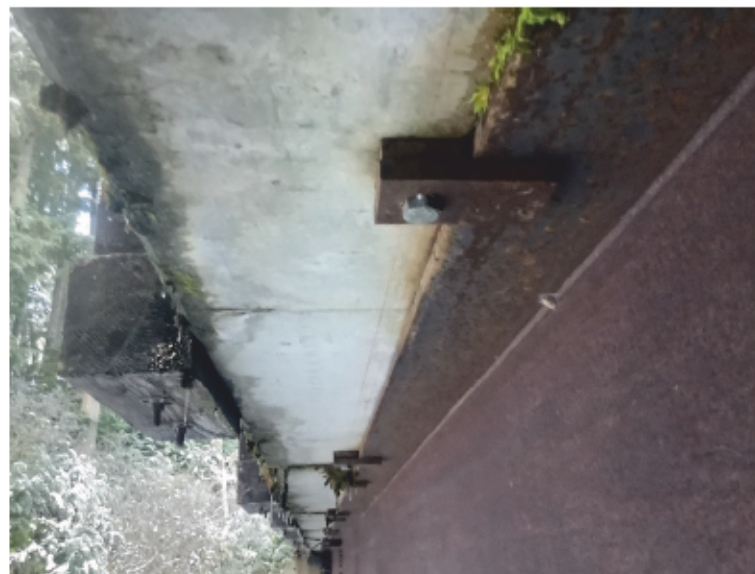
Deck to Girder Bolts      **Good**

Deck to girder bolt

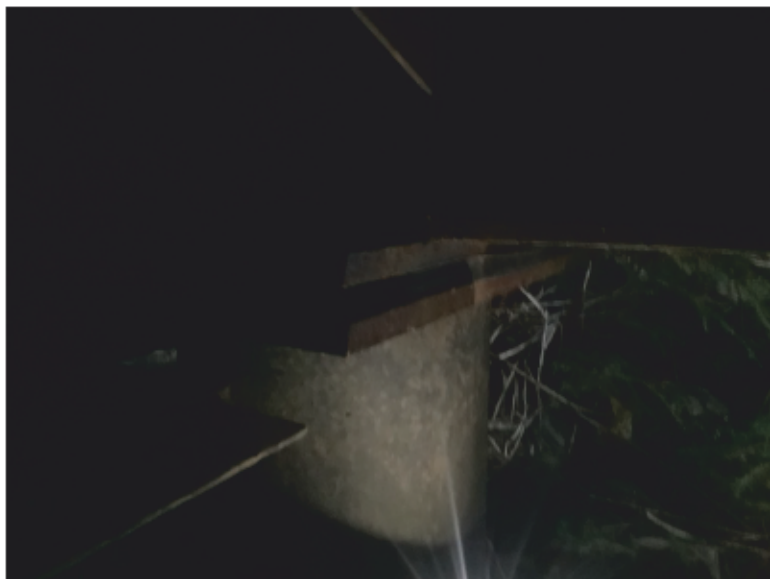
Bearings Fair Bulging

Bearing

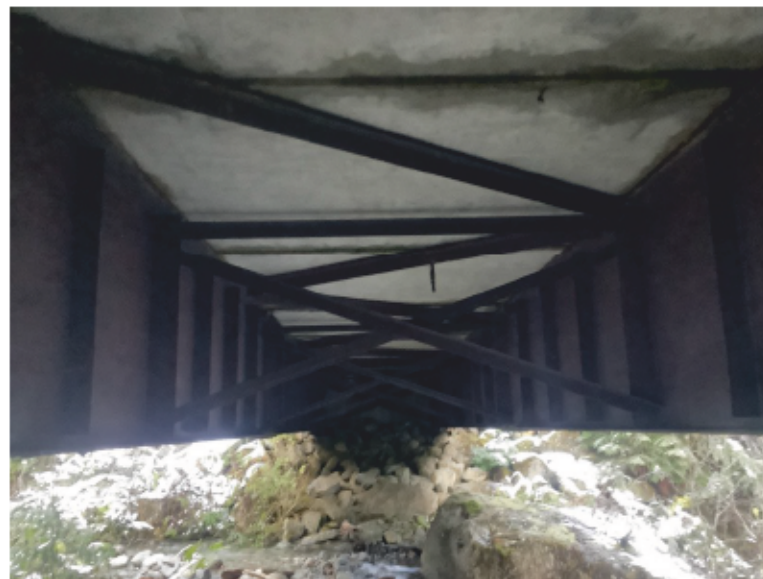
Girders Good Very minor corrosion starting,

Superstructure
