CK-2400  
CK-2400

## NESAKWATCH LAKE 1.07km

2022 Inspection

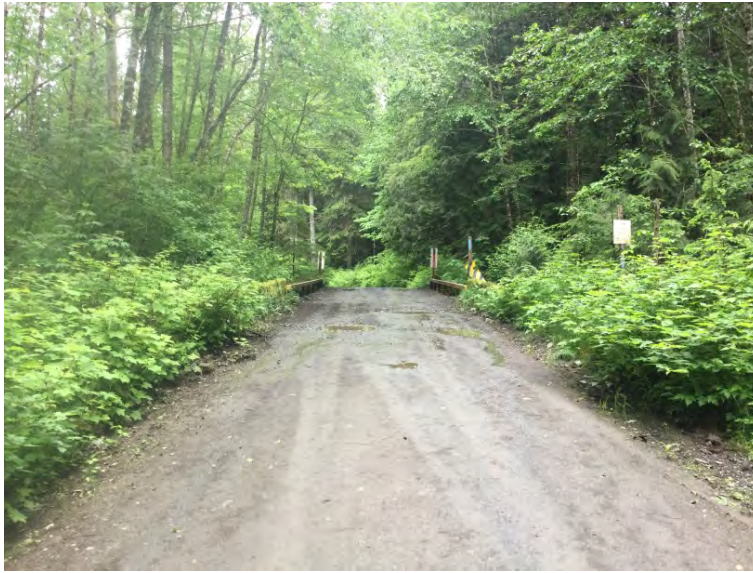
Approach from Right Bank when facing downstream

Potholes at approaches

| Repair Item | Repair Description |
|---|---|
| 1 Approach. Area/sight line brushing. m².<br>Priority:Medium | Brush approaches |
| 2 Approach. Approach surfacing grading. m.<br>Priority:Low | Grade approaches |

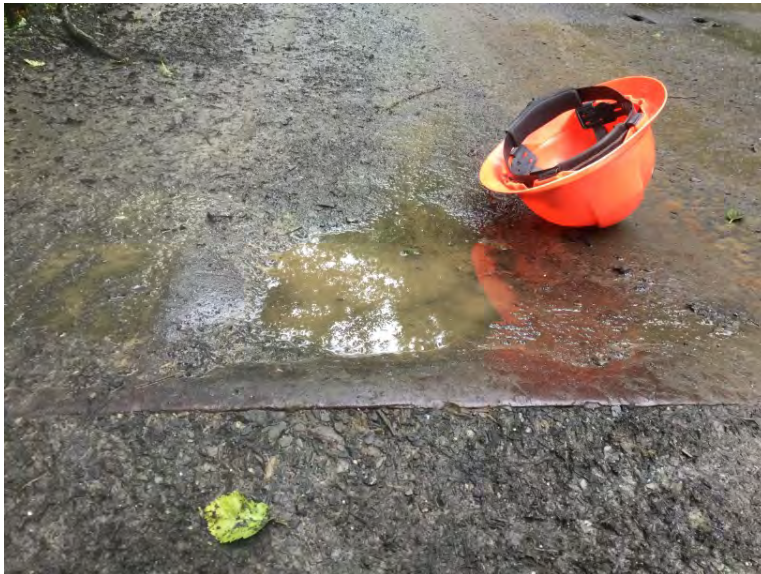
Steel Deck Plate      **Fair**      Minor deformation on wheel path

Running surface deformation on wheel path

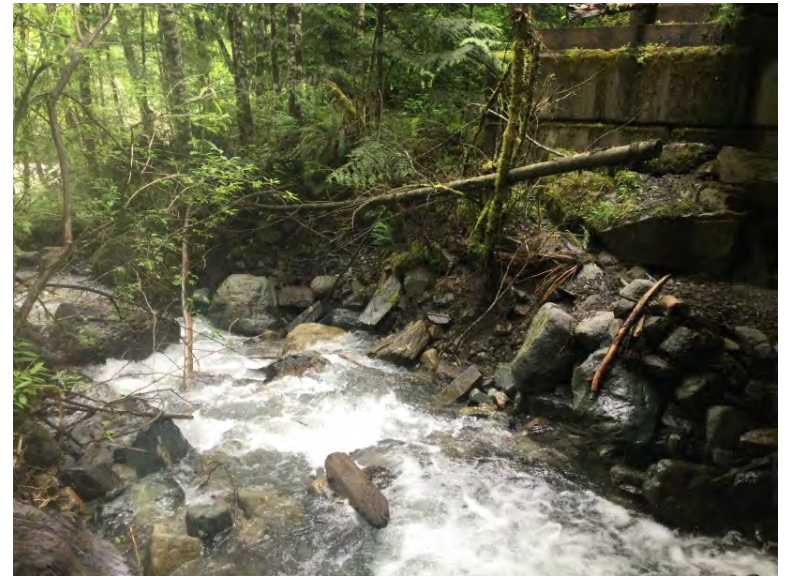
Riprap **Fair**

Downstream right bank riprap erosion

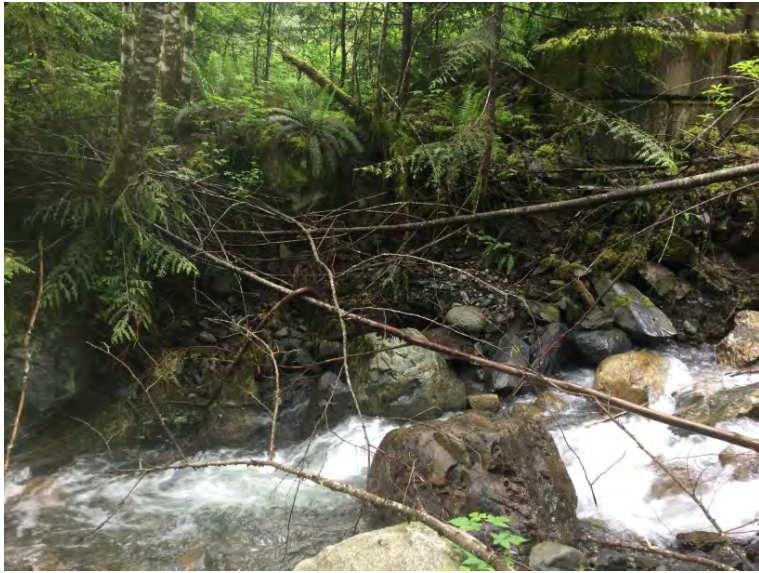
Downstream right bank riprap erosion

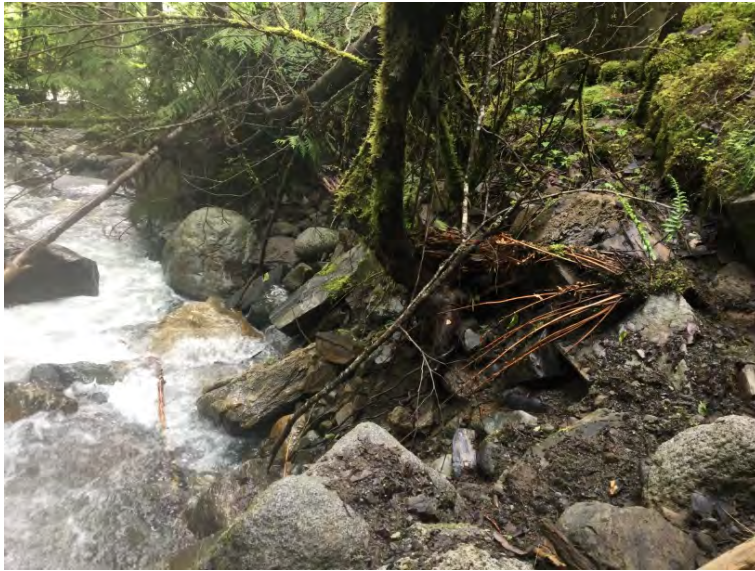
Downstream right bank riprap erosion

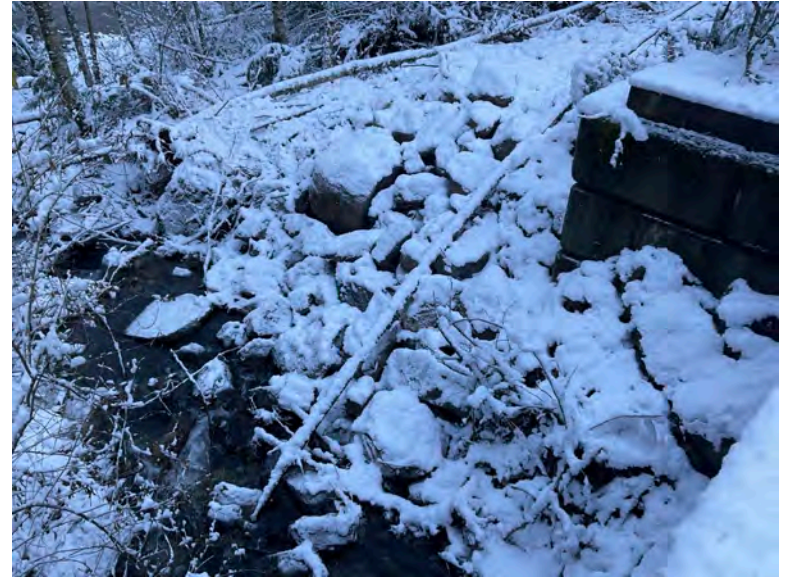
Downstream right bank erosion has been repaired

Downstream right bank riprap repair completed November 28, 2022

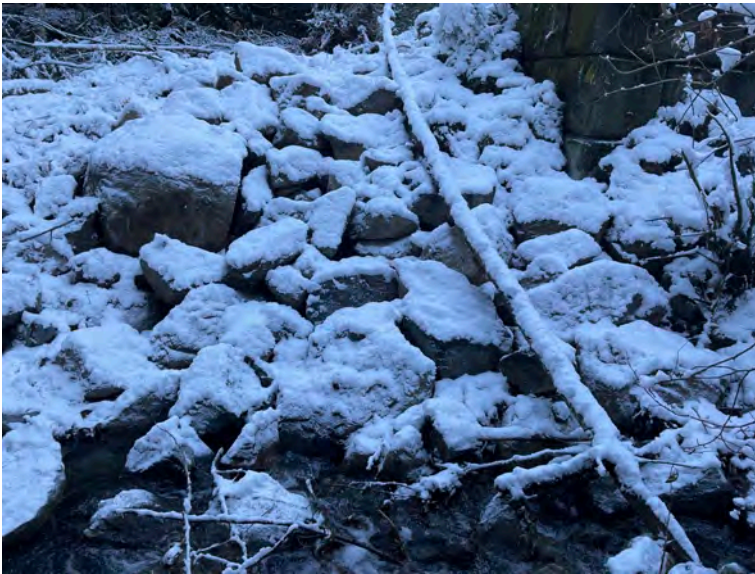
Downstream right bank riprap repair completed November 28, 2022
