CK-2440  
CK-2440

STAVE 29.9km

2022 Inspection

Crossing Name Side Creek

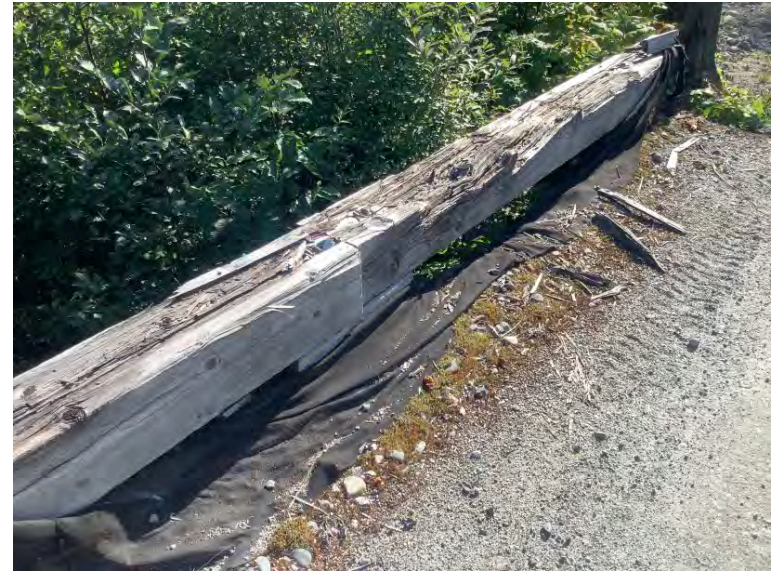
Guard Rail

Curb Rail/Blocks/Posts      **Poor**      Rotting risers, blocks and guardrails

Overall Deck Condition      **Poor**      Due to guardrail condition

Replace guardrail, risers and blocks. Reconnect the concrete no post barriers at both downstream approaches. Post bridge ahead signs. Replace missing delineators. The current load rating of L75 or 68 tonnes to continue.

| Repair Item | Repair Description |
|---|---|
| 1 Structure. Full Curb Replacement. .<br>Priority:Medium | Replace guardrail risers and blocks |

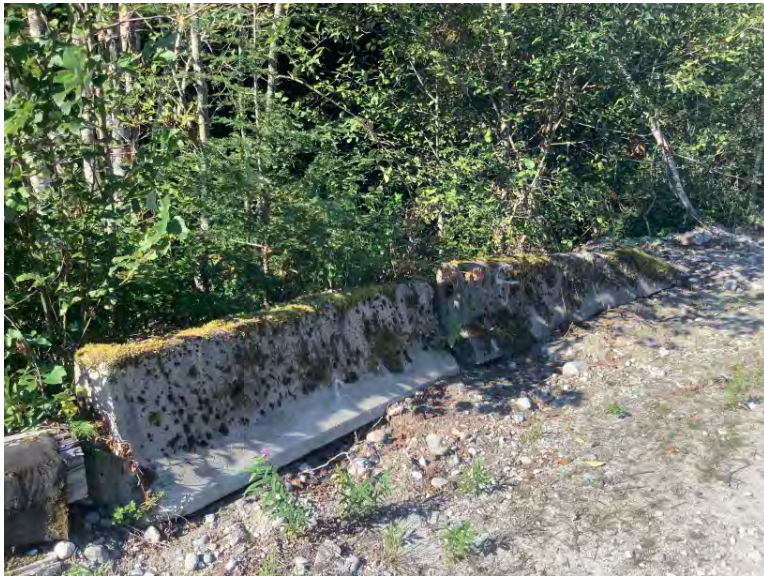
Approach Barrier

Reconnect both downstream concrete no posts

| Repair Item | Repair Description |
|---|---|
| 3 Approach. Approach fenders (re-Install). # of units.<br>Priority:Low | Reconnect both downstream concrete no post sections |

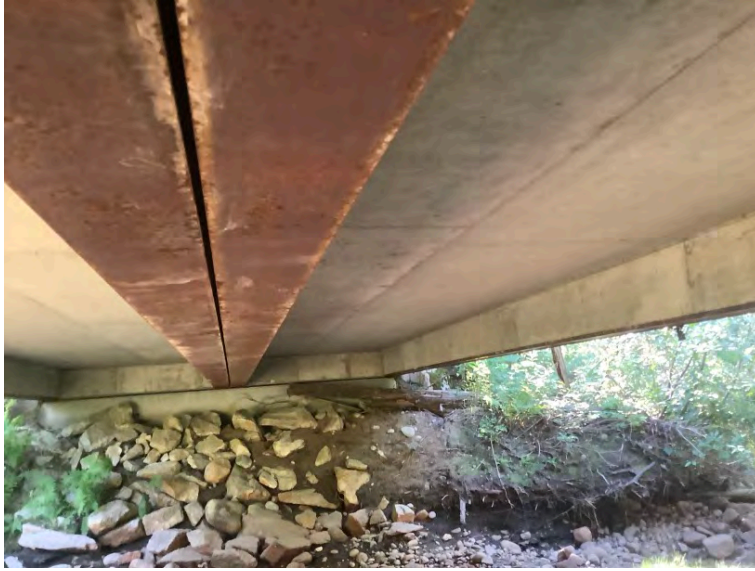
Superstructure

Girders **Good**

2 inverted channel beams with monolithic deck and diaphragms

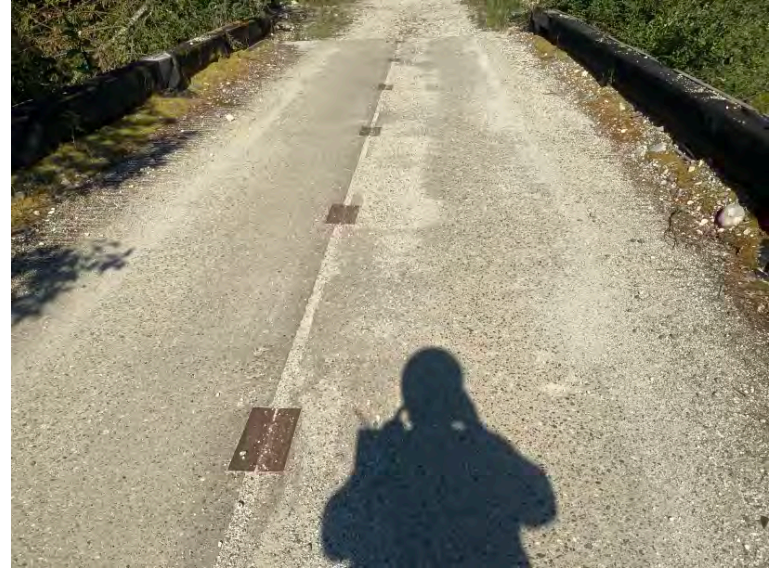
Running Surface      **Fair**

Concrete Deck      **Fair**      Minor track damage
