CK-2441  
CK-2441

FIFTEEN MILE 1.5km

2022 Inspection

Crossing Name Fifteen Mile Creek

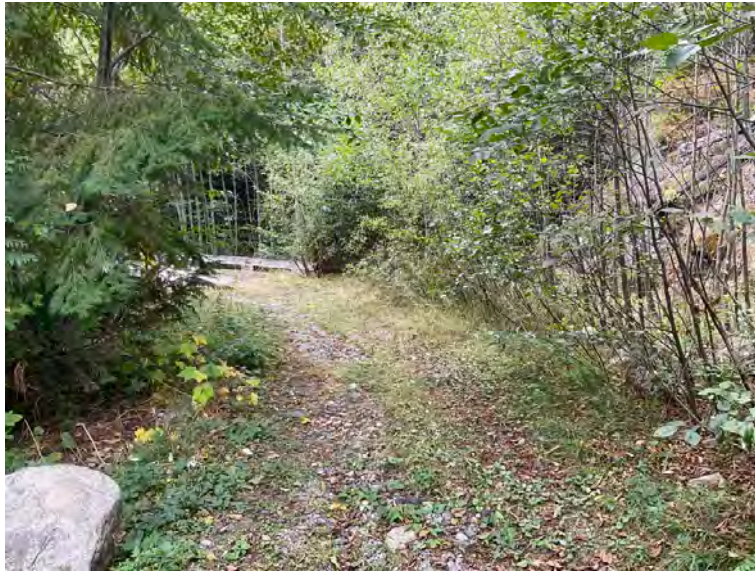
Approach from Left Bank when facing downstream

| Repair Item | Repair Description |
|---|---|
| 1 Approach. Area/sight line brushing. m². Priority:High | Brush prior to activity |

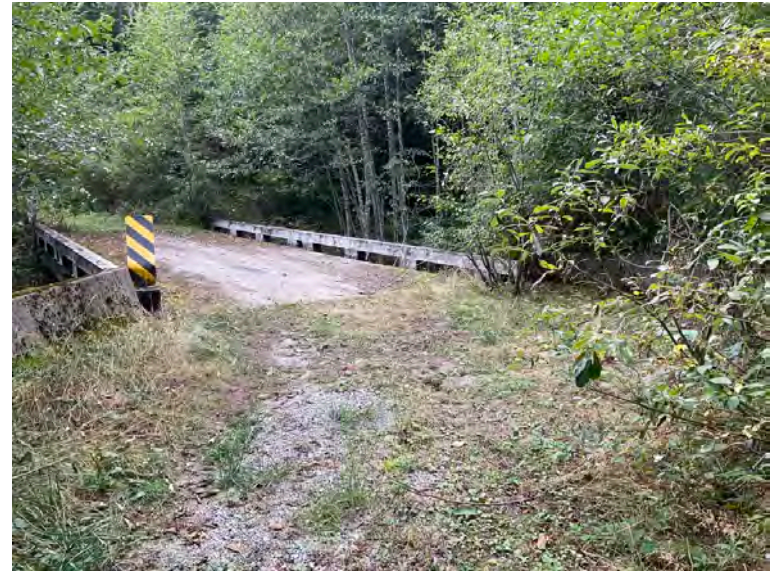
Approach from Left Bank when facing downstream

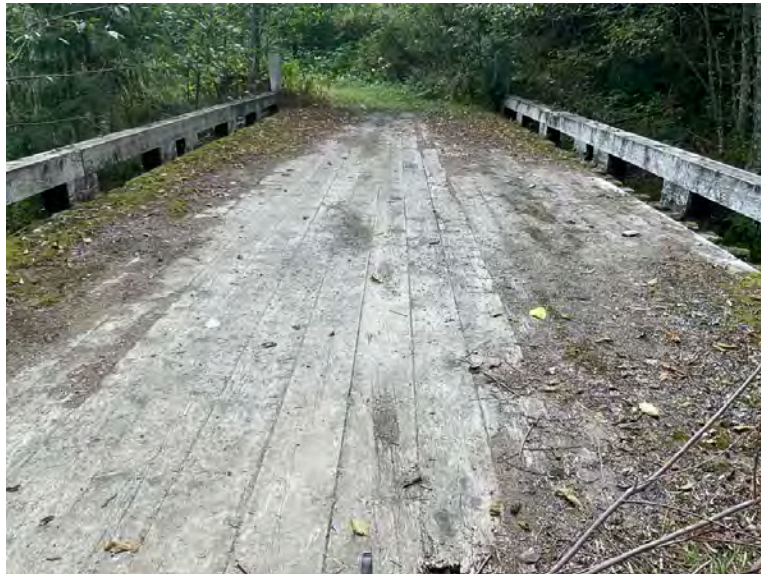
Overall Deck Condition      Poor      Entire deck system requires replacement

Deck

| Repair Item | Repair Description |
|---|---|
| 3 Structure. Major redecking (crossties or laminated deck). m. Priority:High | Replace ties and planks prior to industrial activity |

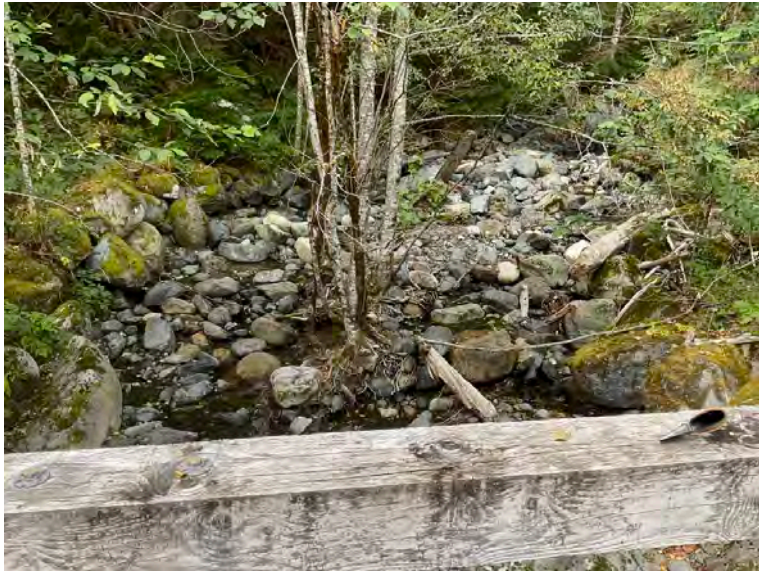
Upstream from Crossing

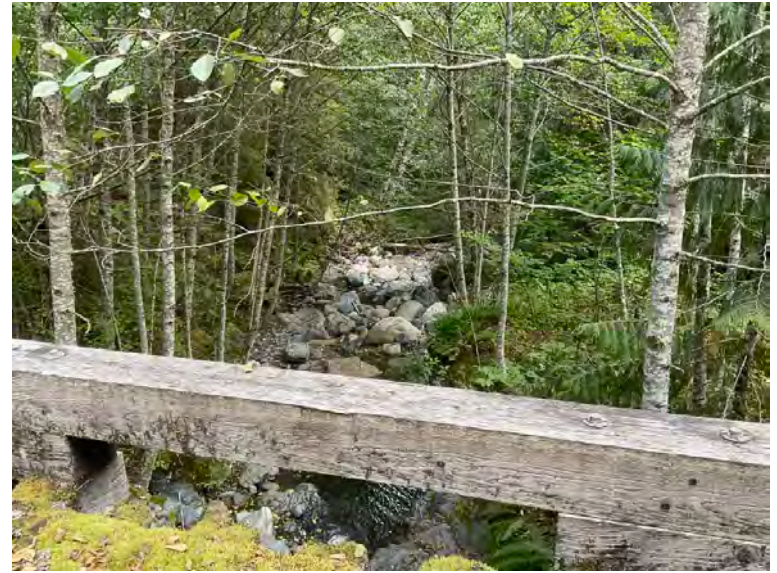
Downstream from Crossing

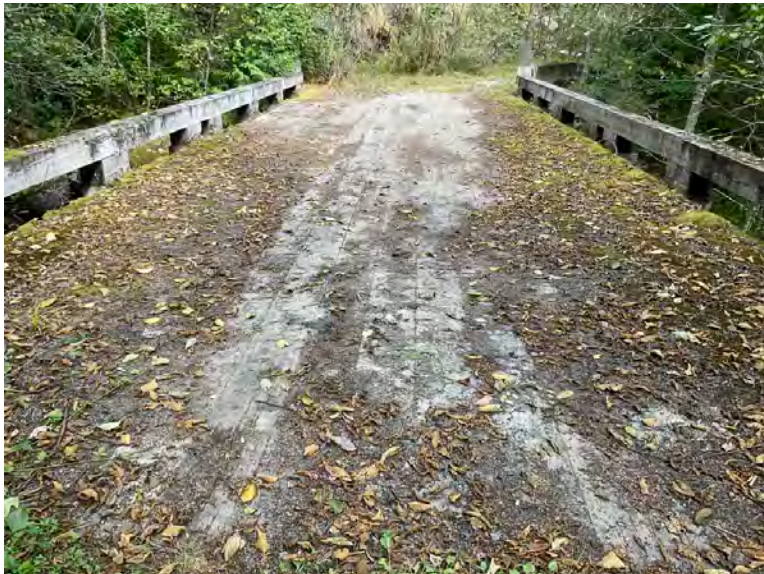
Deck

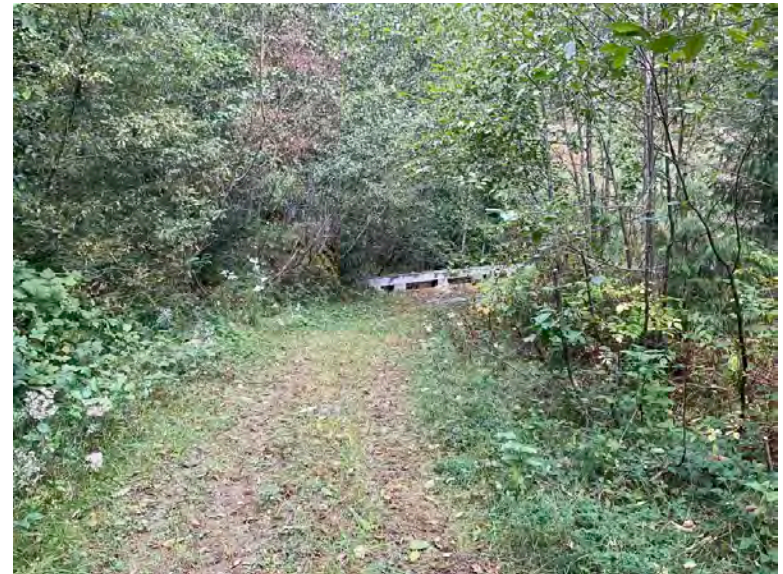
Approach from Right Bank when facing downstream

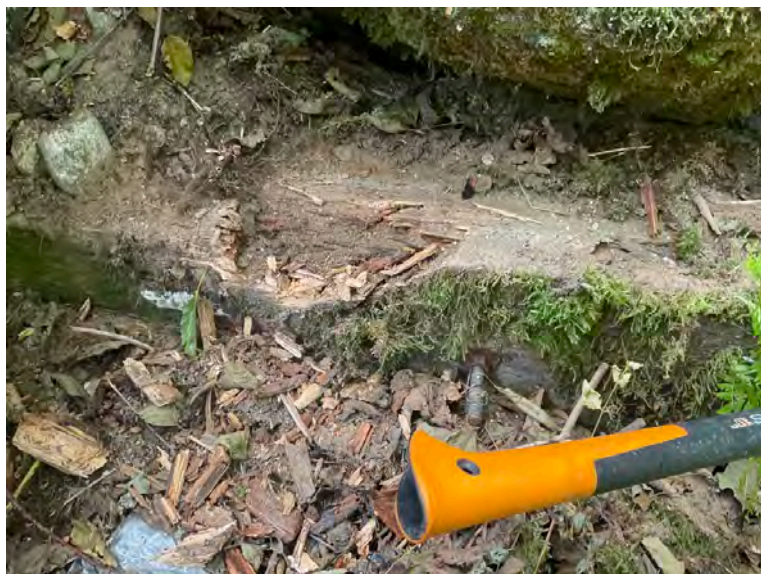
Rotten timber sill

Timber sill condition at right bank

| Repair Item | Repair Description |
|---|---|
| 4 Substructure. Timber caps and log sills. m². Priority:High | Replace timber sills prior to industrial activity |

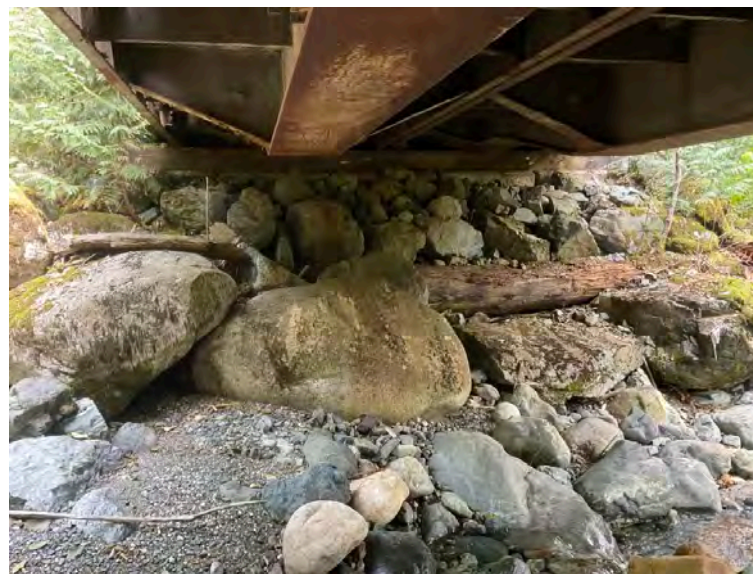
Left Bank Abutment when facing downstream

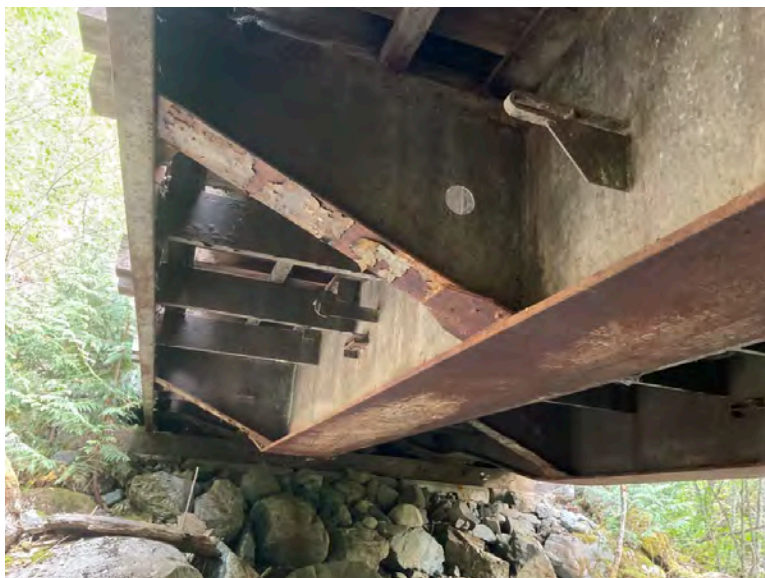
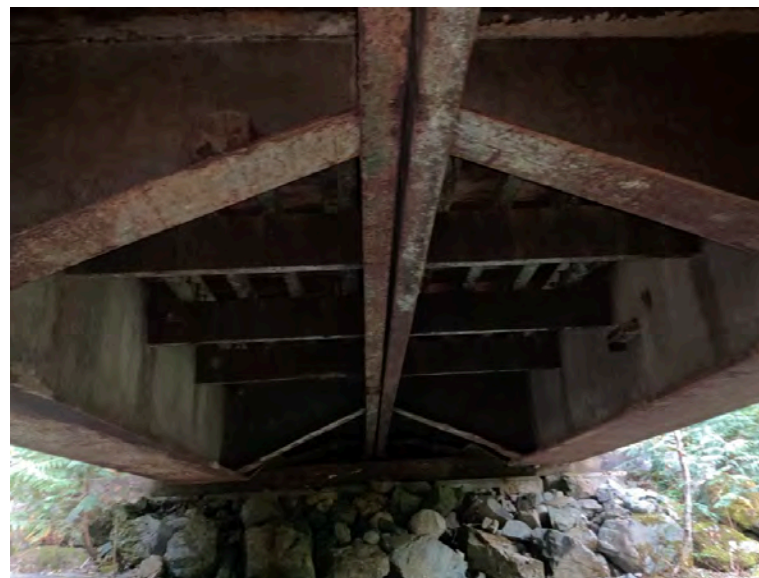
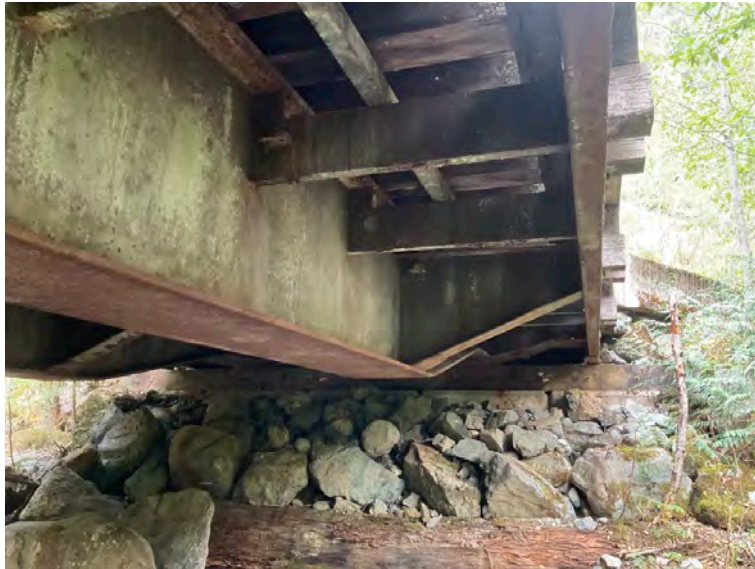
2 Hawker Siddeley railcars

Superstructure

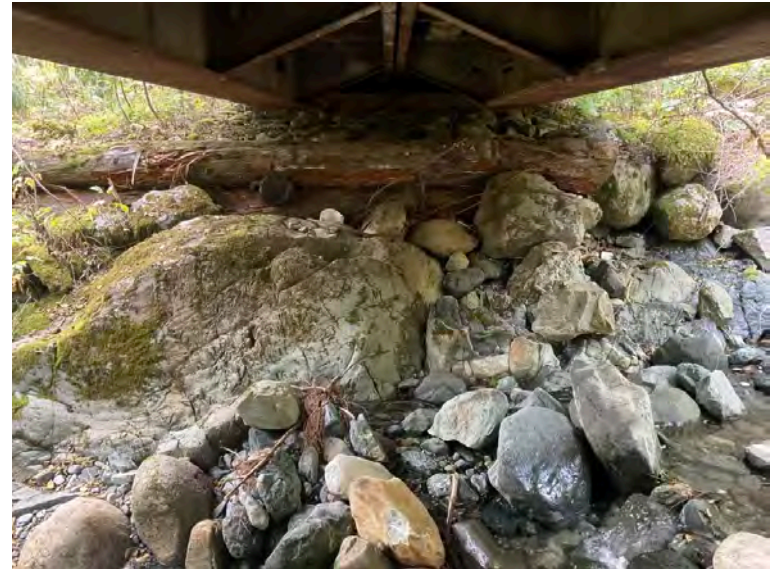
Right Bank Abutment when facing downstream

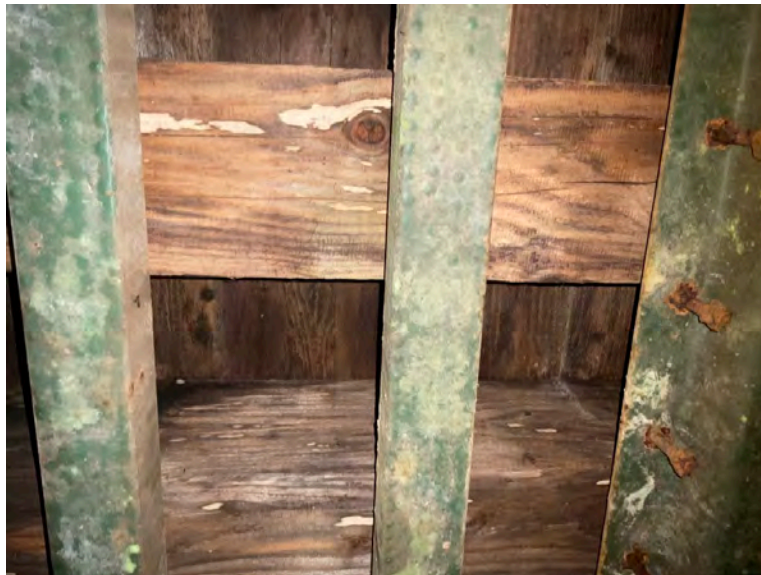
Ties      Poor      Rotten

Tie condition

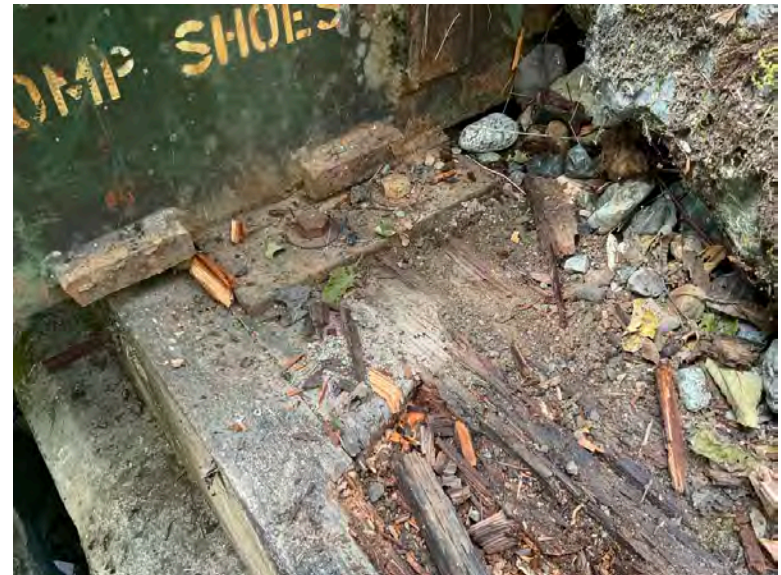
Bearings Fair

Bearing plate and girder connection

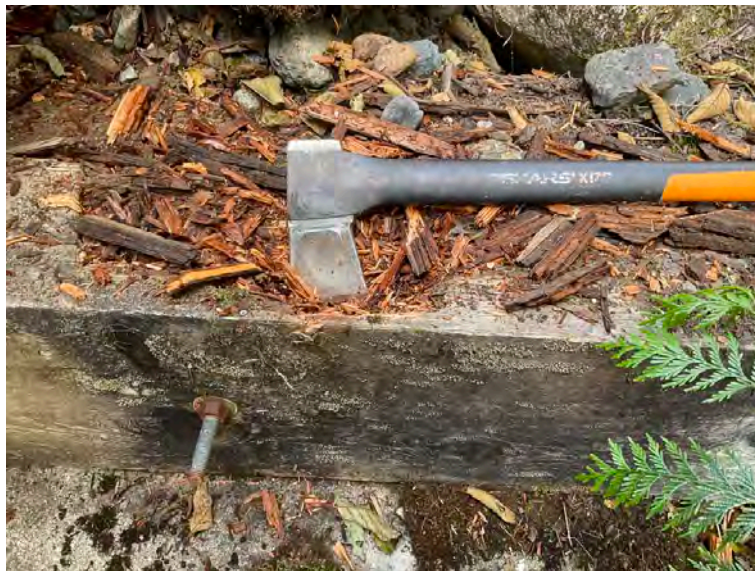
Timber sill condition at left bank

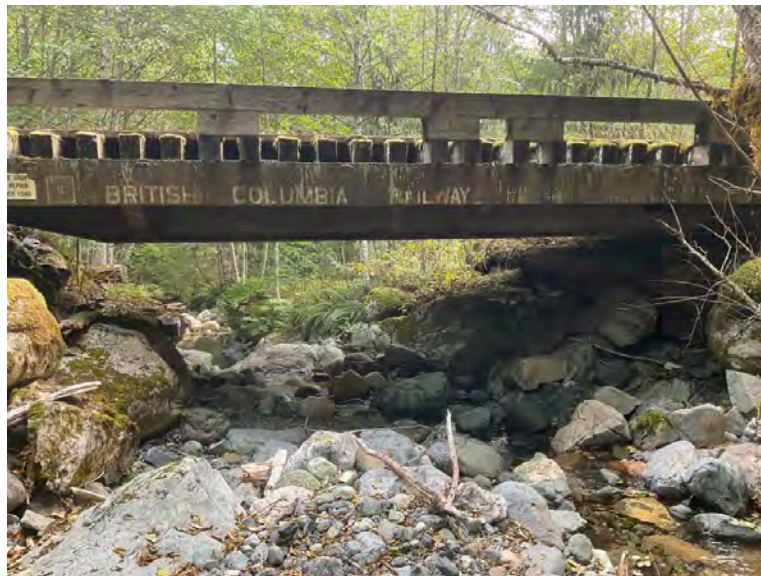
Upstream Profile
