CK-2448  
CK-2448

NORRISH 1.8km

2022 Inspection

Crossing Name Sally Creek

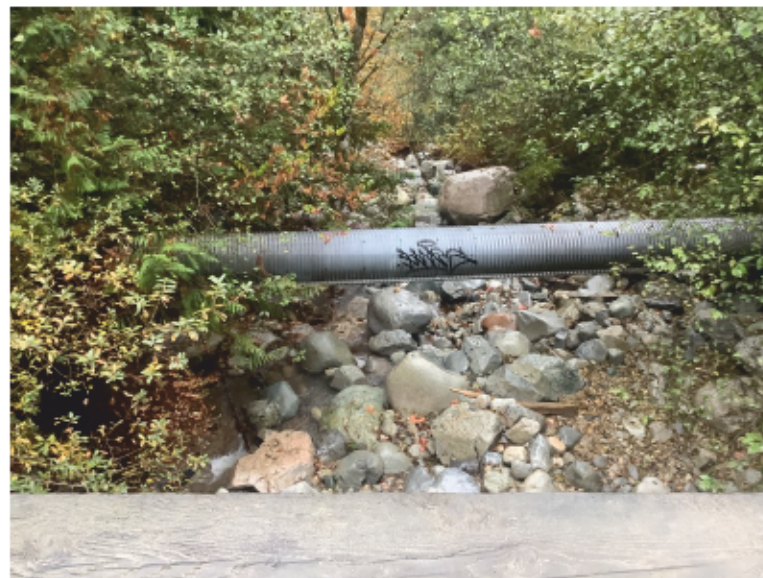
Downstream from Crossing

Riprap Poor Poor to fair. Downstream scour

| Repair Item | Repair Description |
|---|---|
| 1 Channel. Add Riprap (placed). m <sup>3</sup> . Priority:High | Repair downstream riprap. |

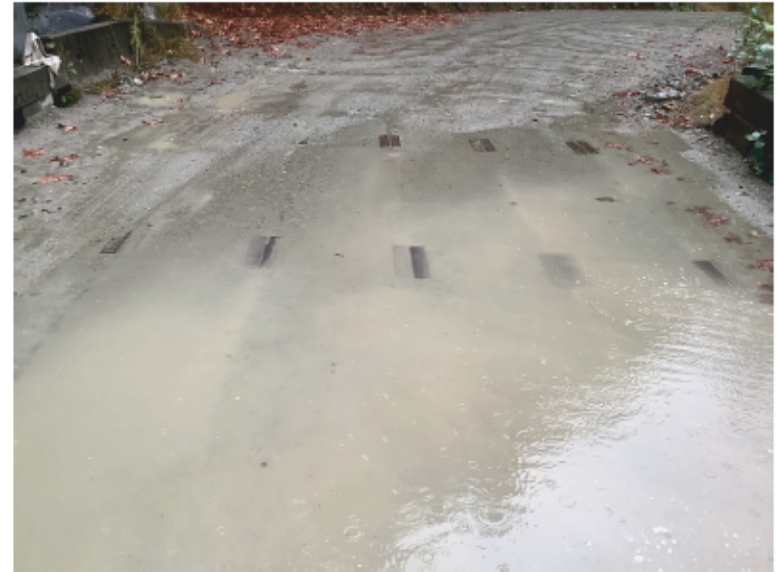
Concrete Deck      Fair      Sediment and pooling water on deck

| Repair Item | Repair Description |
|---|---|
| 2 Approach. Surface drainage maintenance (drains, catch basins, flumes, ditches). # of items. Priority:Low | Add water control measures to reduce standing water on bridge deck |

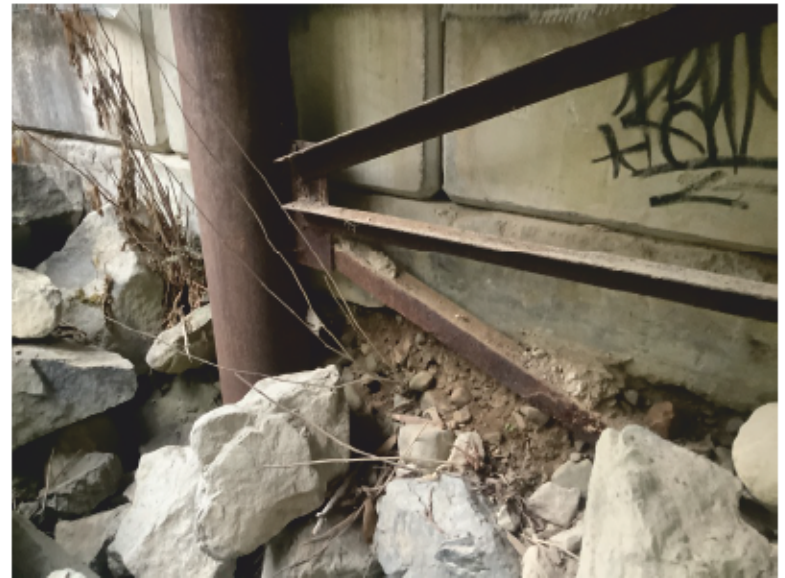
Substructure

Piles or Posts Fair Corrosion noted

Bracing Fair Corrosion

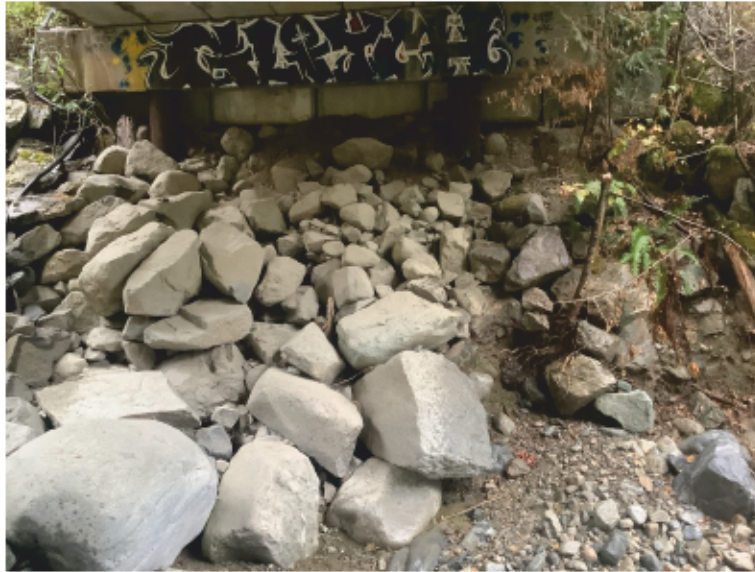
Left Bank Abutment when facing downstream

Comments: Shortened inspection cycle to monitor abutment condition. Recommend completing repairs to abutments as soon as possible to prevent further erosion of river left abutment. Potential to impact foundation, depending on footing depth. Reassess slab damage in 2024.

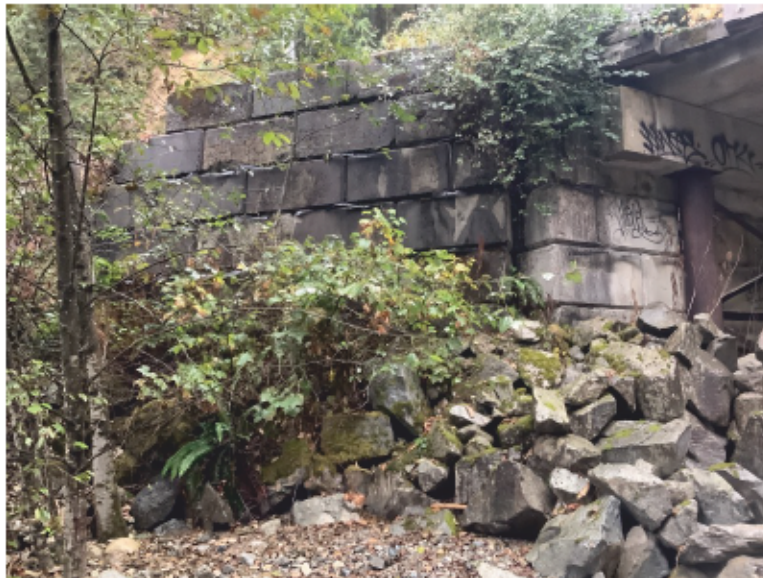
Downstream right wing wall

Wing Wall Good Downstream right lock block wall
