CK-2449  
CK-2449

NORRISH 3.6km

2022 Inspection

Structure Class Major Culvert

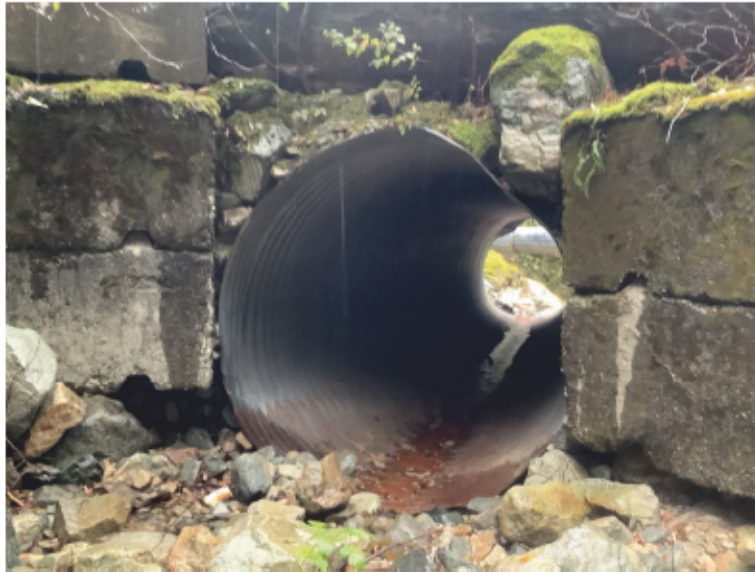
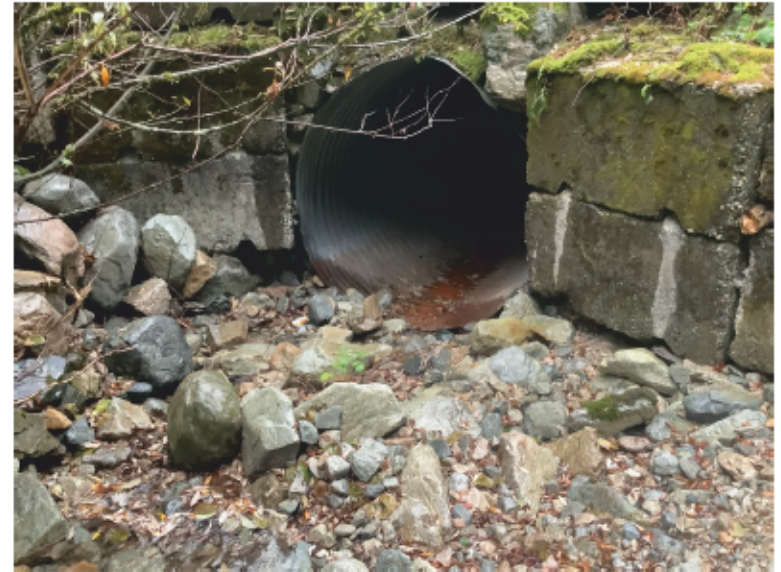
Inlet      Fair      Minor scour beneath fill retention blocks.

| Repair Item | Repair Description |
|---|---|
| 2 Channel. Debris removal. # of sites/items. Priority:Medium | Remove veg at inlet and construct small sump |

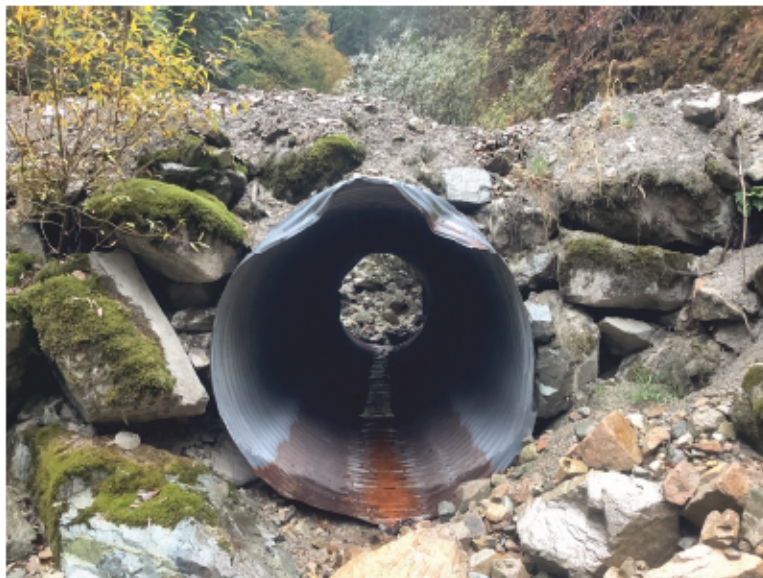
Outlet

Roof      Fair      Minor deformation at outlet

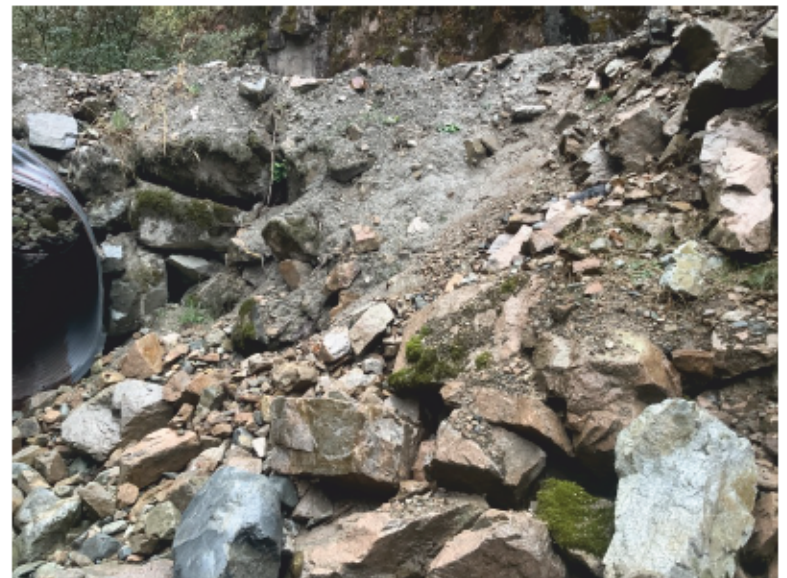
Downstream left riprap

Down stream left riprap has scoured away. Fill at risk. Downstream right toe is scouring, riprap still currently In place. Culvert is short, resulting in oversteepened fills on all 4 corners

| Repair Item | Repair Description |
|---|---|
| 1 Channel. Add Riprap (placed). m³. Priority:Medium | Repair downstream riprap |
