CK-2452  
CK-2452

NORRISH 7.1km

2022 Inspection

Crossing Name Rose Creek

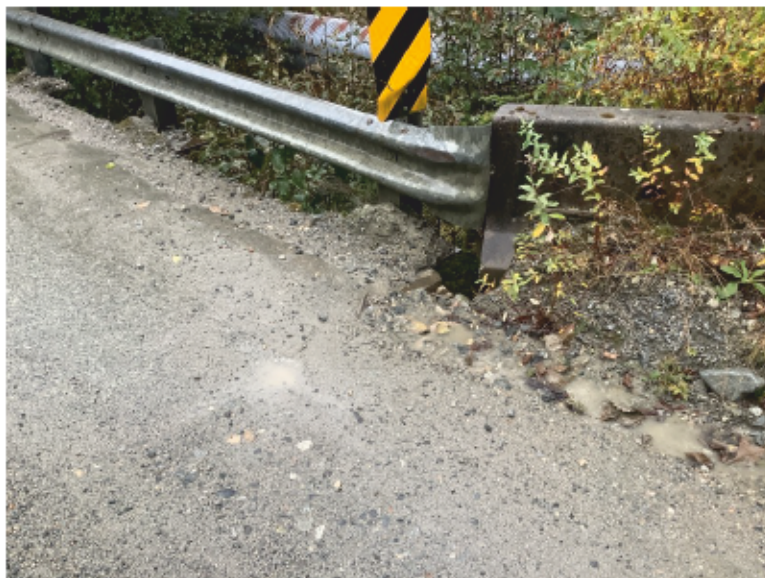
Road Surface Fair Minor potholes. Water flows down road and beside right downstream ballast wall

Water erosion

Ditch right approach to stop water from flowing behind ballast wall.

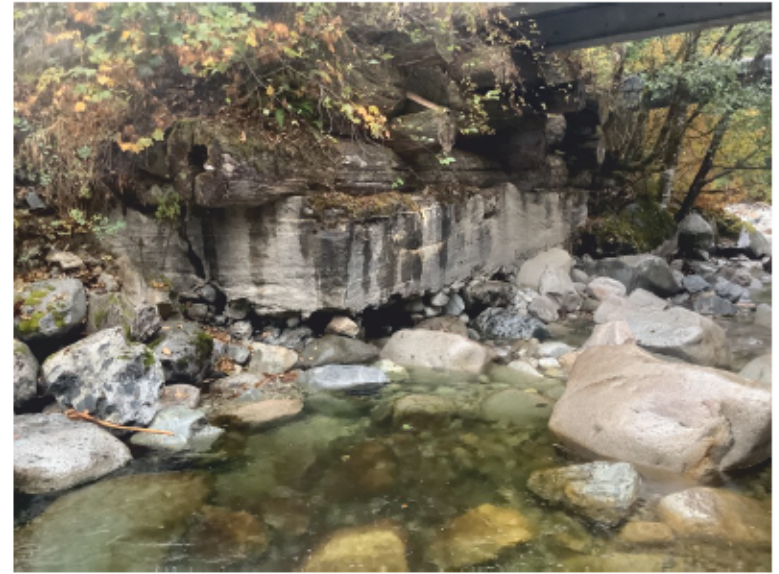
Left Bank Abutment when facing downstream

Concrete Fair Upstream left cip is cracked beneath bearing. And along the upstream side. Also scoured beneath. Could lead to settlement, however appears to be the same as previous inspection.

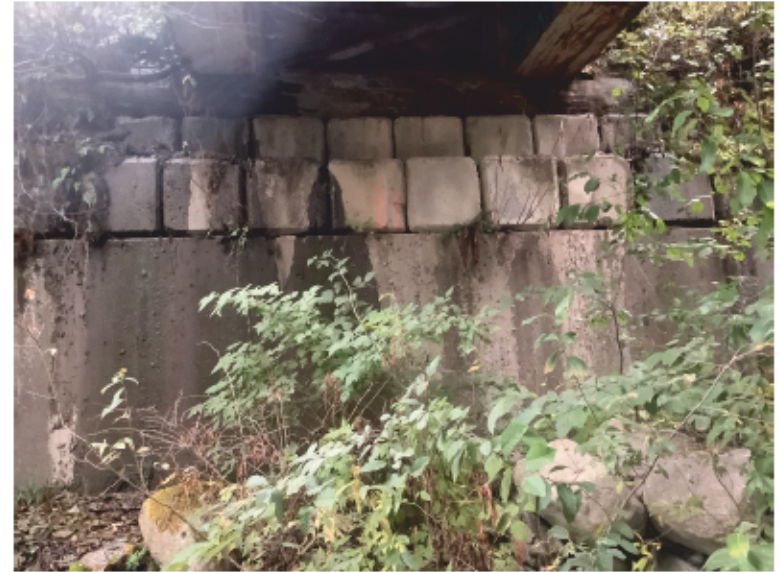
Right Bank Abutment when facing downstream

Caps or Sills Fair Single sill on blocks on right abutment. Up to 80mm sap rot.

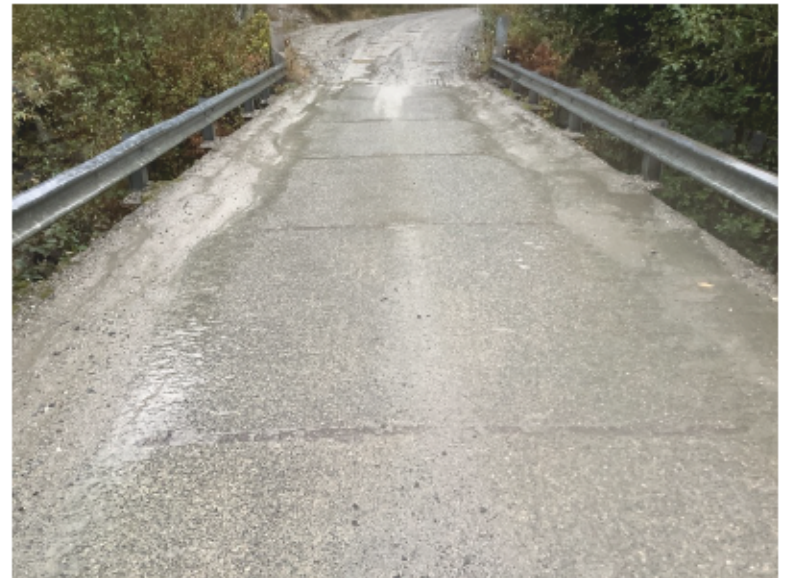
Concrete Deck Fair Shows age. Wear in wheel path
